# TECHNICAL BULLETIN

## LTB00660NAS2

#### Front / Rear Bumper Harness Protective Sleeve

**Situation:** The front and/or rear Parking Aid system may be inoperative.

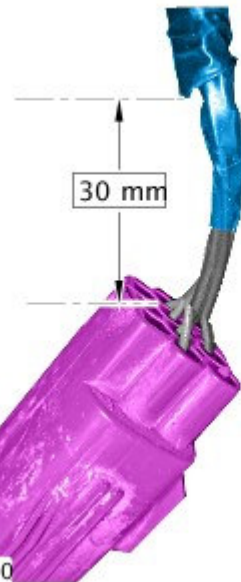
E165440

**NOTE: There must be a minimum of 30mm between the electrical connector and the protective sleeve.**

Use suitable tape to secure the protective sleeve to the rear Parking Aid system sensor wiring harness.
