NUMBER: 02-006-14

GROUP: Front Suspension

Front Suspension Clunk Noise While Making Left And Right Turns

2012 - 2015 (FF) 500

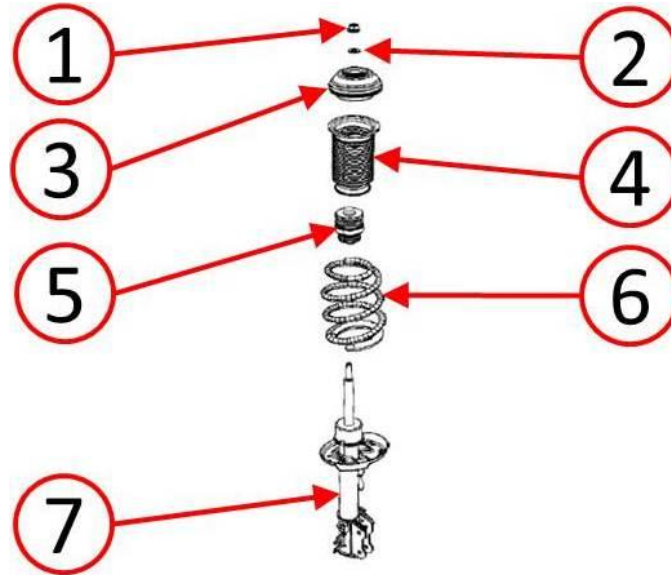
Fig. 1 Strut Assembly

- 1 - NUT, Hex, M12x1.25
- 2 - WASHER, Flat, M12
- 3 - MOUNT, Strut
- 4 - SHIELD, Shock Absorber Dust
- 5 - BUMPER, Jounce
- 6 - SPRING, Front Coil
- 7 - STRUT, Front Suspension

4. Disassemble the front strut assemblies. Refer to the detailed service procedures available in DealerCONNECT> TechCONNECT under: Service Info> 02 - Front Suspension> Front> STRUT, Suspension, Assembly> Disassembly.
5. Discard the old jounce bumpers (5) (Fig. 1).
6. Assemble the front strut assemblies with the **NEW** jounce bumpers (5) (Fig. 1). Refer to the detailed service procedures available in DealerCONNECT> TechCONNECT under: Service Info> 02 - Front Suspension> Front> STRUT, Suspension, Assembly> Assembly.
7. Install the front strut assemblies. Refer to the detailed service procedures available in DealerCONNECT> TechCONNECT under: Service Info> 02 - Front Suspension> Front> STRUT, Suspension, Assembly> Installation.
