Technical Service Bulletin

01 MIL on (DTC P0456 or DTC P0442 (EVAP emission control system leak detected))

01 14 58 2035519/3 January 14, 2014. Supersedes Technical Service Bulletin Group 01 number 13-40 dated November 4, 2013 for reasons listed below.

Model(s)	Year	VIN Range	Vehicle-Specific Equipment
Q7	2013 - 2014	All	Not Applicable

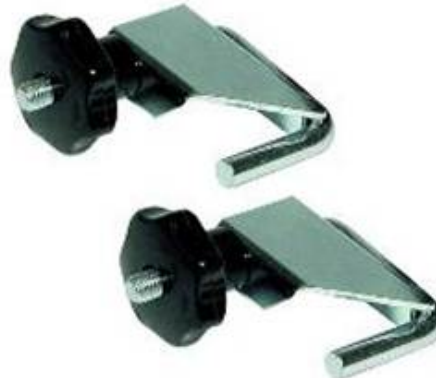
Figure 2. Tool -3094-, hose clamps.

- Clamp off the hose that leads to the LDP air filter (Figure 1). Use hose clamps up to 25 mm diameter (Figure 2).
- Pressurize the EVAP system to 12 inch/water (30mbar), and check pressure loss over time.
