NUMBER: 23-028-14

Hood Latch Release Cable Hangs Down Too Low Under Instrument Panel

This bulletin involves routing and securing the hood latch release cable.

2015 (UF) 200

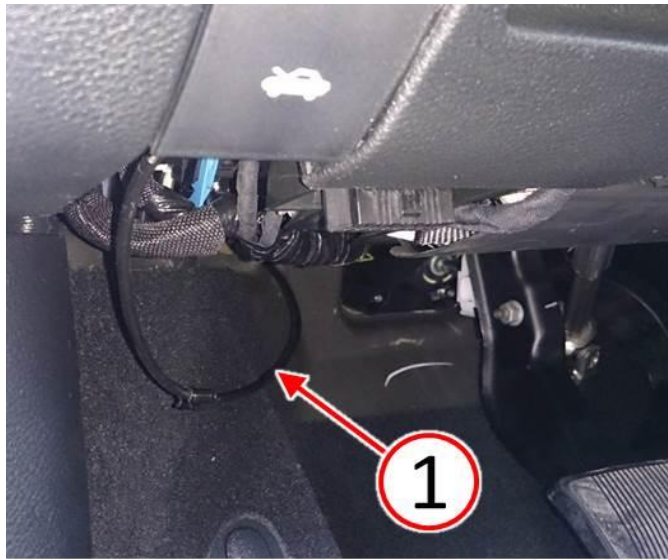
Fig. 1 Hood Release Cable Hanging Down

1. Is the hood latch release cable (1) hanging down too low under the instrument panel as shown in (Fig. 1)?
 - a. YES>>> Continue with the Repair Procedure [Step #2](#).
 - b. NO>>> This Bulletin does not apply. Further diagnosis is required.

1 - Hood Latch Release Cable

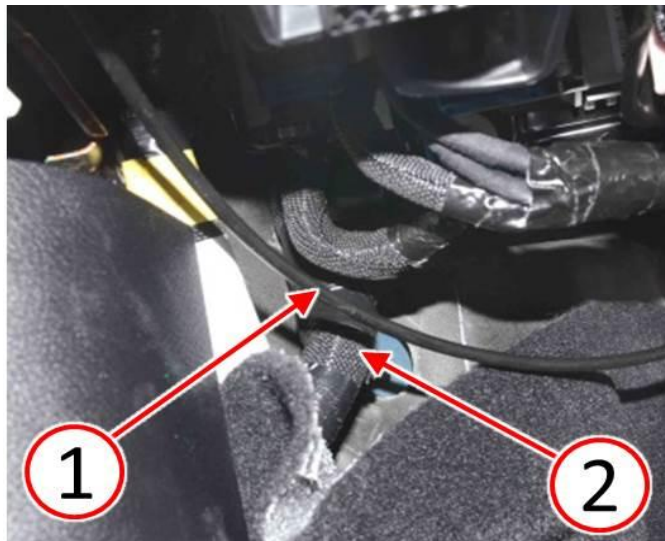
Fig. 2 Hood Release Cable In Front Of Harness

2. Is the hood latch release cable (1) routed in front of the wire harness (2) as shown in (Fig. 2)?
- Yes>>> Continue with [Step #3](#).
 - No>>> Proceed to [Step #6](#)

1 - Hood Latch Release Cable

2 - Wire Harness

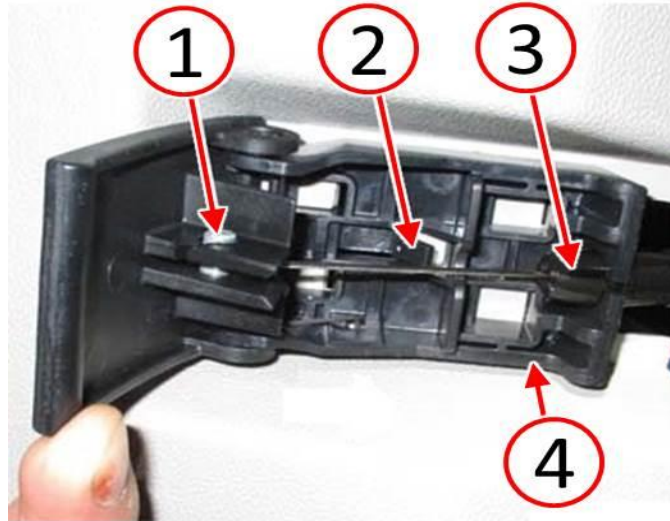
Fig. 3 Disconnect Hood Release Cable

- 1 - Cable End
 - 2 - Retaining Tab
 - 3 - Cable Retainer
 - 4 - Hood Release Handle
-

3. Disconnect the hood latch release cable by pressing the tabs and release the cable (3) from the hood release handle (4) then remove the cable end (1) (Fig. 3).

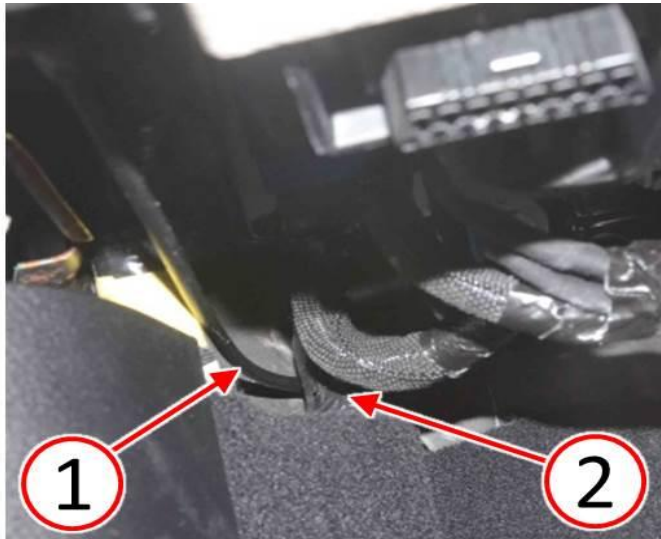
Fig. 4 Route Hood Release Cable Behind Harness

- 1 - Hood Latch Release Cable
 - 2 - Wire Harness
-

4. Route the hood latch release cable (1) behind the wire harness (2) as shown in (Fig. 4).

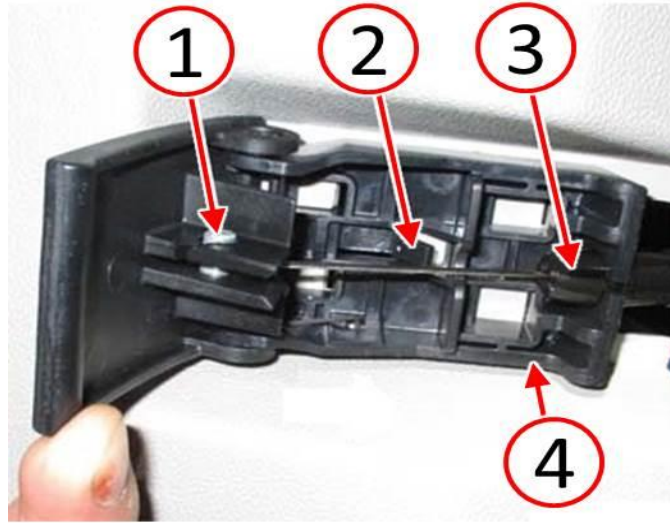
Fig. 5 Connect Hood Release Cable

- 1 - Cable End
- 2 - Retaining Tab
- 3 - Cable Retainer
- 4 - Hood Release Handle

5. Install the cable end (1) then engage the cable (3) into the hood release handle (4) (Fig. 5).

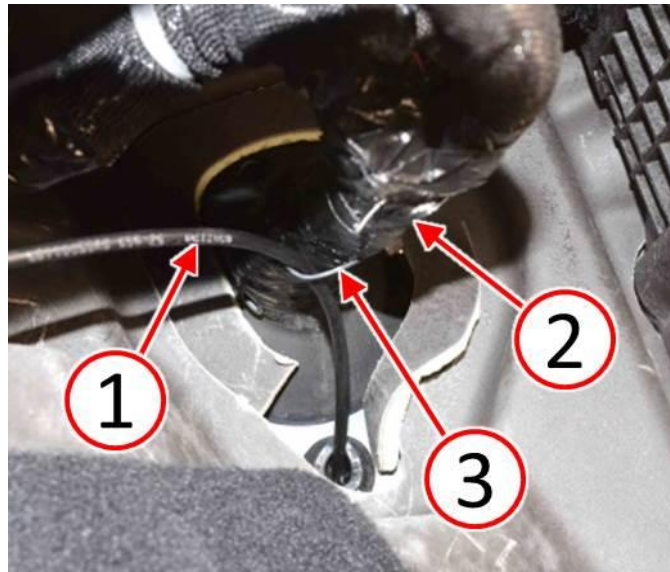
Fig. 6 Secure Hood Release Cable To Harness

- 1 - Hood Latch Release Cable
- 2 - Wire Harness
- 3 - Tie Strap

-
6. Near to where the hood latch release cable passes through the front cowl, secure the hood latch release cable (1) to the wire harness (2) with a tie strap (3) and remove any excess tie strap material (Fig. 6).

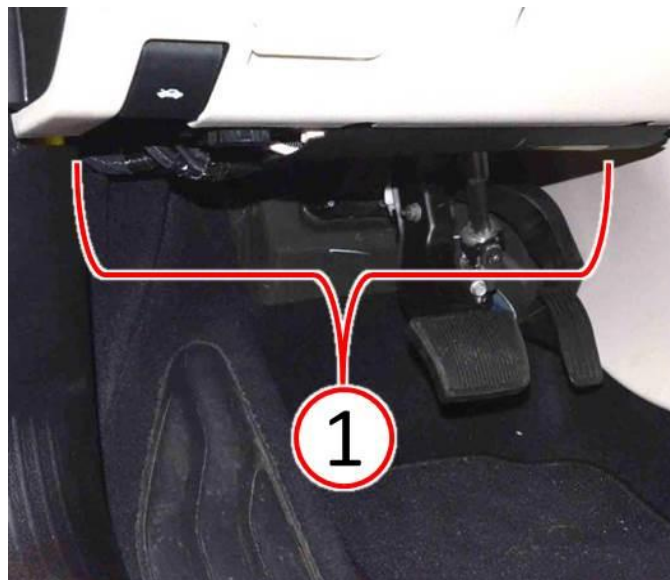
Fig. 7 Hood Release Cable Not Hanging Down

- 1 - Under Instrument Panel
-

-
7. Ensure that the hood release cable is now secured and not hanging down too low under the instrument panel ([Fig. 7](#)).
