SERVICE BULLETIN

APPLICABILITY: 2013MY BRZ

NUMBER: 02-151-14R

SUBJECT: Revised Valve Train Parts to Reduce a Warm Engine
 Tapping Sound from the Left Cylinder Head

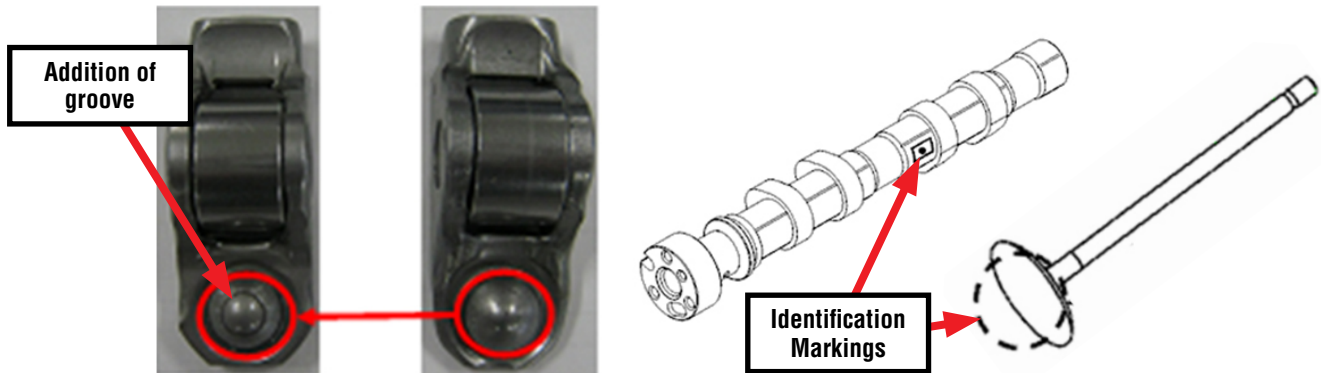
The illustrations below show additional information about the changes to the valve rockers, camshafts and valves to help readily distinguish them from the previous version parts.

If you receive a customer concern of a tapping sound from the B2 cylinder head, confirm it is isolated to the B2 valve train area before proceeding with any repairs. Once verified, order and replace the intake and exhaust camshafts, the 4 intake valves, 4 exhaust valves, all 8 rockers and all 8 pivots. Refer to the service procedures outlined in the applicable Service Manual for installation.

NOTE: When setting the valve clearances, the intakes should be set to 0.13mm +0.02 / - 0.03 and the exhausts set to 0.22mm +/- 0.02. **These are revised clearance specifications and are not reflected in the Service Manual.**

IMPORTANT: Do not mix old and new parts together as it will become impossible to obtain intake valve clearances that are within specification.
