Technical Bulletin

00 14 11 October 15, 2014 **2033708** Supersedes Technical Bulletin V001303 dated May 1, 2013 to include MY15 and update product pictures.

Removing Paint Contaminants from Exterior Paint

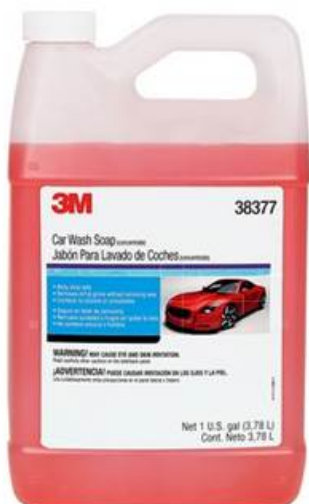
Figure 1

- Wash and rinse vehicle thoroughly using 3M™ Body Shop Clean-Up Car Wash Soap (Figure 1). Follow instructions on the product label.
- Check exterior surfaces using your hand to feel for a rough or gritty texture, indicating contaminants.

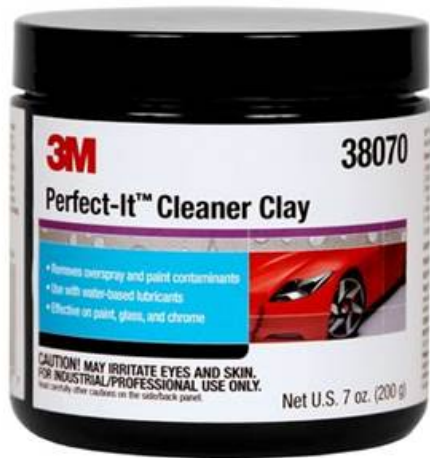
Figure 2

- If contaminants are found, work affected areas with 3M™ Perfect-It III™ Cleaner Clay (Figure 2) following instructions on the product label. Use the 3M™ Car Wash Shampoo as a lubricant. Repeat as necessary.

To reduce scratching, knead clay periodically and store in container.

Dispose of bar when contamination becomes excessive.
