Service Bulletin

Bulletin No.: PIT5288

Subject: RKE / Passive Entry & Start / SWC / Touch Screen Inoperative / No Audio / DTC B3101 U0028 U0029

Models: 2015 Cadillac Escalade Models
2014 Chevrolet Silverado 1500
2015 Chevrolet Silverado, Suburban, Tahoe
2014 GMC Sierra 1500
2015 GMC Sierra and Yukon Models

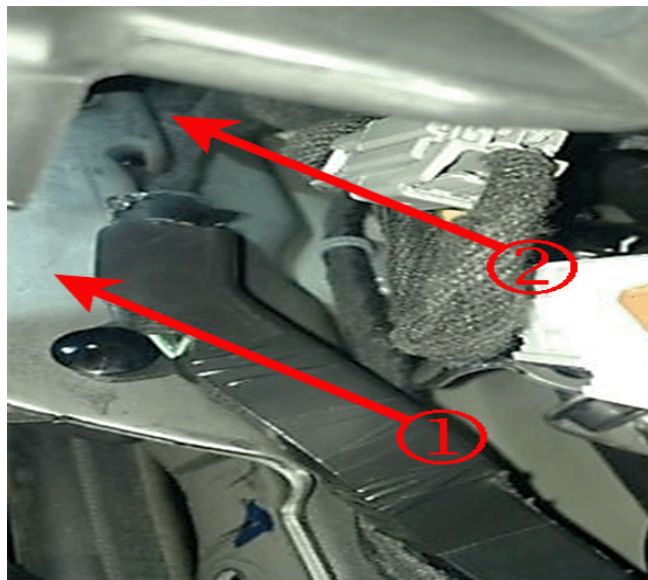
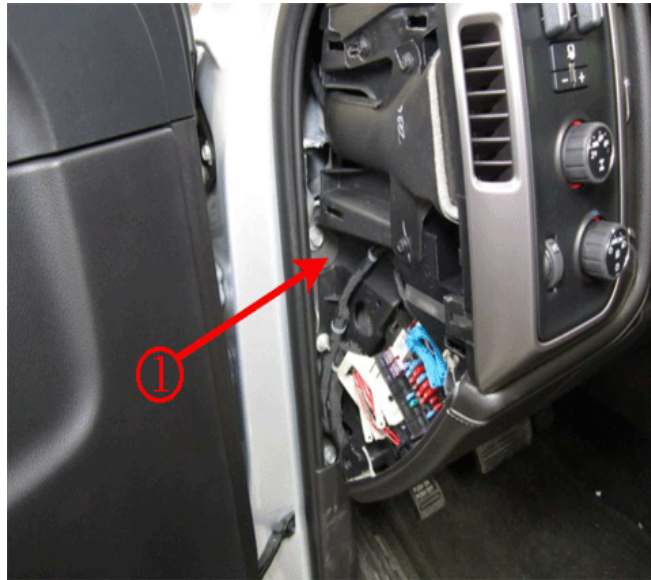
3910938

These concerns could be caused by the dash harness (2) being pinched between the left I/P dash mounting bracket (1) and the body, as shown below. In many cases, the complete harness is not pinched and may not be as apparent as shown in the below photo. When inspecting for a pinched harness, make sure the harness can be moved freely away from the bracket to body interface.

To repair this concern, loosen the left I/P dash mounting bracket bolts and pull the harness free. Open the harness and repair any damaged wires as necessary.
