Bulletin No.: PIC5606A

Service Bulletin

Subject: Diagnosing SES Light On No Start And Various Other Electrical Concerns

Models: 2012 - 2013 Chevrolet Impala
2014 Chevrolet Impala Limited

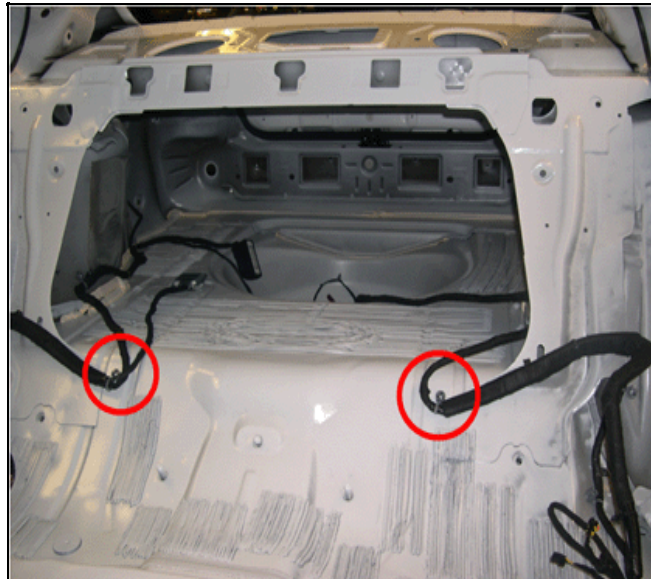
2746263

Vehicles could have the wiring harness under the back seat twisted and pinched causing open circuits, shorts to ground, and shorts to other circuits in the harness.

When diagnosing for the above DTCs, please remove the back seat and check the areas circled in the picture below. If the harness is found to be damaged please repair the harness and reroute it so it is not twisted and pinched under the back seat.

For wiring repairs covered under warranty, please refer to latest version of bulletin 10-00-89-005 for warranty information on wire/connector repairs.
