**SB-10054723-8724**

N13 / EPA10 Engine

Document ID: IK0900094

**Title: Preventative Maintenance on Horton Stratis Fan Hub Anti Rotation Bracket****Applies To: ProStars, LoneStars, Workstar****DESCRIPTION**

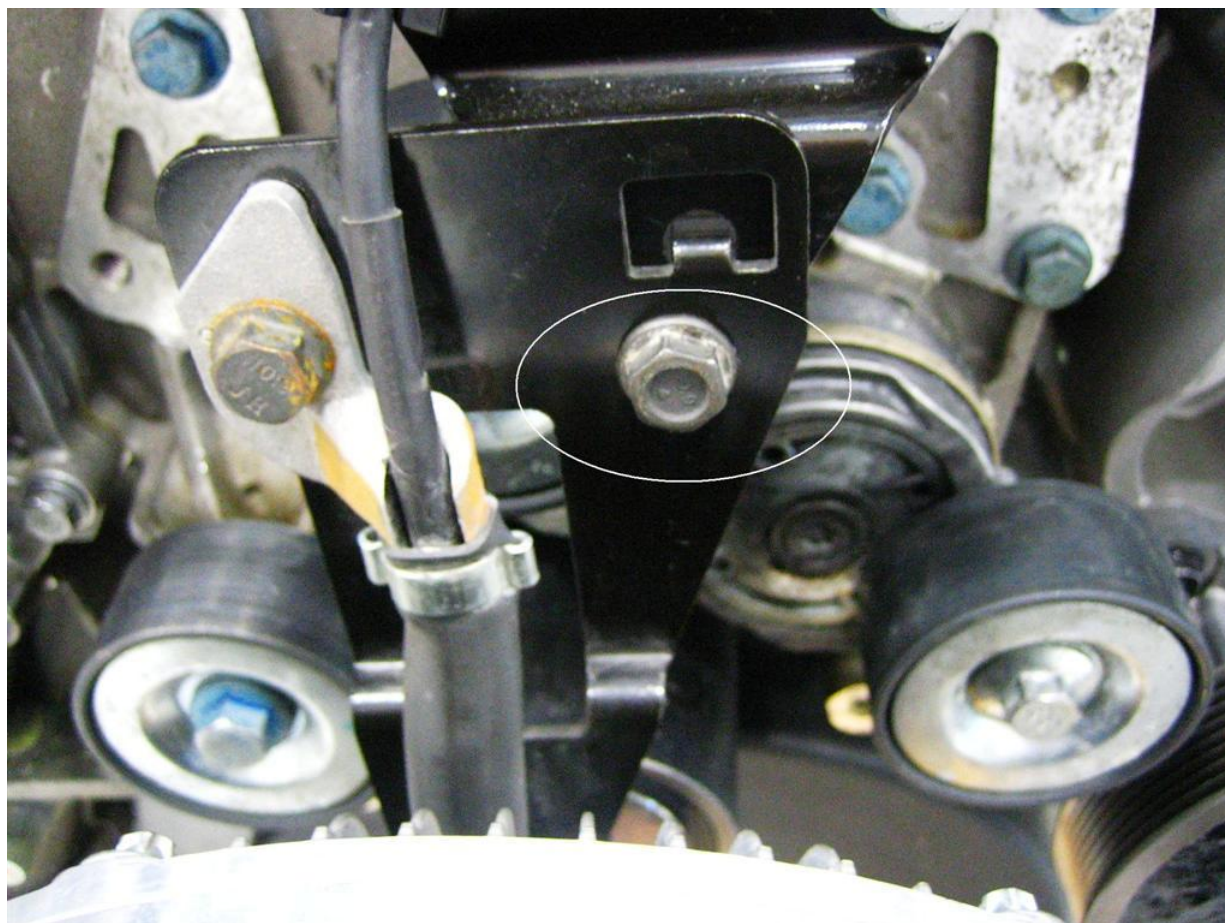
The bolt that attaches the Horton Stratis Anti Rotation Bracket (ARB) to the engine found missing or loose.

When performing any routine maintenance or under hood service it is important to visually inspect the fan / fan hub for loose or missing mounting and support hardware. We have seen a few recent cases where this bolt has loosened and needs to be secured before additional damage has occurred. Failure to secure the loose hardware / bolt could result in a fan hub failure. Torque value on this bolt is 17 Inch Pounds (23 Nm)

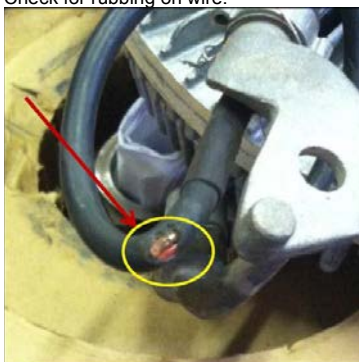
- Check for rubbing on wire.

- If rubbing is present and inside wires are visible, but no copper is visible apply heat shrink over the harness.
- If copper can be seen, check to see if it is only one single wire, or multiple wires.
  - If it is one wire, place electrical tape over the wire.
  - Using 4:1 heat shrink will allow the heat shrink tubing to pass over the connector as shown. P/N: ZBJE849565 or equivalent

- If multiple wires are showing copper, remove and replace the fan hub assembly.
  - Reroute the wiring harness at outlined in the "Harness Re-Route Procedure" in this iKNow article.

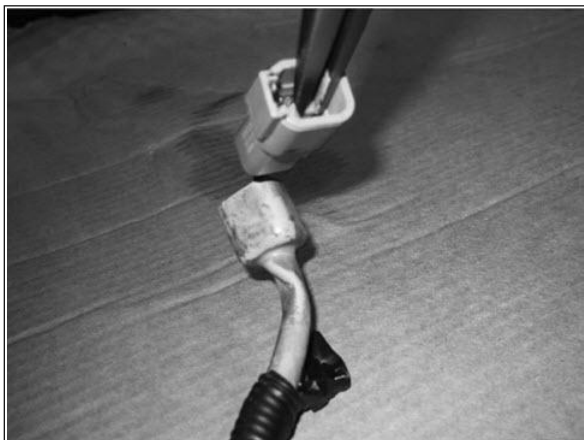
**Figure 2. Primary Lock**

9. Using needle nose pliers, remove primary lock from fan clutch harness connector (Figure 2).
