SB-10054998-4055

Title: 8600 Front Spring Shackle Contacting Fuel Tanks**Applies To: 8600 TranStar Models Only****DESCRIPTION**

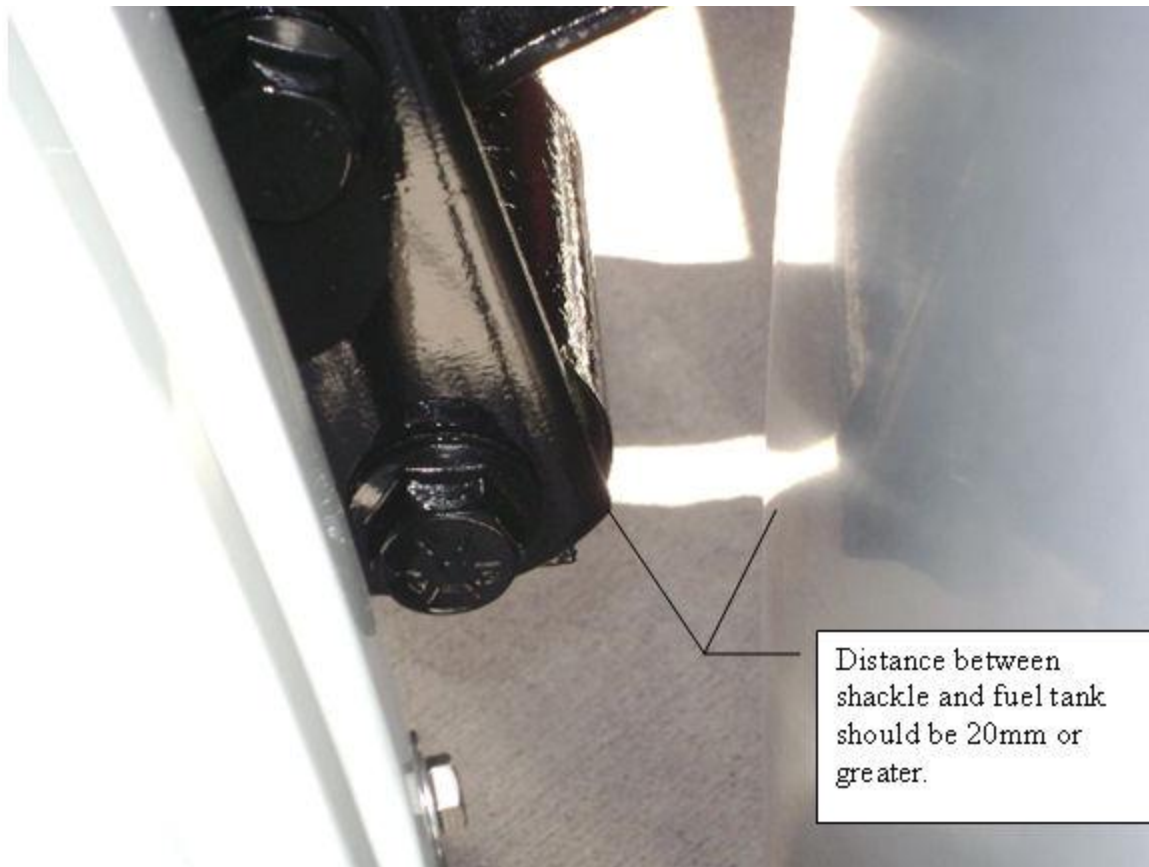
Rear shackle of steer axle spring suspension contacting fuel tank when unit is in use

Damage to fuel tank.

1. Verify that there is a least 20mm or more of clearance between the spring shackle and front of fuel tank

Loosen tank straps and move tank toward rear of vehicle to achieve a minimum of 20mm of clearance. Make sure tank straps are properly positioned and retorque to 37 to 45 ft lbs.
