Service Bulletin

Bulletin No.: PI1181

Subject: Oil Pan Heater Cord Replacement

Models: 2012-2014 Chevrolet Sonic
Equipped with 1.8L Engines (RPO LUW, LWE)
and Oil Pan Heater (RPO KPK)
Vehicles Built Prior to September 6, 2013

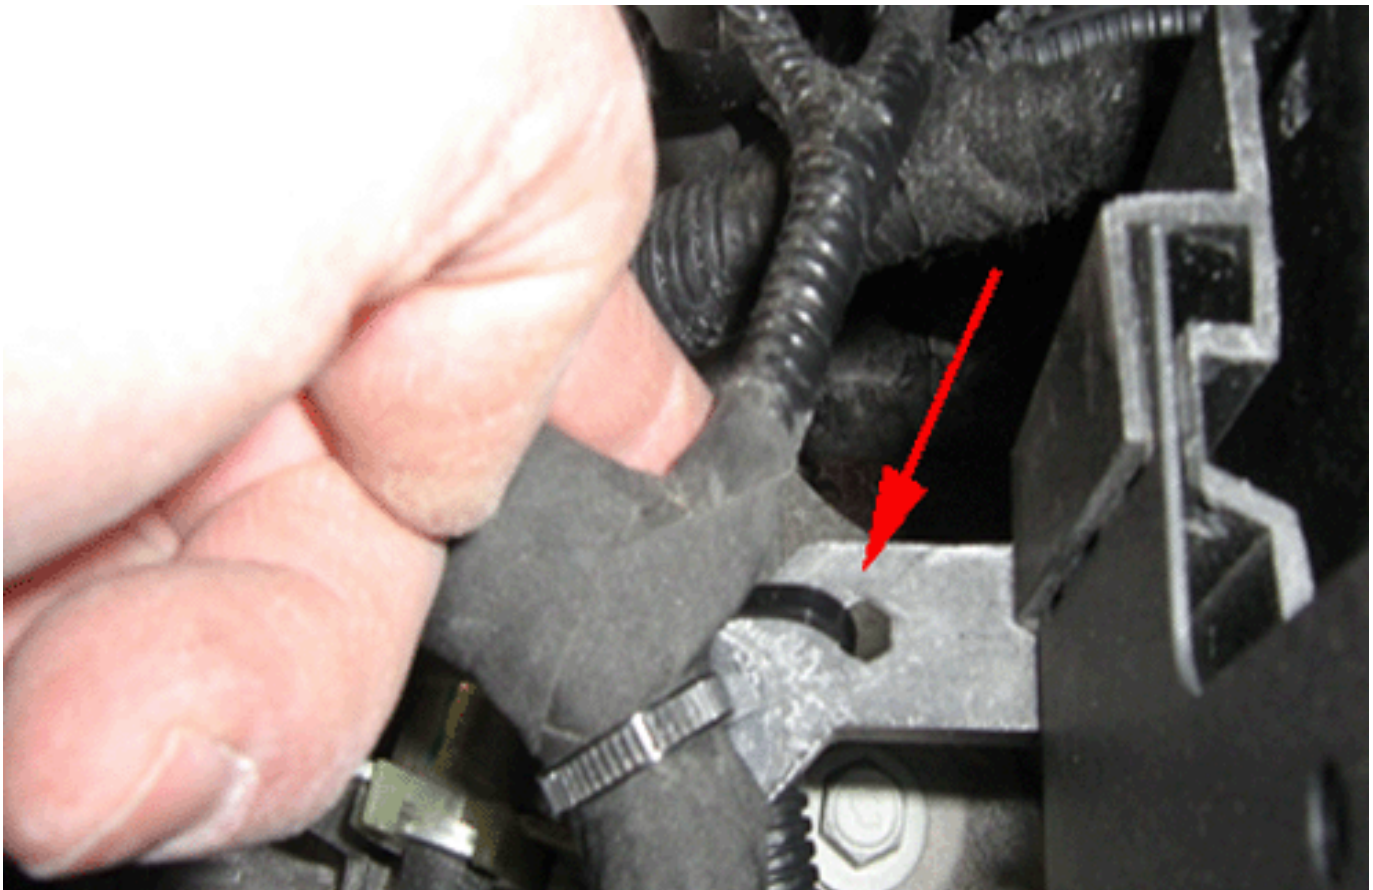
The Sonic oil pan heater cord is bundled in production with the battery cable harness. Should the heater cord become damaged and require replacement, the complete battery harness has to be replaced.

1. Prep the new cord for installation by removing all the clips except the one closest to the female end of the cord.
2. Remove each end of the cord where it enters and exits the vehicle harness and discard the ends and associated clips.
3. Plug the new cord into the oil pan heater and route the cord along the top of the existing vehicle harness using tie straps to secure.

- Tie strap the new cord to the existing hole on the battery tray while routing the cord underneath the ECM harness as shown in the illustration above.
