SB-10055373-6141

GROUP Engine	MODEL 2012MY Optima (QF)
	NUMBER 138	DATE January 2014
TECHNICAL SERVICE BULLETIN		
SUBJECT: SERVICE ACTION: OPTIMA (QF) EWGA INSPECTION AND ADJUSTMENT (SA119A)

SUBJECT: SERVICE ACTION: OPTIMA (QF) EWGA INSPECTION AND ADJUSTMENT (SA119A)

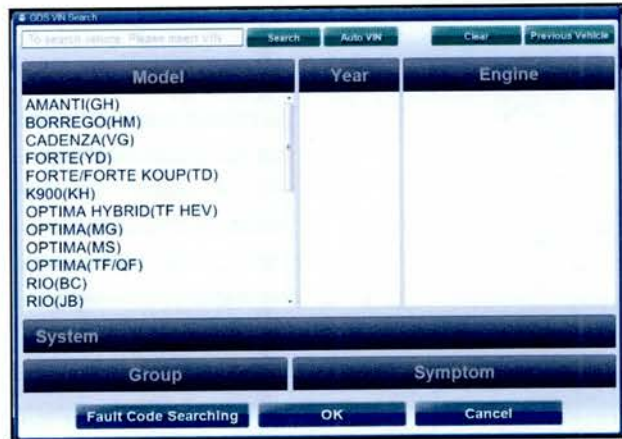
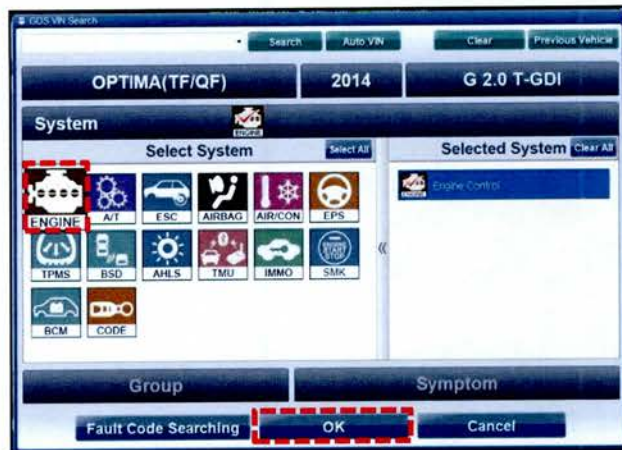
Enter vehicle information by pressing the **Auto VIN**, entering the VIN or selecting the vehicle model, model year, engine type, and **Engine Control** as the system, and then click **OK**.

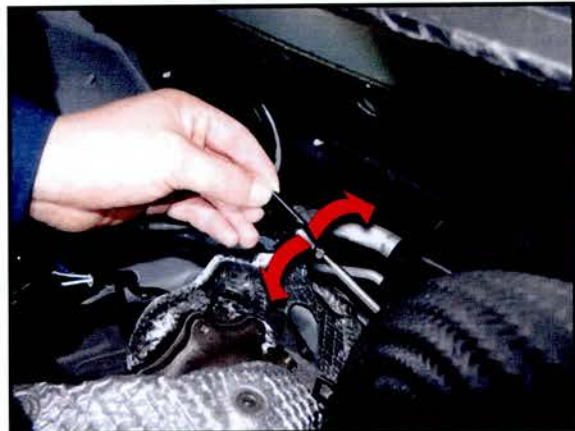
- Adjust the rod end by rotating it clockwise or counterclockwise until specification is within range (See Tables A and B below). Then, temporarily install the rod end and tighten the rod end lock nut. Check the **Adaptation Value for the Lower Mechanical Stop of Boost Pressure**, using GDS.
