# Technical Service Bulletin

## 97 No start (DTC P068A00)

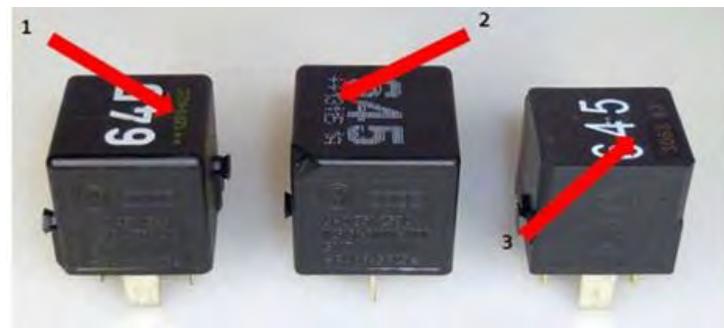
Figure 7. Relay manufacture data: Tyco Electronics relay with a yellow label (1), Tyco Electronics relay with a white label (2), Hella relay with a white label (3).
