SB-10055797-1297

Technical Service Bulletin

97 Replacement fuse panel SA/SB has no power distribution bar (SA panel)

97 14 44 2037079/1 April 29, 2014.

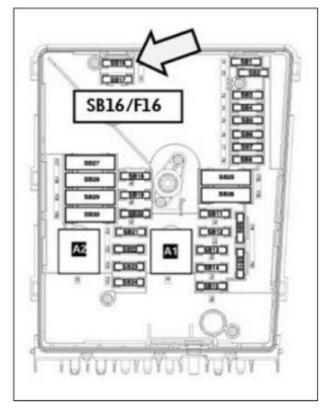
Figure 3. 30A fuse in position SB16.

- 2. Install the power distribution bar from the original fuse panel to the new replacement SB panel.
- 3. A 30A fuse must be used in position SB16 (Figure 3) after the new fuse panel assembly is installed.
