ATB 51877-00169 REV1 (1409)

Front Brake Caliper Bracket Contacts Rotor Causing Grinding, Rubbing, or Screeching Noise

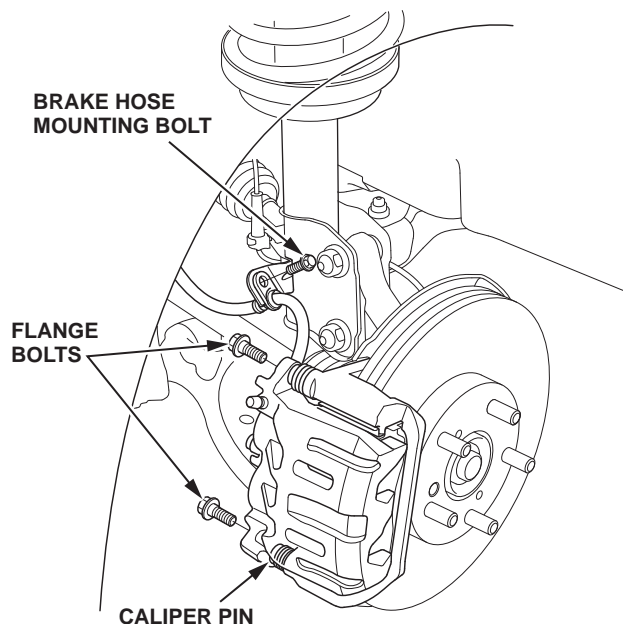
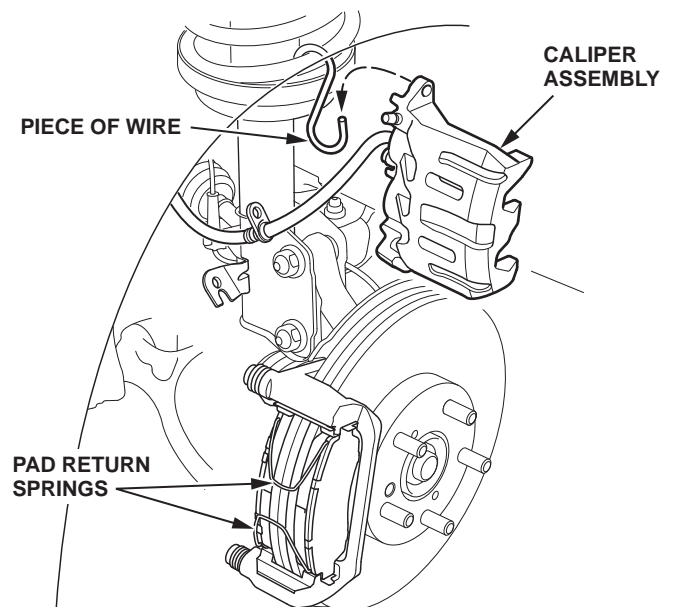
1. Raise and support the vehicle.
2. Remove the front wheels.
3. Remove the brake hose mounting bolt.

4. While holding the caliper pins with a wrench, remove the flange bolts. Being careful not to damage the pin boots, remove the caliper and hang it up out of the way. To prevent damage to the caliper or brake hose, use a short piece of wire to hang the caliper from the undercarriage. Do not twist the brake hose excessively. Check the hose for damage and deterioration.

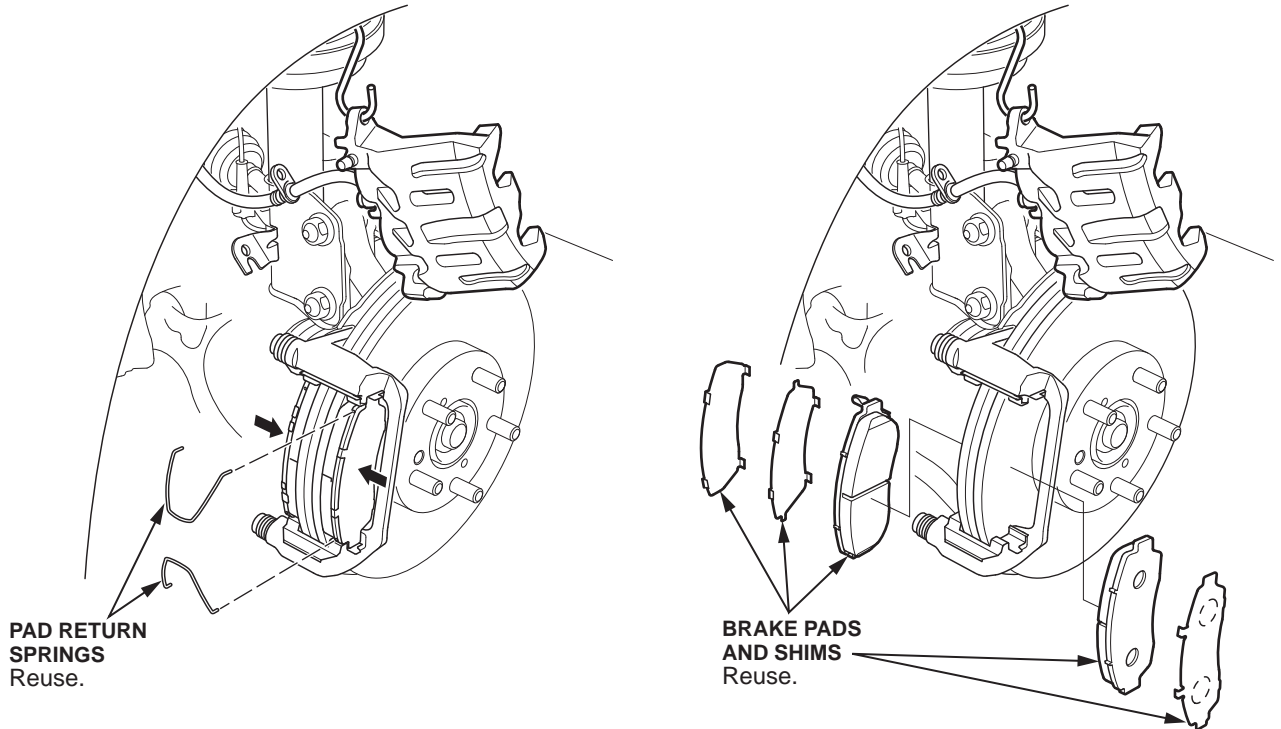
5. Hold the brake pads and remove the pad springs.

NOTE: The pad return springs are installed on the pads to prevent brake drag. Be careful when removing the caliper body or the spring could pop out of position.

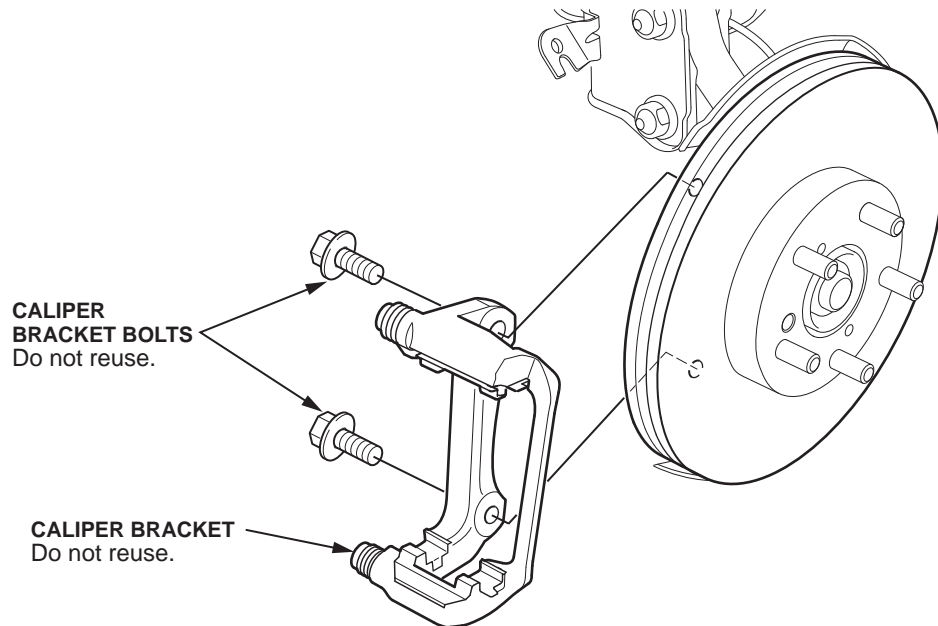
6. Remove the brake pads

7. Remove the brake caliper bracket mounting bolts, then remove the caliper bracket from the knuckle.

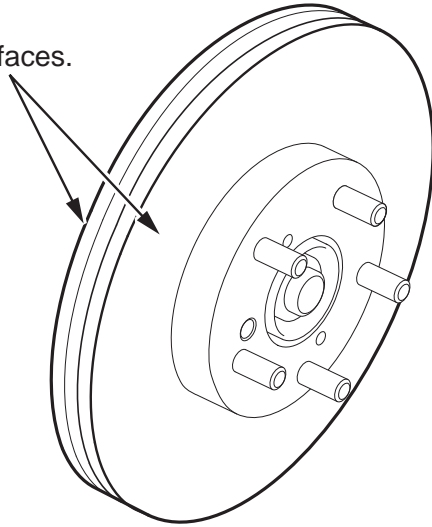
Inspect both disc surfaces.

8. Inspect both surfaces of the brake disc and the insides of both brake retainers for any damage. Repeat for the opposite side.
- If there is damage go to step 09.
 - If there is no damage go to step 11.

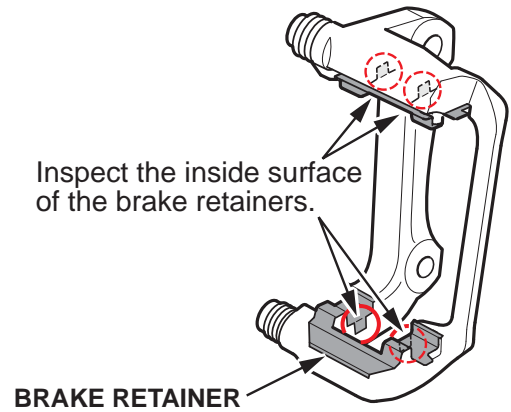
Inspect the inside surface of the brake retainers.

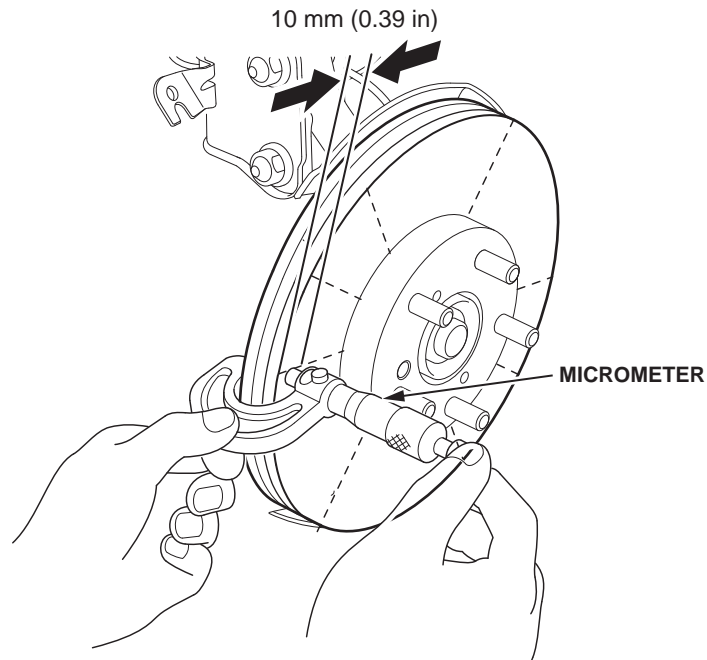
9. Refinish the damaged brake disc (or the side which has a damaged retainer) with a Honda-approved commercially available on-car brake lathe to remove any damage. Refer to S/B 00-088.
10. After refinishing the disc, use a micrometer to measure the brake disc thickness about 10 mm (0.39 in) in from the outer edge of the brake disc. Maximum refinishing limit: 26.0 mm (1.024 in)
- If the disc is within specification, go to step # 11
 - If the disc is not within specification, replace the brake disc then got to step #11

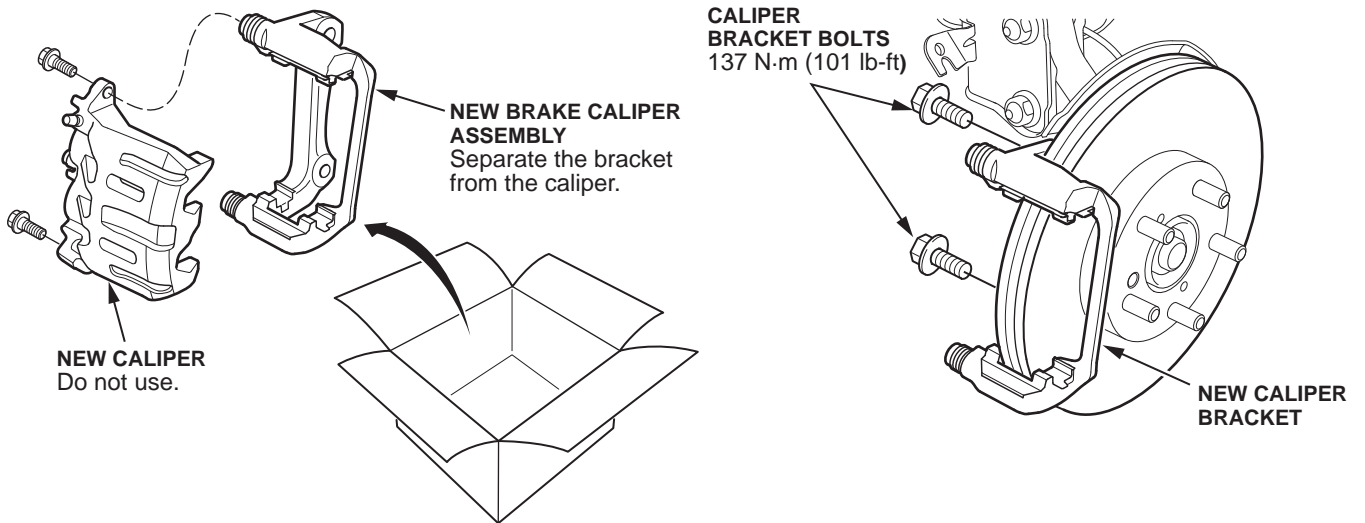
11. Remove the new caliper bracket from the caliper. The new caliper will not be used.

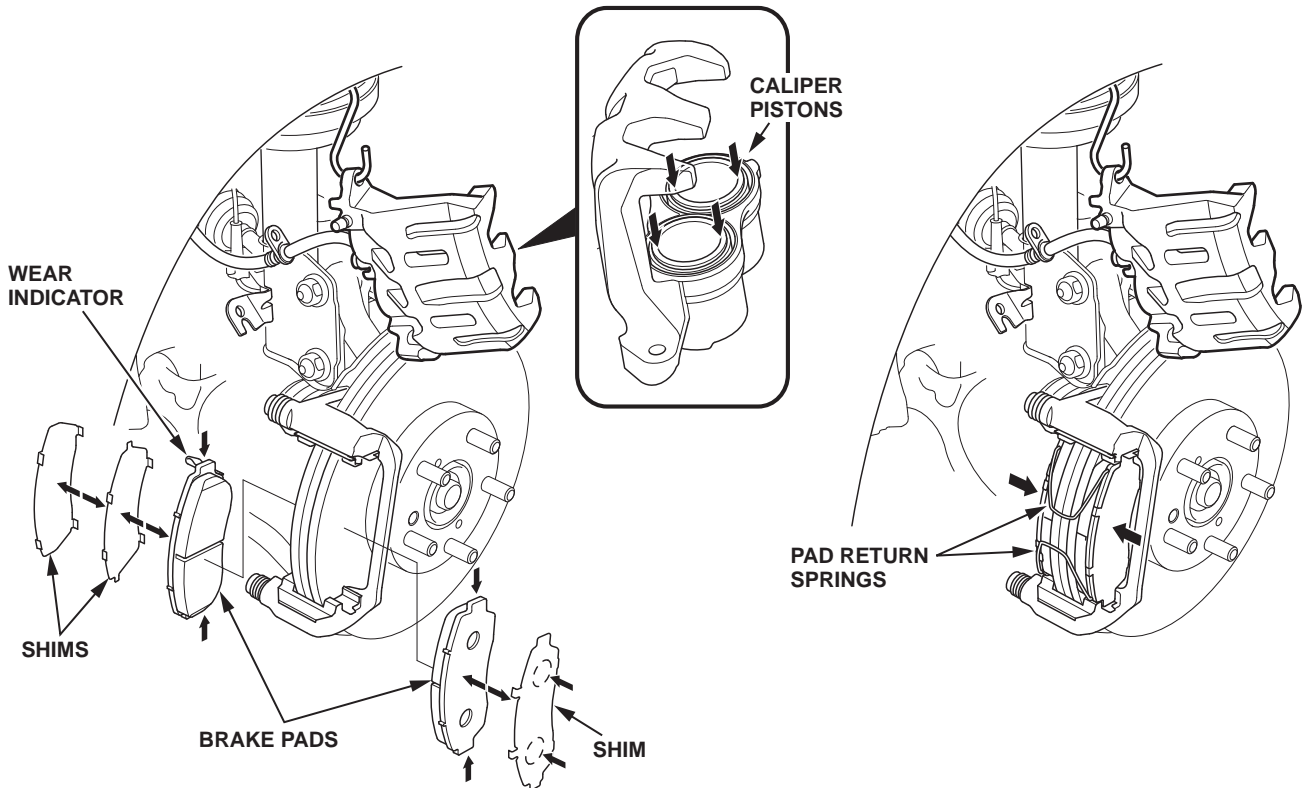
12. Install the new brake caliper bracket and torque the bolts to **137 N-m (101 lb-ft)**.

13. Apply a thin coat of M-77 assembly paste to the retainer mating surface of the brake pad.

NOTE: Keep grease and assembly paste away from the brake disc and brake pad surface. Contaminated brake disc or brake pads reduce stopping ability.

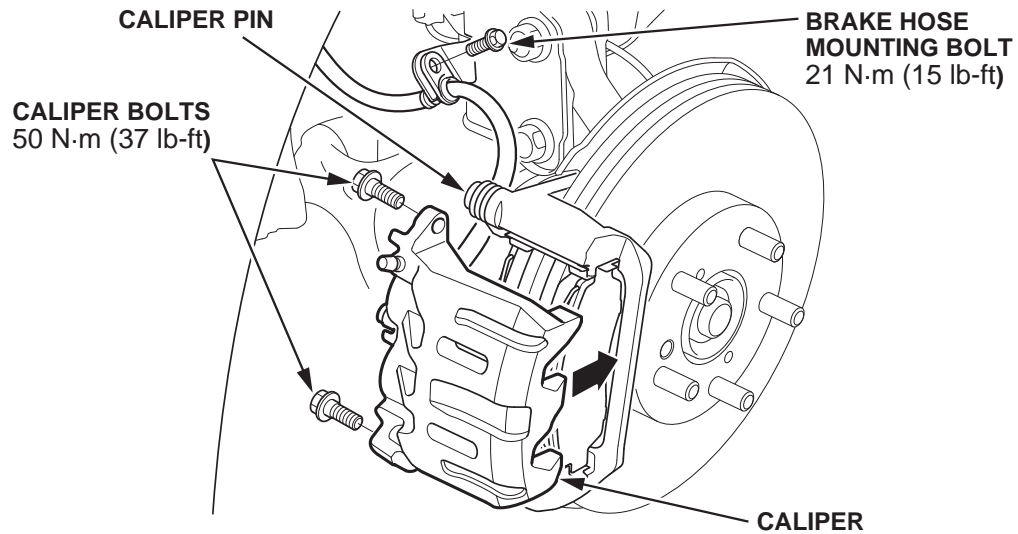
14. Install the original brake pads with the wear indicator on the upper inside position on the new caliper bracket.
15. While holding the brake pads, insert the pad return spring ends into the pad installation holes securely.
16. Install the original caliper onto the bracket. Hold the caliper pin with a wrench and install the flange bolts, and torque them to **50 N·m (37 lb-ft)** being careful not to damage the pin boot.

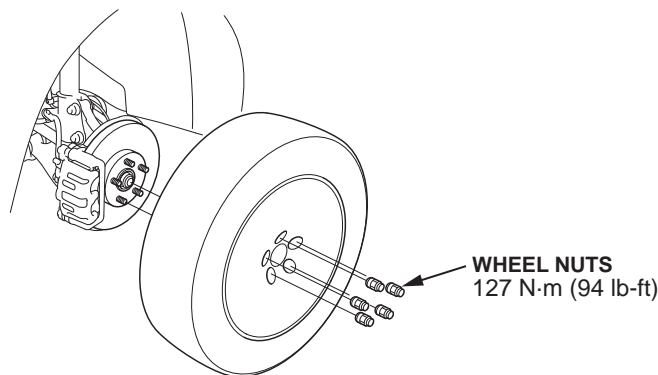
17. Install the brake hose mounting bolt and torque them to **21 N·m (15 lb-ft)**.
18. Clean the mating surfaces between the brake disc and the inside of the wheel, then install the front wheels.
