SB-10057201-2909

Title: Turbocharger Oil Supply Tube Retrofit

Applies To: ProStar® 122, ProStar® 113, WorkStar®, CAT®, TranStar®, PayStar®, LoneStar® models equipped with 2010 MaxxForce® 11 & 13, N13 Engines

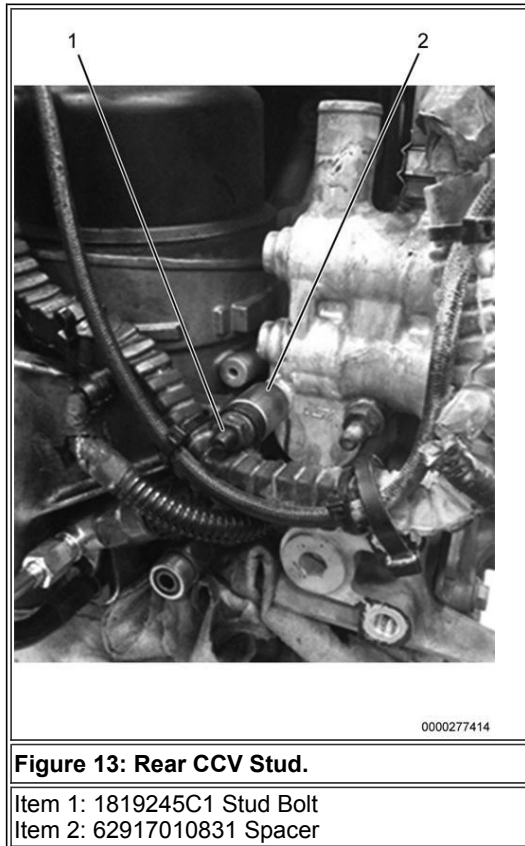
NOTE: The EOP connector may contact the engine harness on early MaxxForce® 11 & 13 (EPA 10) Engines.

31. If EOP sensor connector contacts engine harness:

- Remove rear coolant control valve (CCV) stud bolt, and install spacer with longer stud bolt (Figure 13, Items 1 and 2).
- Install EOP sensor connector.
- Secure engine harness to longer stud with original nut. Tighten nut to standard torque.

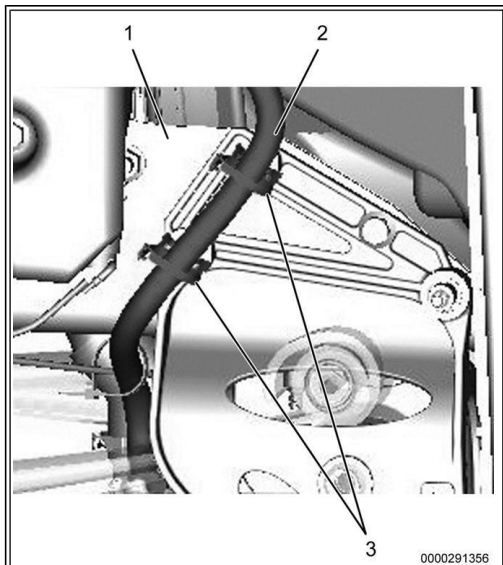
Figure 17: Frame Mounted Heater Hose Routing.

Item 1: Frame
 Item 2: Heater hose
 Item 3: Tie strap (4) (2 not shown)

11. Using two 3948245C1 spin huck saddles and four tie straps (Figure 17, Item 3), secure heater hose (Figure 17, Item 2) to frame (Figure 17, Item 1).
12. Attach heater hose to lower radiator hose. Using torque wrench, tighten clamp to standard torque value.
13. Fill cooling system.
