star bulletin

Date: November 13, 2014
Order No.: T-B-28.00/13
Group: 28

SUBJECT: MY2014 to Present, Model W/X166
Transfer Case Breather Design Change

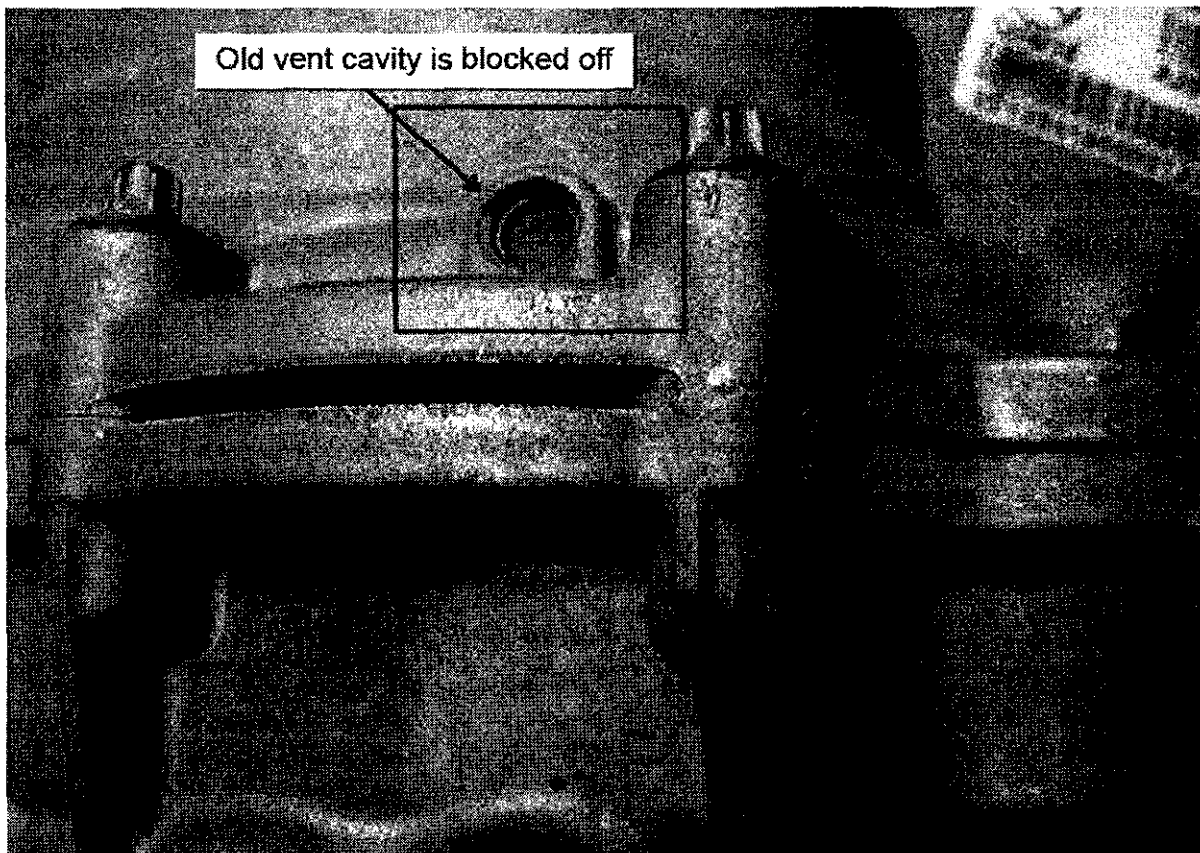
Figure 2. Former vent blocked off in new transfer case

The 166 single speed transfer case breather vent is no longer installed on the top of the transfer case. An open vent has been added to the design near the input of the transfer case (Figure 1). The original vent location is now blocked off (Figure 2). Transfer cases should not be replaced for missing vents in this case.
