MODEL
2011-2013MY
Sorento (XM)

NUMBER
041

TECHNICAL SERVICE BULLETIN

SUBJECT: FRONT STRUT AND DUST COVER REPLACEMENT

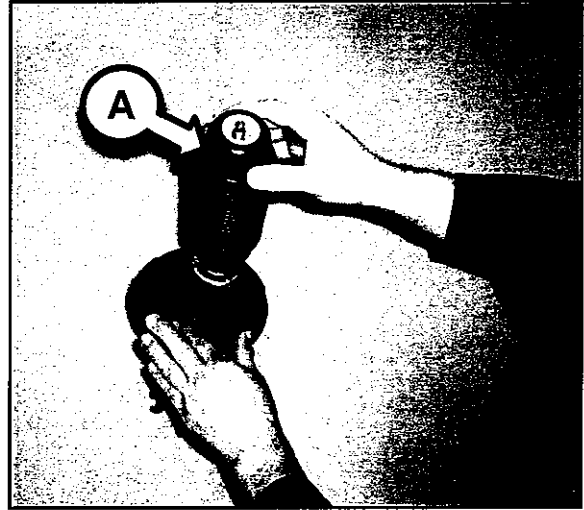
1. Remove and disassemble the front strut assemblies by referring to the service procedures in the applicable Workshop Manual on KGIS.
2. Remove the dust cover (A) from the strut shaft.

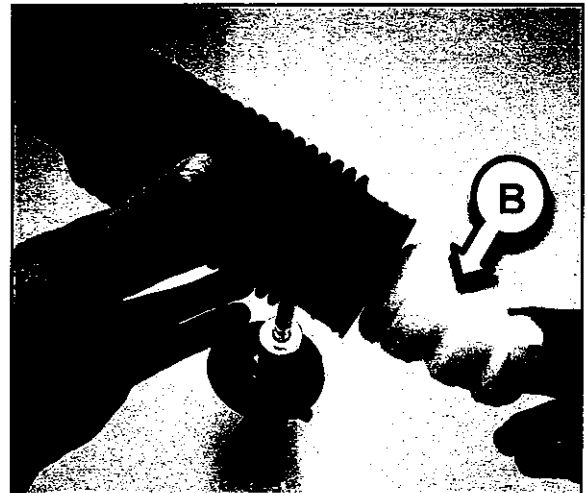
3. Remove the bump stop (B) from inside the dust cover.

Discard the dust cover and the strut.

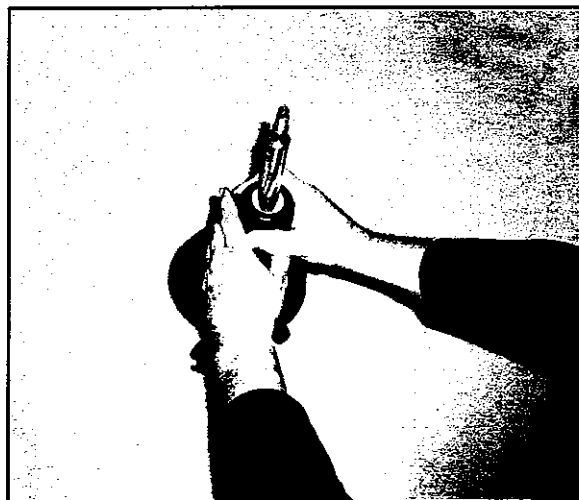
5. Install the dust cover onto the bump stop. Make sure the bump stop is properly seated inside the dust cover.

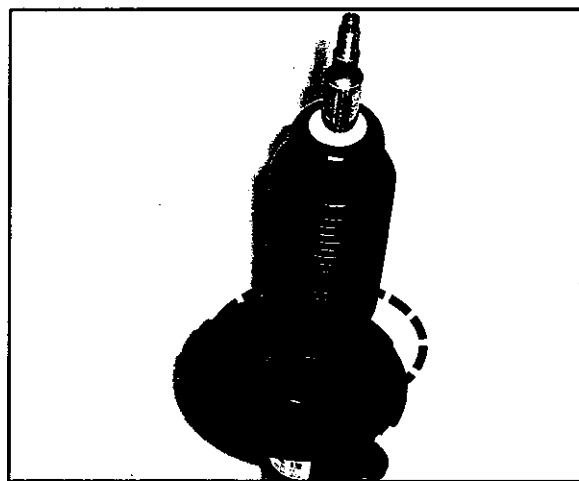
6. Pull the dust cover and bump stop until the bottom lip of the dust cover is slightly below the strut body.
