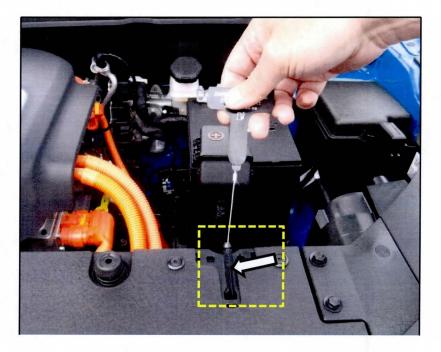
When attempting to use the manual/emergency release for the charge port on 2015MY Soul EV, it may appear as if the mechanism attached to the release handle has become detached from its mounting location. The plastic guide (see image below) is meant to free float on the cable and will protrude from the slot when pulled. The mechanism is operating as designed and no repairs <u>or calls to Techline</u> are required. Simply pull the handle until the charge port door opens and then re-insert the cable and handle back into the slot.
