HYUNDAI NEW THINKING. NEW POSSIBILITIES. Technical Service Bulletin	GROUP CAMPAIGN	NUMBER 14-01-038-2
	DATE NOVEMBER 2014	MODEL(S) ELANTRA SEDAN (MD) ELANTRA COUPE (JK)
SUBJECT: OVERHEAD CONSOLE SUNGLASS HOLDER LATCH REPLACEMENT PROCEDURE, (SERVICE CAMPAIGN TU1)

Description: In some Elantra sedan and Elantra coupe vehicles the sunglass holder in the overhead console may open unintentionally while driving over bumpy roads. This bulletin describes the procedure to replace the sunglass holder latch to correct this condition.

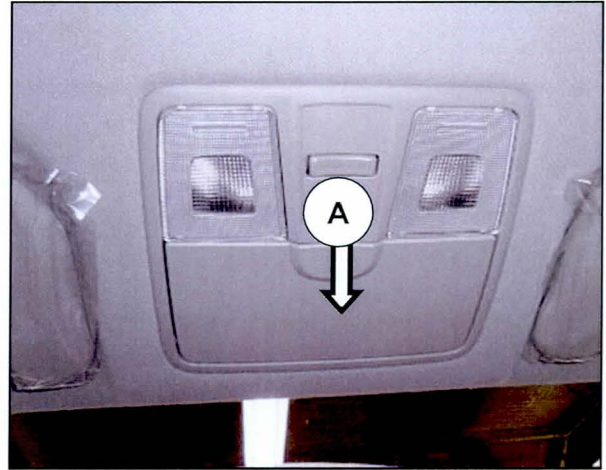
1. Open the sunglasses holder (A).

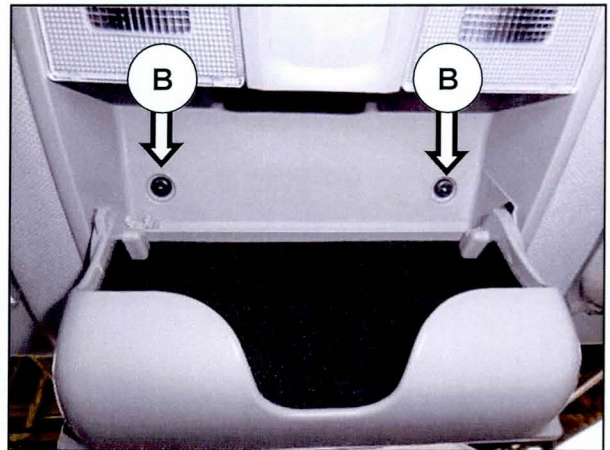
2. Remove the two screws (B).

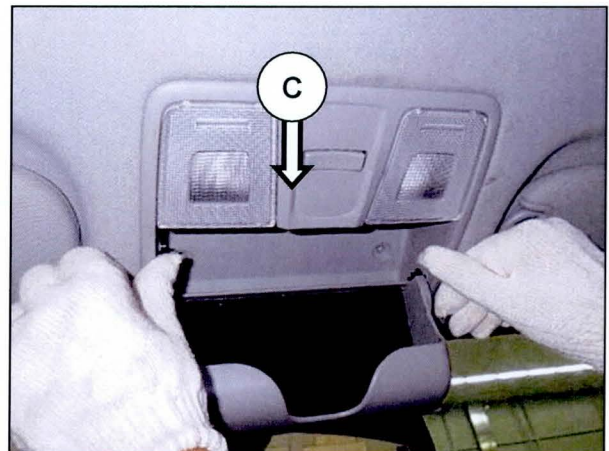
3. Pull down the overhead console (C) to separate it from the headliner.

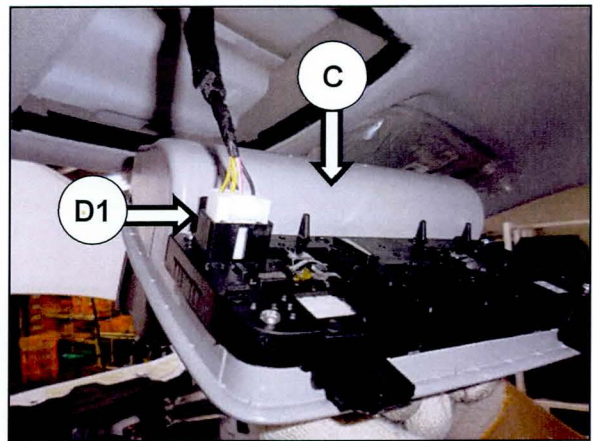
- 4a. Disconnect the connector (D1).

Picture to the right shows a non-sunroof model.

Remove the overhead console (C) from the vehicle.

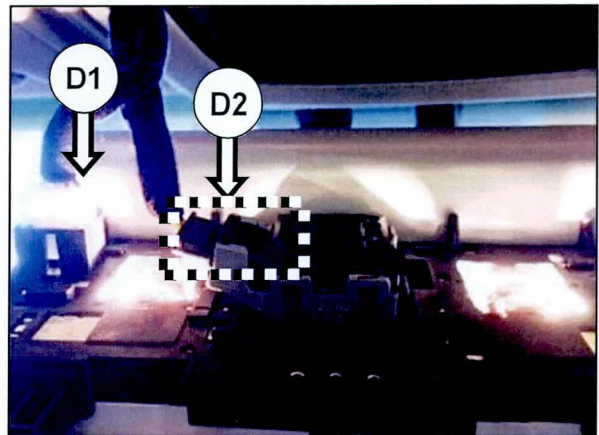
- 4b. For a sunroof-equipped model, also disconnect the connector (D2).

A small flathead screwdriver may be required to remove connector (D2).

Remove the overhead console (C) from the vehicle.

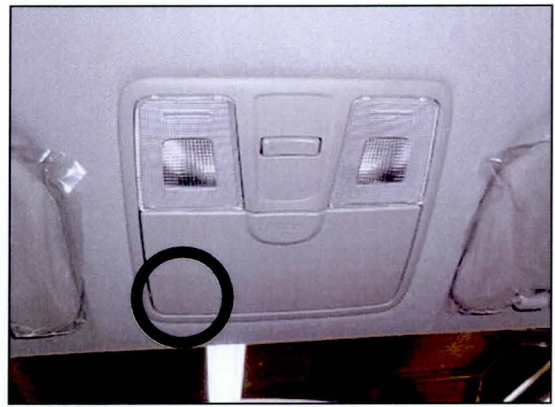
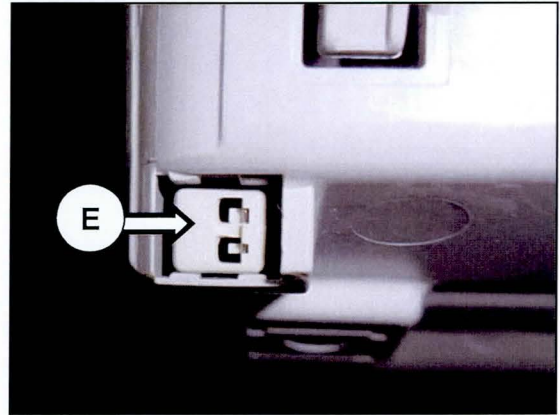
5. The sunglass holder latch (E) is located at the front left side of the overhead console.

There is no visible difference between the old and the new part. Be careful to not re-install the old part.

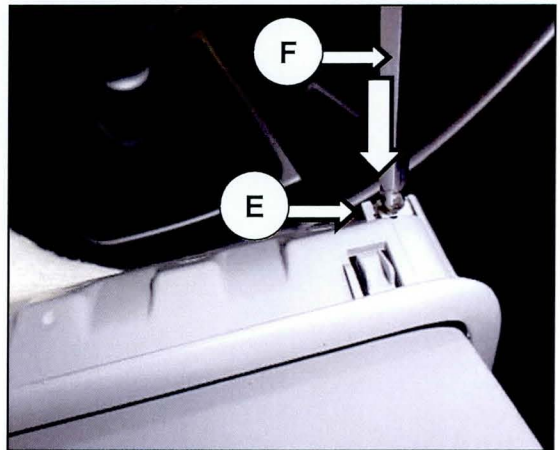
6. Push the back side of the holder latch (E) with a driver (F) to remove the holder latch from the overhead console.

Set the console on a clean surface that will not get damaged nor cause damage to the console during removal of the holder latch.

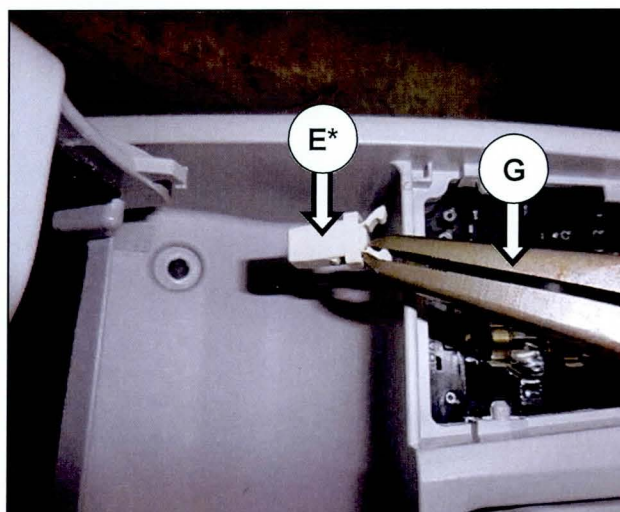
7. Insert the new holder latch (E*) with needle nose pliers (G) in the orientation shown.

Before installation, compare the orientation of the holder latch (E*) with the picture on the right. The slotted side should be facing away from your view.

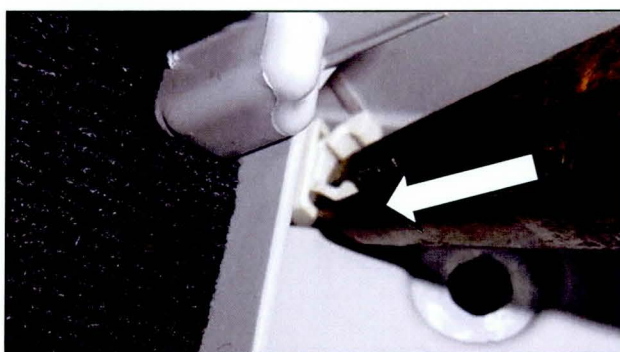
8. Push in the new holder latch (E*) in the direction of the arrow. You should hear and feel a confirmation "click."

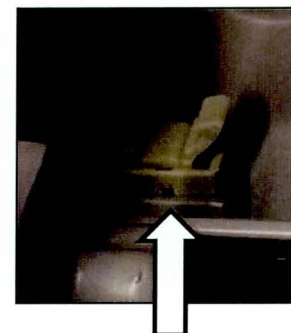
9. Confirm the correct orientation of the holder latch installation by comparing it to the pictures to the right.

Close and open the sunglasses holder to confirm that it operates normally.

= Correct

= Incorrect

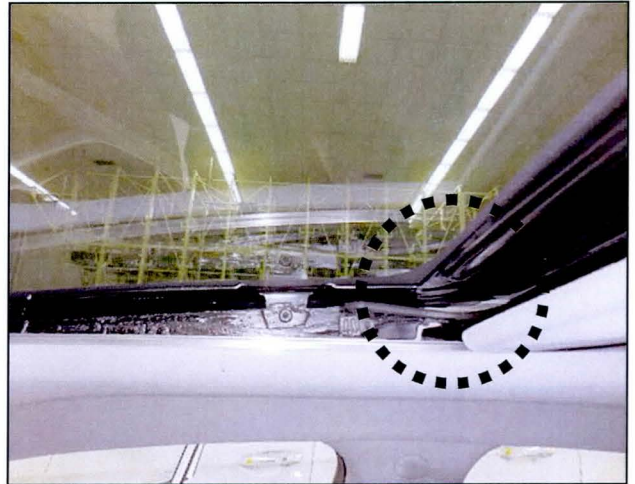
1. Start the sunroof reset procedure under the following conditions:
 - Sunshade open
 - Sunroof glass closed

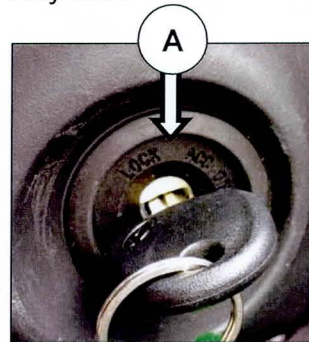
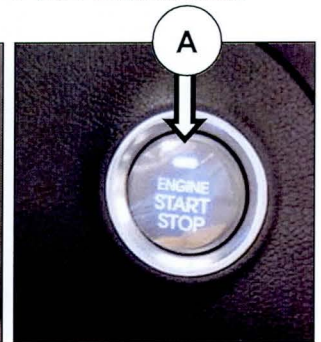
2. Turn the ignition key (A) to the "ON" position.

For push-button start, press button (A) 2 times for "ON" without depressing the brake pedal. (Do not start the engine.)

Key start

Push-button start

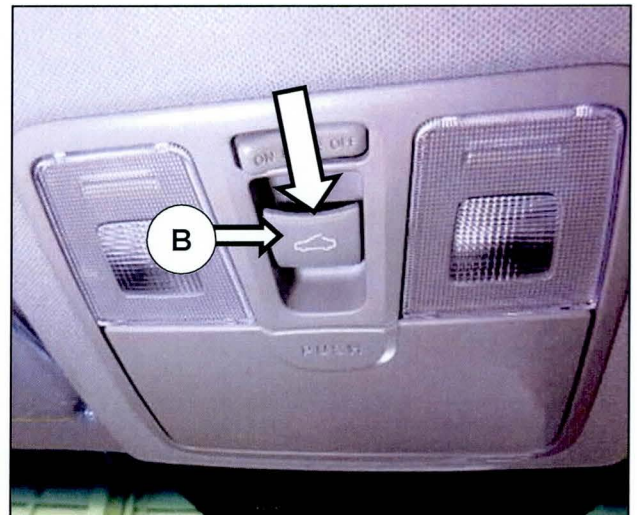
3. Push and hold the sunroof glass switch (B) forward in the direction of close for 10 seconds.

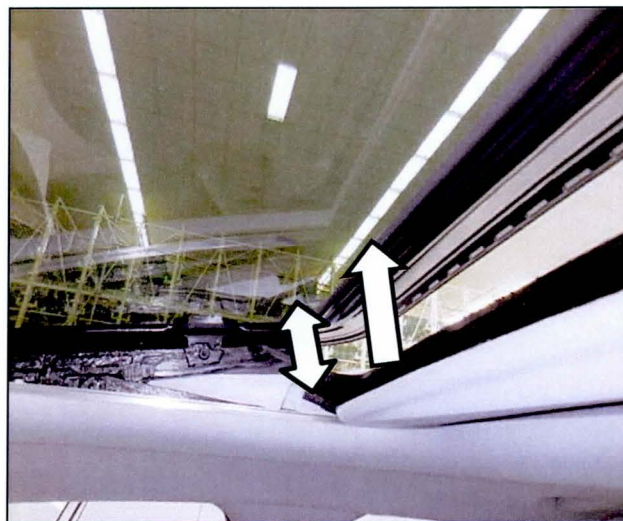
4. Keep holding the switch until the sunroof glass automatically tilts up and then moves up/down slightly.

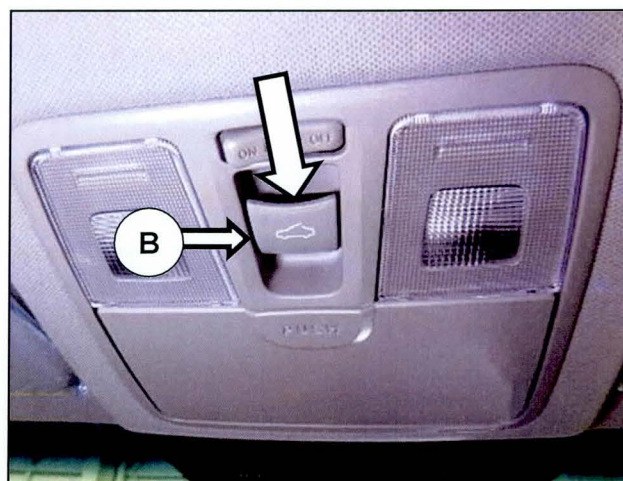
5. After the sunroof glass moves in Step 4, release the sunroof switch (B).

6. Within 3 seconds of releasing the switch (B), push and hold the switch (B) forward in the direction of close again until the sunroof glass moves as follows:
 - Tilt down → Slide open → Slide close

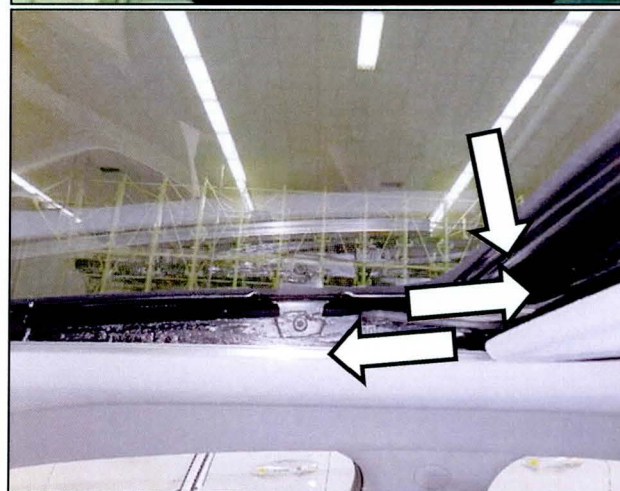
DO NOT release the control lever (B) until the operation is completed. If you release the control lever (B) during the operation, you must restart the sunroof resetting procedure.

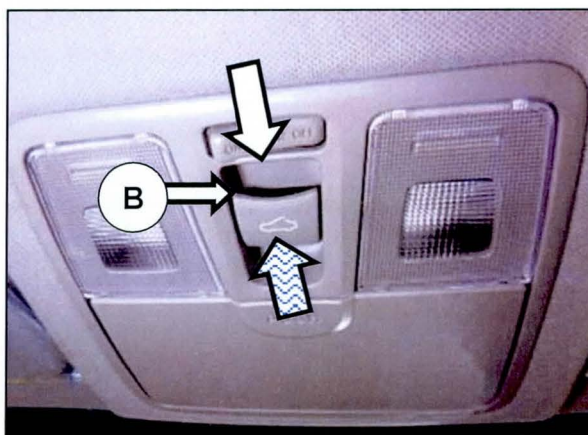
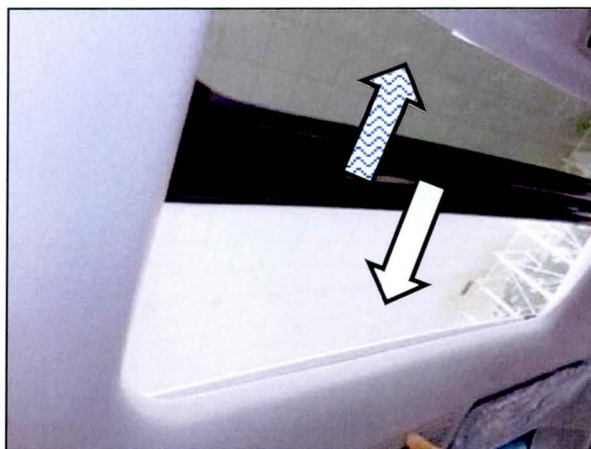
7. Confirmation:
- a. Push the sunroof glass switch (B) rearward past the detent to open the glass completely.
 - b. Push the sunroof glass switch (B) forward past the detent to close the glass completely.

If the sunroof glass does not open or close fully when pressing the switch one time past the detent, repeat the sunroof motor reset procedure.
