## Technical Service Bulletin

GROUP	NUMBER
SUSPENSION	14-SS-003
DATE	MODEL(S)
NOVEMBER 2014	SANTA FE SPORT (AN)

**SUBJECT:** 2015MY (AN) SANTA FE SPORT TPMS WARNING LIGHT ON WITH SHIPPING SWITCH IN THE "OFF" POSITION

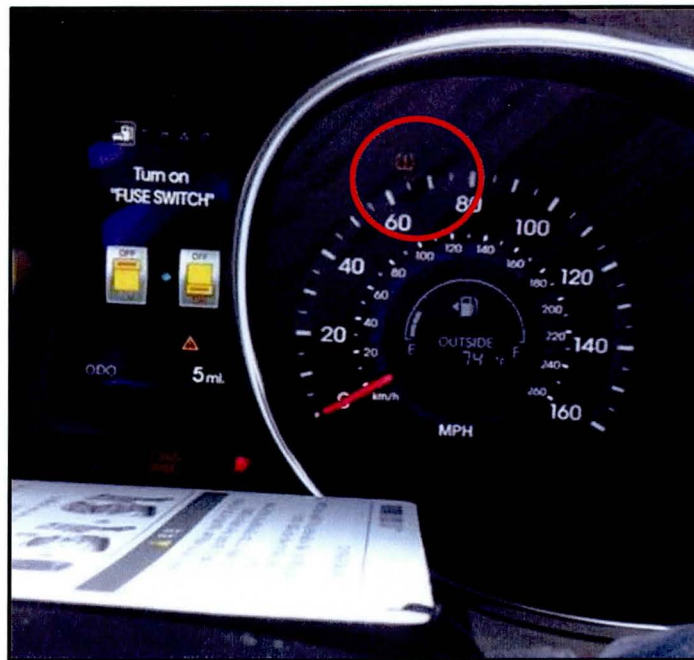
**Description:** This bulletin provides TPMS information for 2015MY Santa Fe Sport (AN) vehicles. The TPMS warning lamp may be illuminated when the shipping switch is in the "OFF" position. This is a normal condition for the 2015MY Santa Fe Sport (AN).

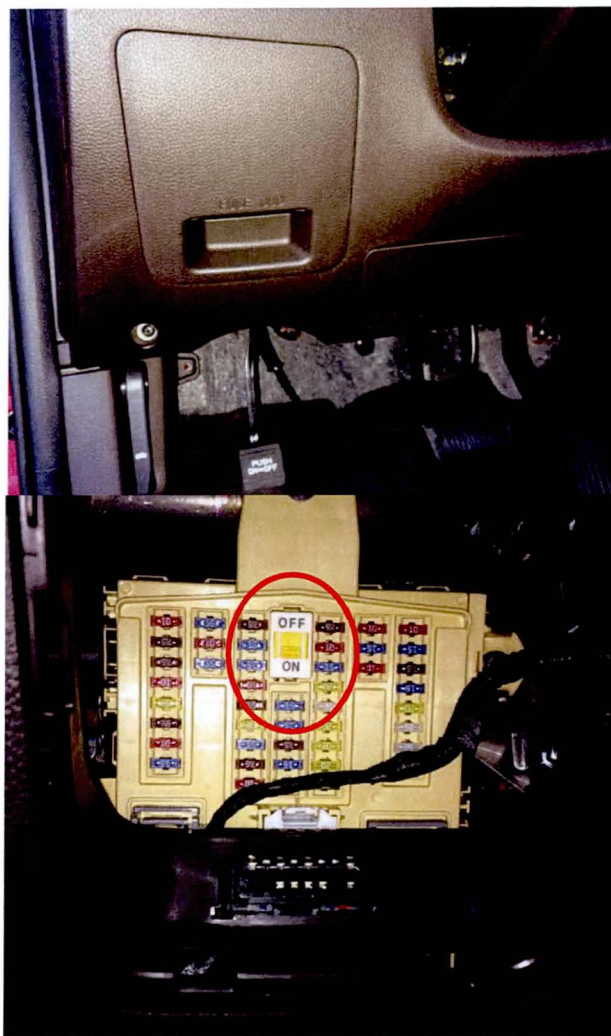
1. Locate and remove the fuse panel cover on the lower left area of the dash. The shipping switch is behind the cover. Turn the fuse switch to "ON."

2. Set the (cold) tires to the pressure indicated on the tire placard sticker.
3. Drive the vehicle above 15 mph for 3 minutes.
4. The TPMS warning lamp should turn off.

If it remains illuminated, inspect the vehicle for TPMS concerns as per normal service procedures.
