TECHNICAL BULLETIN
JTB00257NAS3
06 MAR 2014

SECTION: 204-04

Wheel/Tire Balancing and Optimization

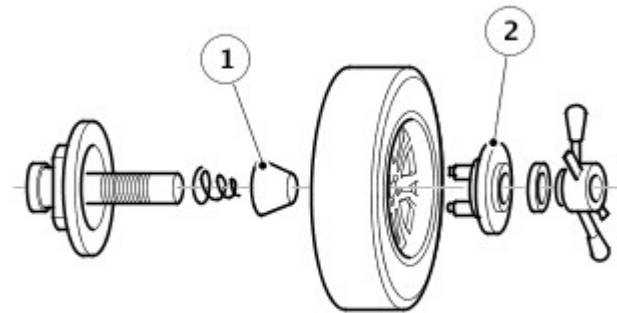
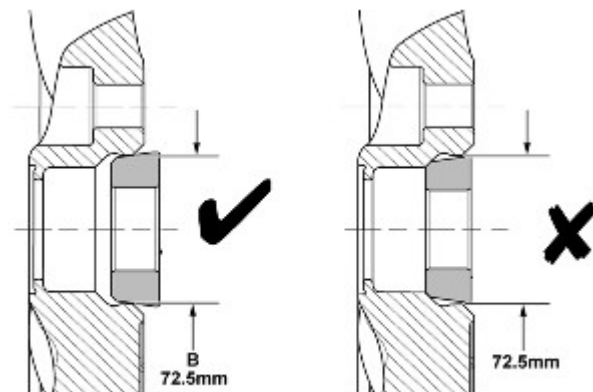
E160494

Mount each wheel/tire assembly (using the correct wheel-fitting attachment) to the balance machine and balance until the residual imbalance dynamic is minimized.

- Target is 0g (zero grams) on each plane; maximum is inner 5g / outer 5g.
- Use the 'bulls-eye' balancing mode to minimize residual imbalance.

**NOTE: When using adhesive weights, use the attachment arm on the balancing equipment to ensure accurate weight positioning.**

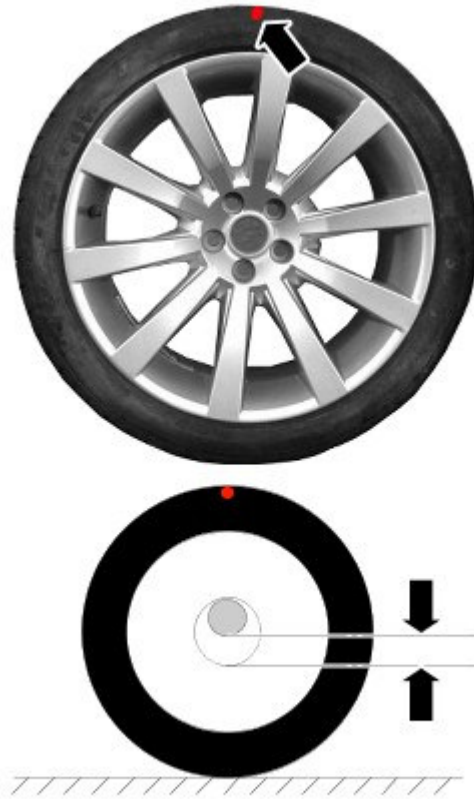
E146997

Prior to tightening the wheel nuts, the marked high point of RFV must be installed to the vehicle with the RFV high point 'up'.

8.   **NOTE: If RFV equipment is not available and the tire has not been removed from the wheel and the RFV spot (red dot) is still visible, install wheel/tire assembly with red dot 'up'.**
