NUMBER: 23-028-14

Hood Latch Release Cable Hangs Down Too Low Under Instrument Panel

2015 (UF) 200

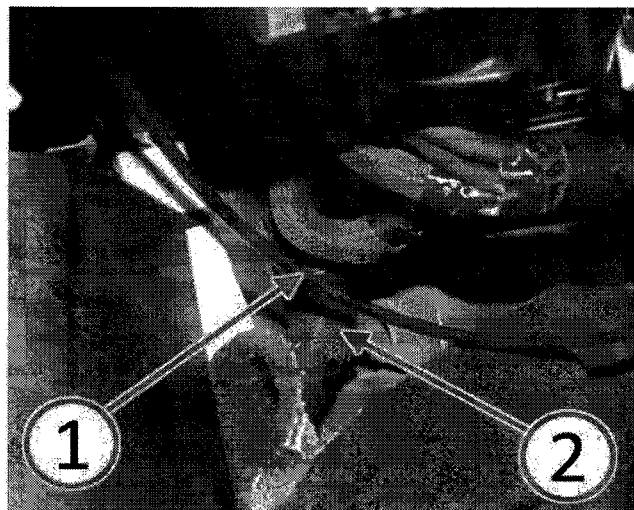
Fig. 2 Hood Release Cable In Front Of Harness

-
2. Is the hood latch release cable (1) routed in front of the wire harness (2) as shown in (Fig. 2)?
- a. Yes>>> Continue with Step #3.
 - b. No>>> Proceed to Step #6

1 - Hood Latch Release Cable

2 - Wire Harness

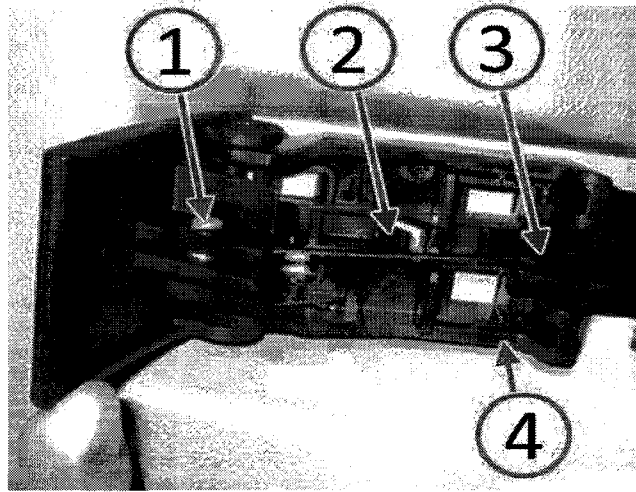
Fig. 3 Disconnect Hood Release Cable

- 1 - Cable End
 - 2 - Retaining Tab
 - 3 - Cable Retainer
 - 4 - Hood Release Handle
-

3. Disconnect the hood latch release cable by pressing the tabs and release the cable (3) from the hood release handle (4) then remove the cable end (1) (Fig. 3).

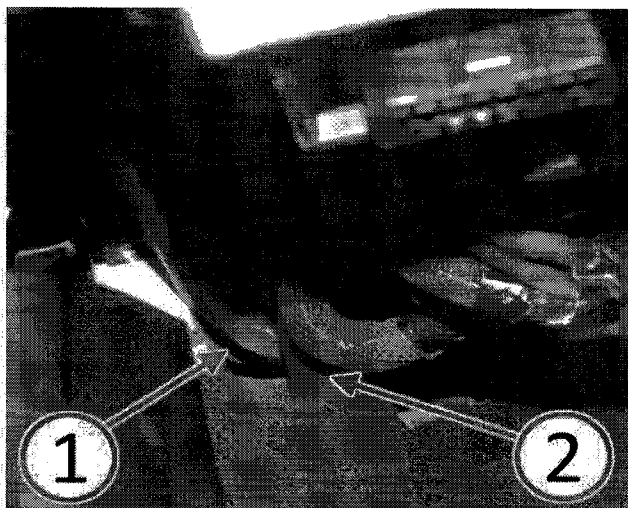
Fig. 4 Route Hood Release Cable Behind Harness

- 1 - Hood Latch Release Cable
 - 2 - Wire Harness
-

4. Route the hood latch release cable (1) behind the wire harness (2) as shown in (Fig. 4).

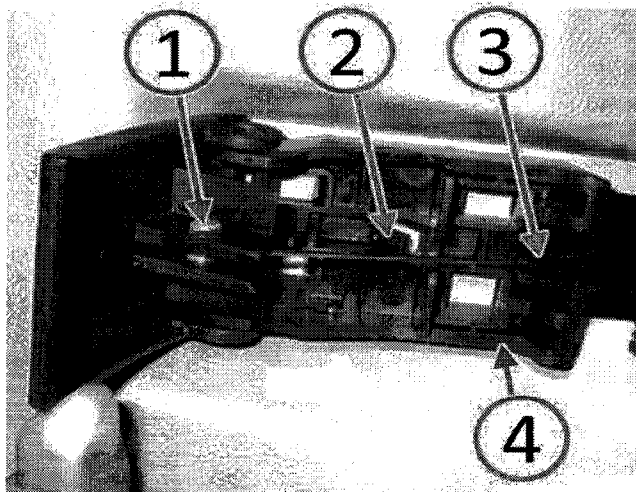
Fig. 5 Connect Hood Release Cable

- 1 - Cable End
- 2 - Retaining Tab
- 3 - Cable Retainer
- 4 - Hood Release Handle

5. Install the cable end (1) then engage the cable (3) into the hood release handle (4) (Fig. 5).

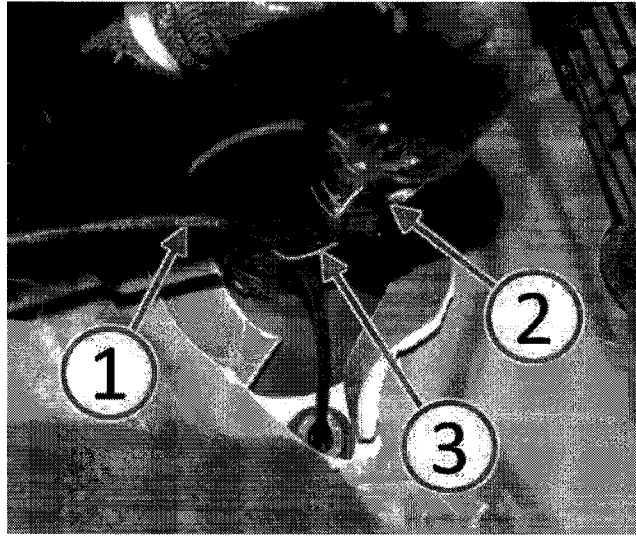
Fig. 6 Secure Hood Release Cable To Harness

- 1 - Hood Latch Release Cable
- 2 - Wire Harness
- 3 - Tie Strap

-
6. Near to where the hood latch release cable passes through the front cowl, secure the hood latch release cable (1) to the wire harness (2) with a tie strap (3) and remove any excess tie strap material (Fig. 6).

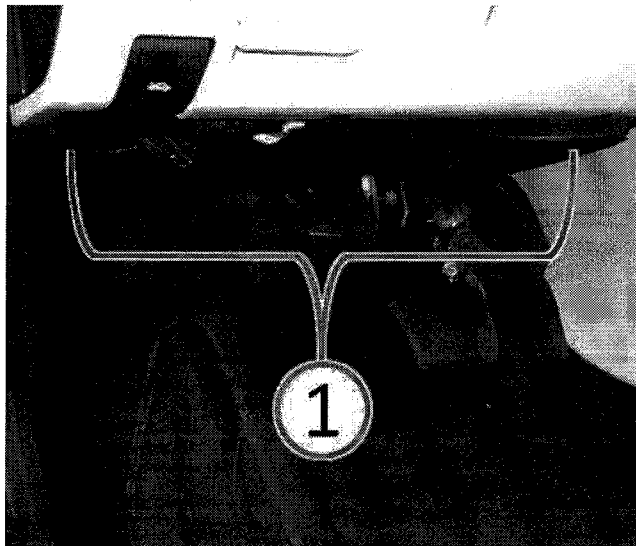
Fig. 7 Hood Release Cable Not Hanging Down

- 1 - Under Instrument Panel
-

-
7. Ensure that the hood release cable is now secured and not hanging down too low under the instrument panel (Fig. 7).
