# Technical Service Bulletin

## 01 MIL on (P0491 and P0492 stored at same time)

01 14 97 2033001/7 October 2, 2014. Supersedes Technical Service Bulletin Group 01 number 14-89 dated August 19, 2014 for reasons listed below.

Model(s)	Year	VIN Range	Vehicle-Specific Equipment
S4	2010 - 2011	All	3.2 FSI AVS and 3.0 TFSI engines
A5	2010		
S5 cabriolet	2010 - 2013		
A6	2009 - 2012		
A7	2012		
Q5	2010 - 2012		
Q7	2011 - 2012

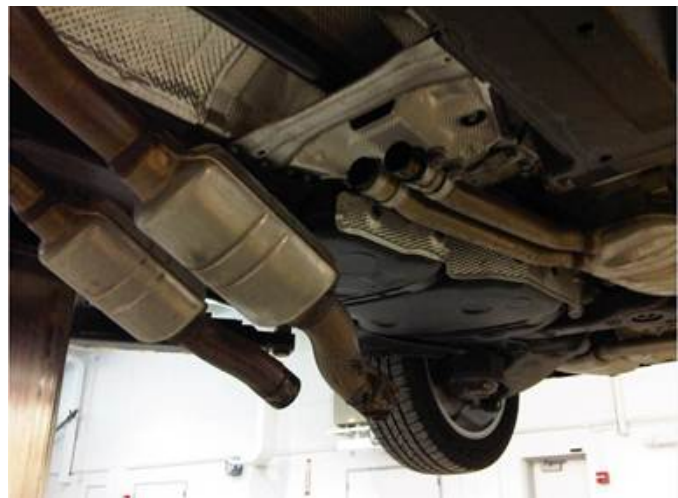
*Figure 7. Lowered catalytic converter pipes*

1. Move the exhaust sliding bushings (that connect the catalytic converter and muffler) back, then lower the catalytic converter pipes (Figure 7).

For Q7, unbolt muffler from catalytic converter. Cover mufflers with plastic bag to prevent water from entering.

Cleaning water will drain out of the catalytic converter pipes during the cleaning process.

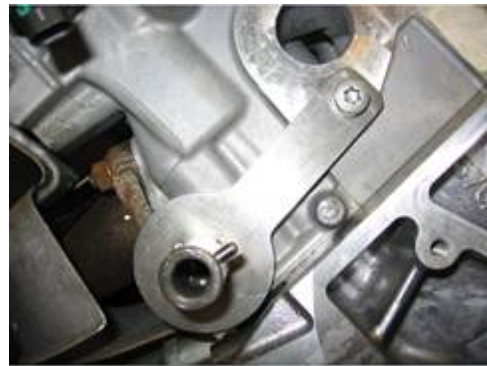
**Figure 13.** Engine adaptor on bank one.

2. To catch water, put a pan under the front of the engine and under the disconnected catalytic converter pipes.
3. Install engine adaptors on the appropriate banks (Figure 13, Figure 14).

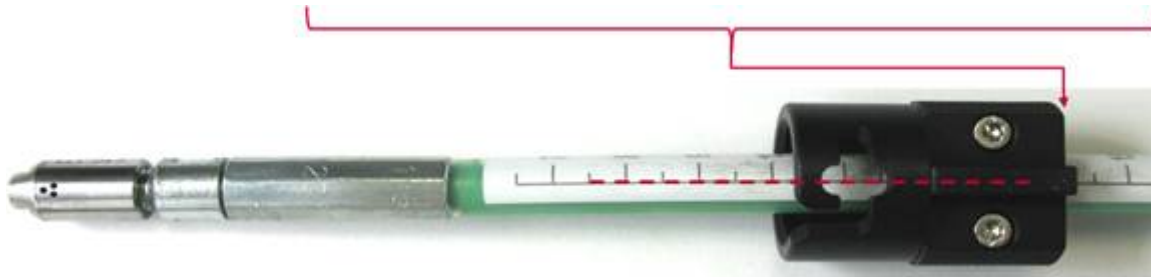
1. Because every port has a different distance to the cylinder head, use the table below to position the hose adaptor for the special single port cleaning hose (the hose with the scale) correctly into the hose. The back side of the hose adaptor must align with the number on the scale of the cylinder to be cleaned (Figure 14). The longitudinal slot on the hose adaptor must align with the black line on the scale for correct rotational positioning (Figure 15).

Dimensions Port	1	2	3
Bank One	10.5	19.5	28.5
Bank Two	13.7	22.7	31.8

**Figure 15:** Arrow indicating how the back side of the adaptor must align with the scale. Red dotted line indicating how the longitudinal slot must align with the black line on the scale.

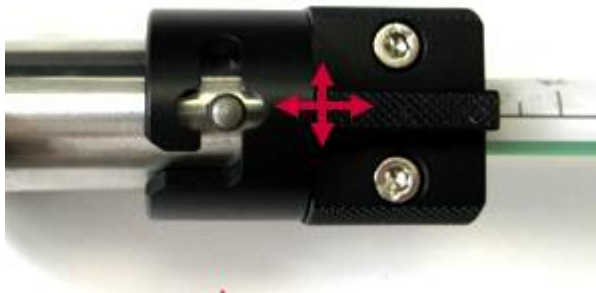
**Figure 16.** Locking position / transvers longitudinal movement and of the hose adaptor

2. After adjusting the position of the hose adaptor, insert the special single port cleaning hose into the hose adaptor, and bring it back into locking position (Figure 16).

3. While cleaning, make sure that the pressure washer is supplying pressure greater than 1800 psi.
4. Based on the washer's pressure, clean the port based on the table below. While cleaning, continuously move the hose adaptor within the longitudinal and transvers slots (Figure 16).

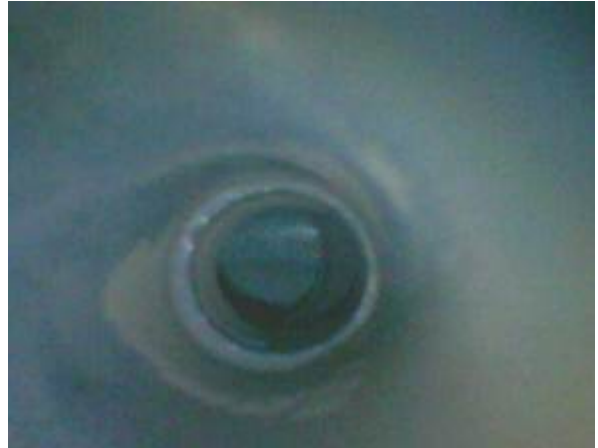
**Figure 17.** Clean single port.

5. Do the same for all remaining cylinders.
6. It is recommended that after cleaning, all single ports are checked with snap-on boroscope BK6000 (or similar, with 90-degree lens), to make sure all ports are clean (Figure 17).
