Technical Service Bulletin

66 Paint flakes off radiator grille or license plate holder

66 14 42 2038652/1 October 9, 2014.

Model(s)	Year	VIN Range	Vehicle-Specific Equipment
A4, A5, Q5	2013 - 2015	All	Not Applicable

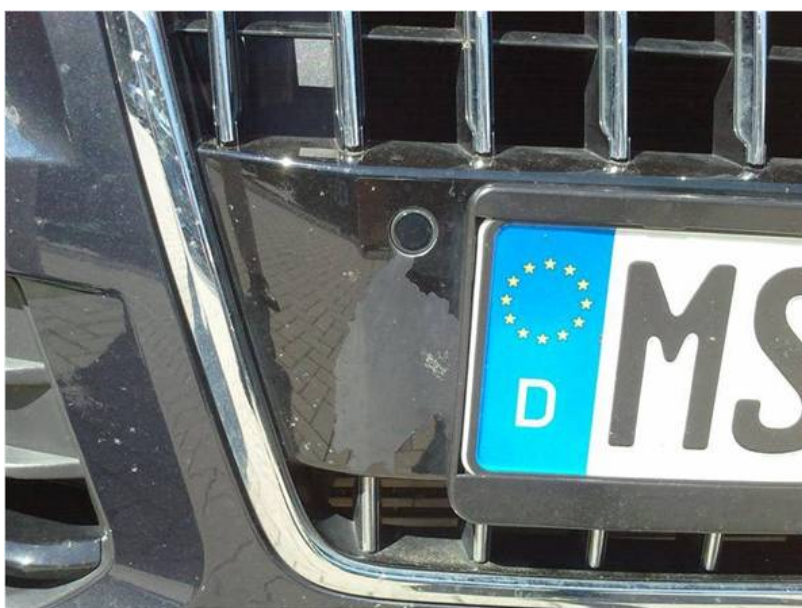
Figure 1. Example of flaked-off paint.

The paint is flaking off of the radiator grille or front license plate holder (Figure 1).

The surfaces of these components were too smooth (due to high-gloss polishing tools), which led to weak adhesion of the paint during production. Only components with color index T94 are affected.

Replace the components according to the instructions in Elsa at *Repair Manual >> Body >> Body Exterior >> 66 Exterior Equipment >> Radiator Grille/Front Trim*.
