# Technical Service Bulletin

## 94 A6 and A3 third brake light - repair authorization

94 14 48 2038098/1 August 11, 2014.

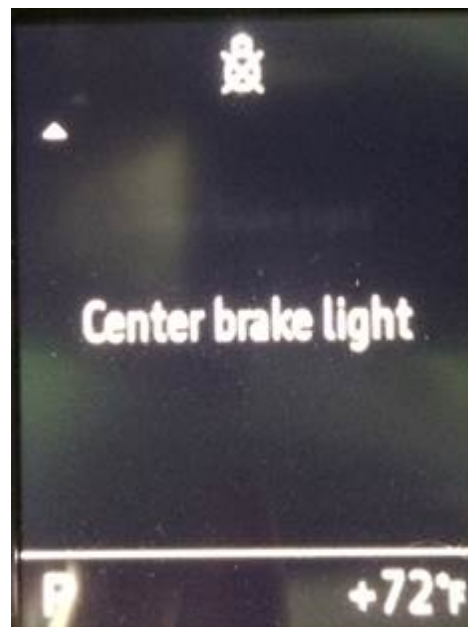
- Center brake light warning is displayed in the instrument cluster (Figure 1).
- One of the following DTCs is stored:
  - DTC VAG01503** (Bulb for high-mount brake light - Open circuit/short circuit to B+) in the comfort system central control module, J393 (address word 46) (A6 only).
  - DTC B12C615** (Bulb for high-mount brake light - Open circuit/short circuit to B+) in the vehicle electrical system control module, J519 (address word 09) (A3 only).
- The center brake light is operational during visual inspection.

*Figure 1. Center brake light warning.*

Verify the condition via DTC memory. Do not disconnect the brake light from the electrical connector.

If the vehicle is within the New Vehicle Limited Warranty, contact a TAC consultant. Attach the following to the TAC ticket:

- Diagnostic log showing the DTC as listed in the *Condition*.
- Photo of instrument cluster warning, if currently displayed.
- Photo of all brake lights with brake pedal pressed. (Include this even if all brake lights are currently operational.)
