Bulletin No.: 14105A Date: May 2014

### F/CMVSS NONCOMPLIANCE RECALL

**SUBJECT:** Passenger Side Instrument Panel Performance

MODELS: 2009-2014 Chevrolet Express

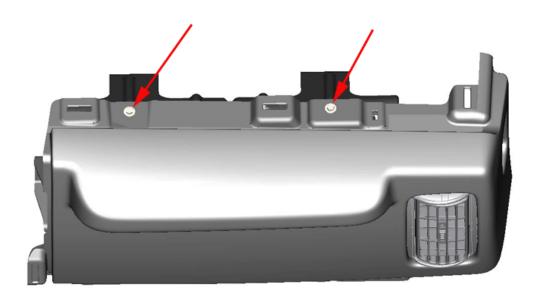
3785217

1. Remove the instrument panel upper trim pad. Refer to Instrument Panel Upper Trim Pad Replacement in SI.

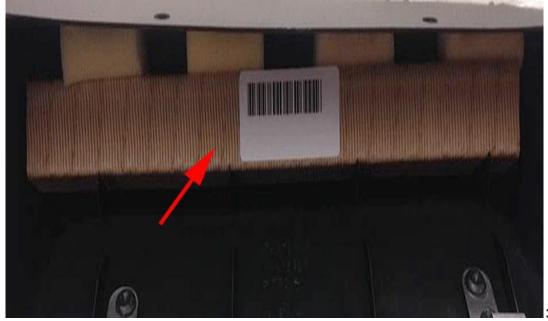
3804499

Remove the upper two screws that attach the instrument panel pad to the instrument panel bracket.

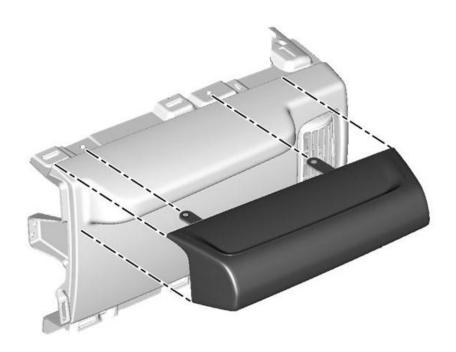
3785223

3. Inspect the brow assembly before installation to ensure the energy absorbing material is present.

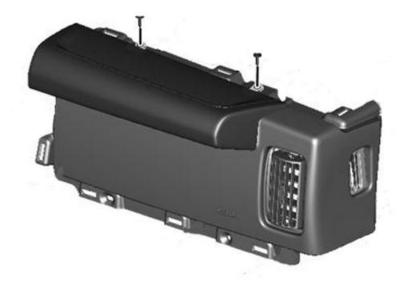
3785220

4. Install the brow assembly to the instrument panel.

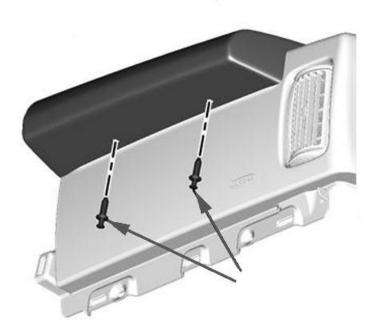
3785225

5. Secure the brow assembly to the instrument panel using the two screws that were previously removed. Tighten the screws to 3 N-m (27 lb in).

6. Using the brow assembly as the template, drill two holes using an 8 mm (5/16 in) bit. The depth of the hole should be no more than 30 mm (1.25 in) deep.

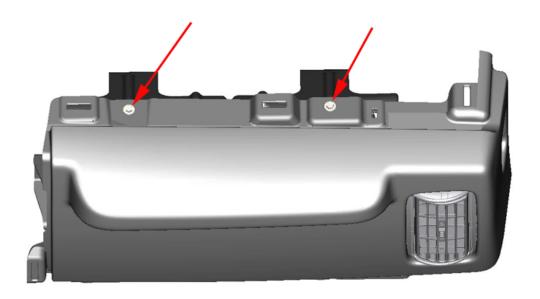
3785217

1. Remove the instrument panel upper trim pad. Refer to Instrument Panel Upper Trim Pad Replacement in SI.

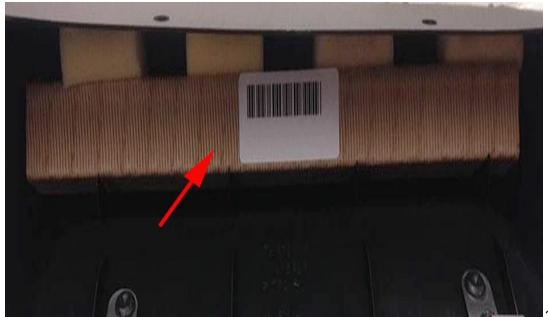
3804499

Remove the upper two screws that attach the instrument panel pad to the instrument panel bracket.

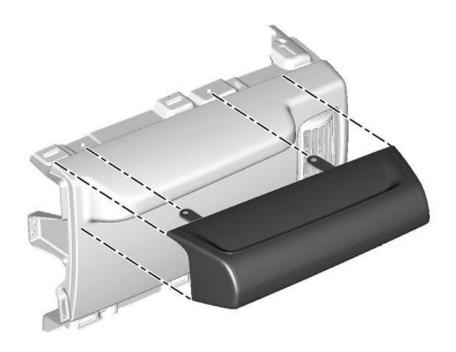
3785223

Inspect the brow assembly before installation to ensure the energy absorbing material is present. Page 7 May 2014 Bulletin No.: 14105A

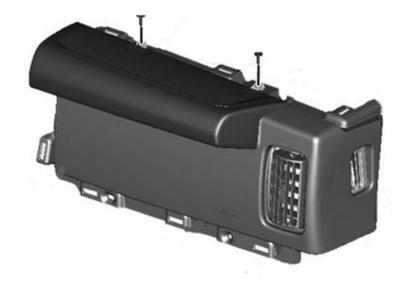
3785220

4. Install the brow assembly to the instrument panel.

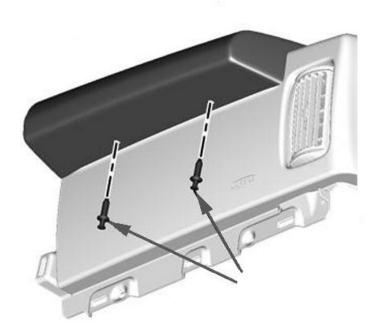
3785225

5. Secure the brow assembly to the instrument panel using the two screws that were previously removed. Tighten the screws to 3 N-m (27 lb in).

6. Using the brow assembly as the template, drill two holes using an 8 mm (5/16 in) bit. The depth of the hole should be no more than 30 mm (1.25 in) deep.
