Service Bulletin

SUBJECT: Service Update for Inventory and Customer Vehicles
Underbody Appearance
Expires with Base Warranty

MODELS: 2014 Chevrolet Silverado 1500
2014 GMC Sierra 1500

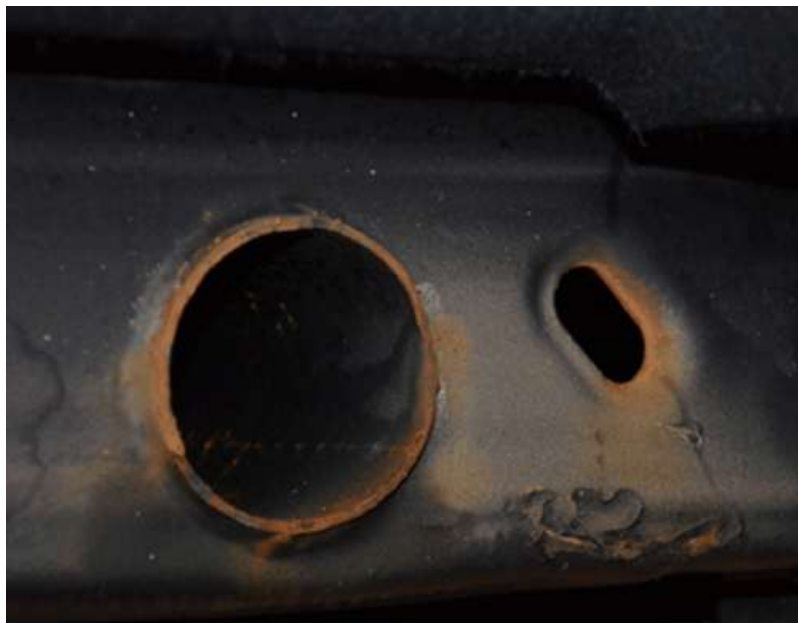
3687196

- Frame and flanges (visible through wheelhouse and underneath door(s))

Repair Required

1. Any loose rust or coating should be wire brushed off.
2. Using a rag and general purpose adhesive remover, wipe down the affected repair area.
3. For the front spring mounts, frame and body mounts, apply a coat of Daubert Nox-Rust® P/N X-121B “One Coat Rust Preventative Coating” (aerosol), or equivalent.
4. For the rear axle assembly and rear shock mounts, apply a coat of Lloyds Kryptonite Metal Treatment P/N 36502 Life Long Rust Protection (14 ounce aerosol), or equivalent.

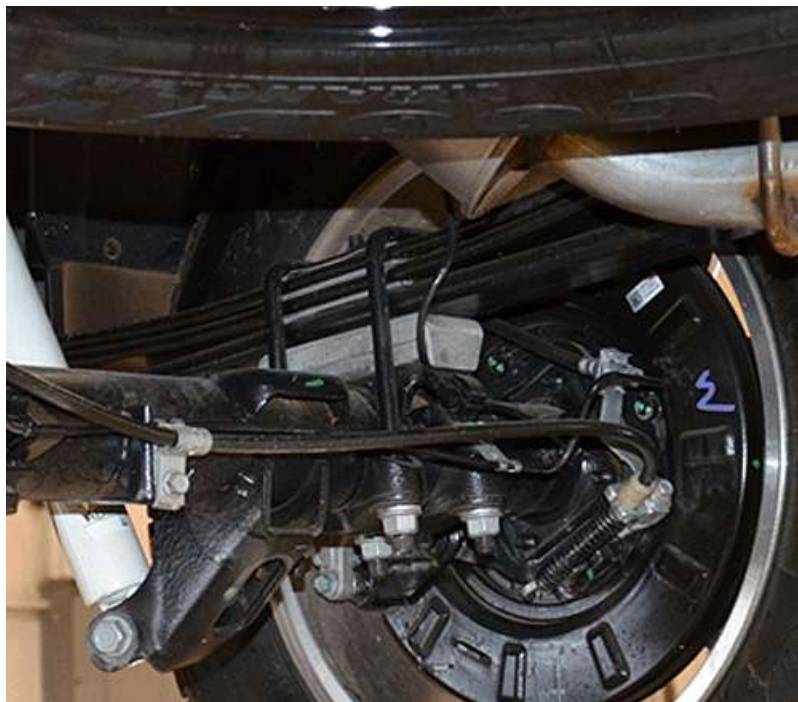
3687935

- Rear shock lower mounts

No Repair Required

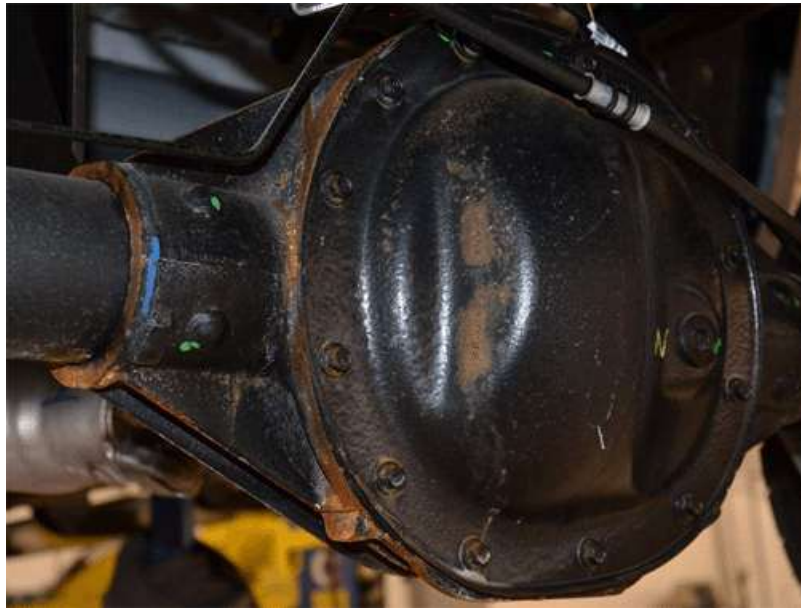
3686525

- Rear axle assembly

Repair Required
