# Emissions Service Action

**Code: 28G8**

**Subject: 2012-2013 MY Jetta SportWagen TDI® Clean Diesel Engine Vehicles  
Glow Plug Control Module**

October 21, 2014

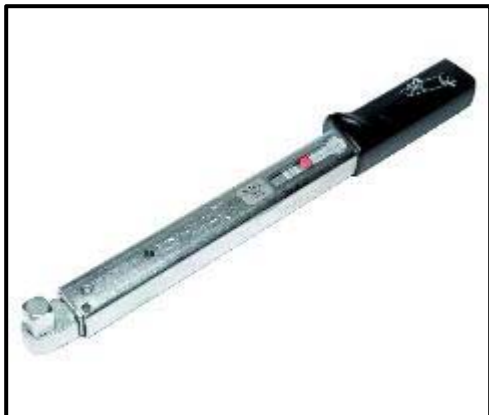
- VAG 1331 – Torque Wrench 5-50Nm (or equivalent)

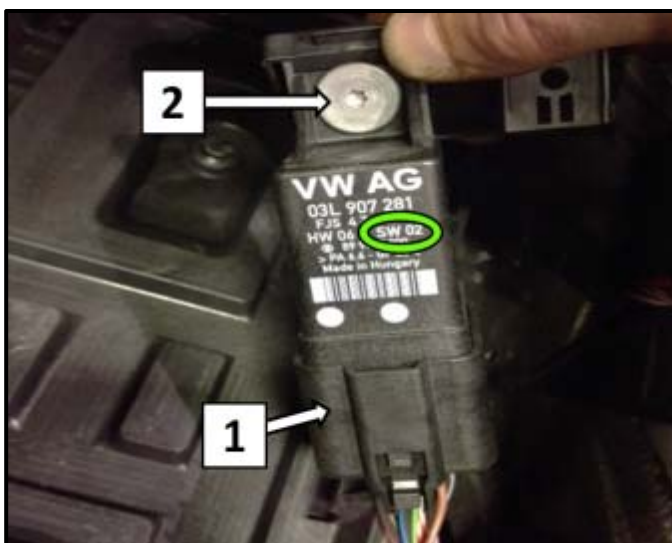
- ⇐ Inspect the software version of the glow plug control module <circle>.
- If the software version <circle> is "SW 02," DO NOT REPLACE the glow plug control module.
  - If the software version <circle> is not "SW 02," REPLACE the glow plug control module with part number (03L 907 281).
- ⇐ If replacing the glow plug control module, disconnect electrical connector <1>, remove screw with bracket <2> and reinstall onto new glow plug control module.
