# Tech Tips

### TT 13-14-01

## 2014-2015 Jetta, Passat, Beetle 1.8L/2.0L (engine codes CPRA, CPKA, CPPA, CPLA) – Rear Main Seal Bolts Missing

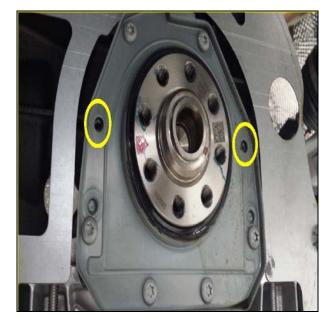
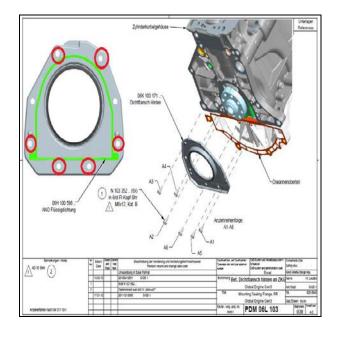
There are <u>no bolts</u> installed at the 9 and 3 o'clock positions from the factory. <u>No bolts</u> need to be installed in these locations while performing repairs. See photos for reference.
