Tech Tips

TT 64-14-03

2012-2015 Beetle/Beetle Convertible Rattle Noise when Closing Door-Window Regulator Loose

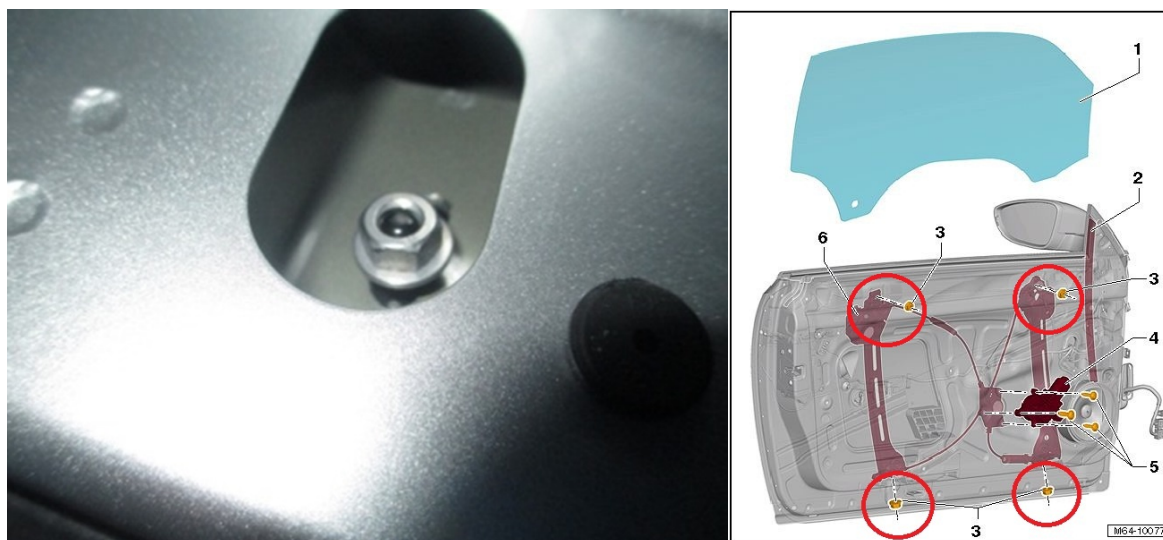
Fig. 1

Complaints of a rattle noise when closing the front door, or rattle from door when driving on bump roads may be caused when the front window regulator mounting nuts have become loose in the door. This concern may be more noticeable with the window closed. (See Fig. 1)

This occurs due to insufficient torque on the fixation nuts for the window regulator. The regulator rails can then move in the door creating the noise concern.

- Remove the front door trim panel to gain access to all four window regulator mounting nuts; see Repair Manual Group 70, Interior Trim in Elsa.
- Remove the caps for the front window regulator nut on the underside of the door.
- Remove the caps for the upper window regulator nuts on the door.
- Remove and replace the 4 regulator mounting nuts with part number N 908 877 03.

- Adjust the front door window accordingly; see Repair Manual Group 64 Glass, Window Regulators in Elsa.
- Once the front door window is properly adjusted, torque the regulator fixation nuts to **8 Nm** using torque wrench 1783 (VAG1783).
