SERVICE BULLETIN

APPLICABILITY: 2015MY Forester
SUBJECT: Stain Removal from the Headliner

NUMBER: 12-173-14R
DATE: 10/28/14
REVISED: 11/13/14

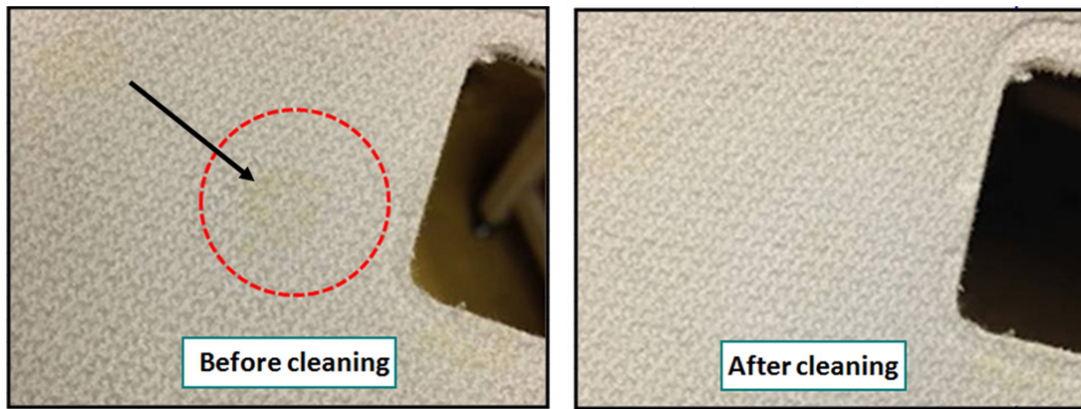
This bulletin provides a procedure for removing the type of stain shown in the photo below which occurred during production of the headliner. “Before” and “After” photo examples are shown below.

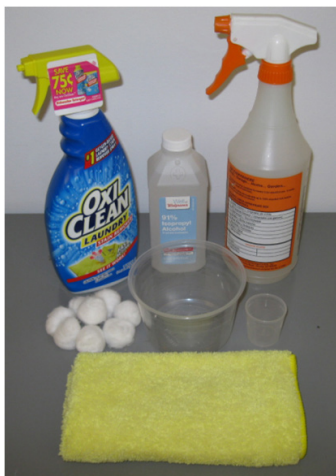
- OxiClean™ Laundry Stain Remover
- **91%** Isopropyl Alcohol
- Spray Bottle containing clean, warm water*
- Cotton Balls
- Measuring Cup
(a clean used medicine dispensing cup works well)
- Mixing Container
- A **CLEAN** detailing towel (microfiber preferred)

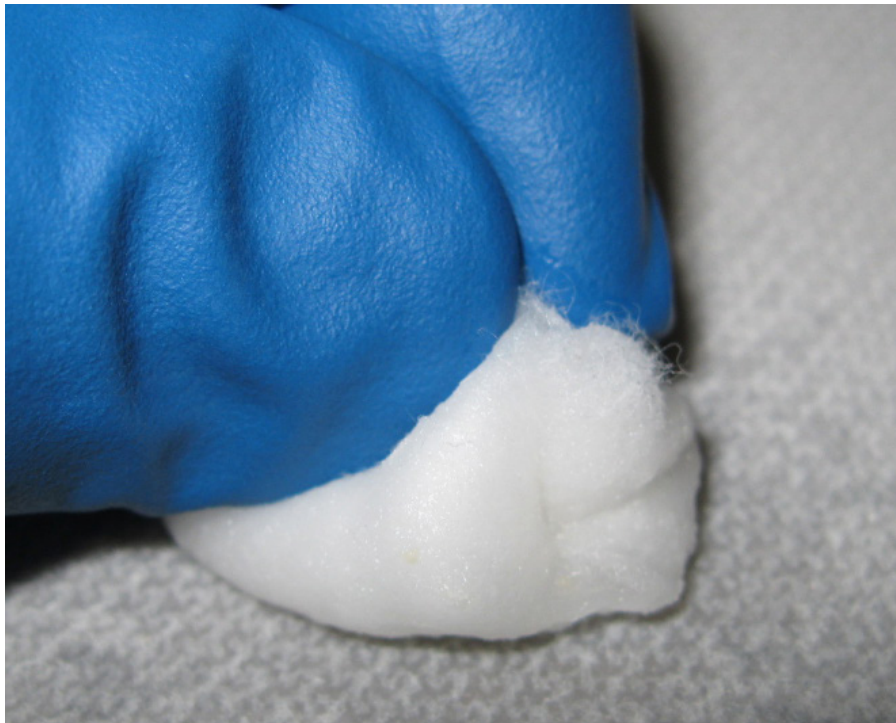
STEP 3- Dip a cotton ball into the cleaning solution then repeatedly dab or pat it directly on the stain until the stain is removed.

VERY IMPORTANT: Use **ONLY** a dabbing or patting action when applying the cleaning solution to the stain. **DO NOT RUB** the stain with the cotton ball as rubbing may affect the texture of the headliner material. This will make the affected portion stand out because of inconsistent texture with the material of the surrounding area.

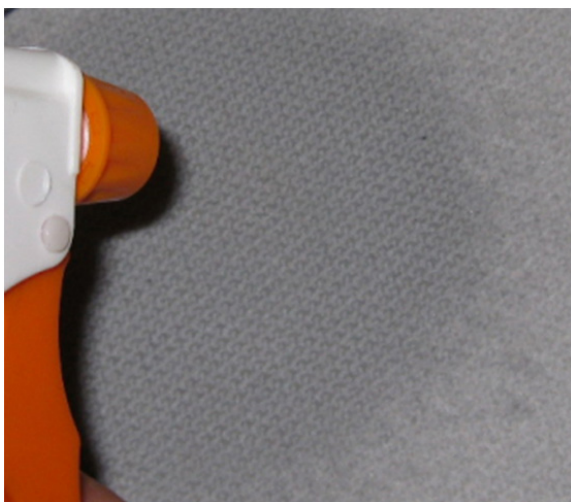
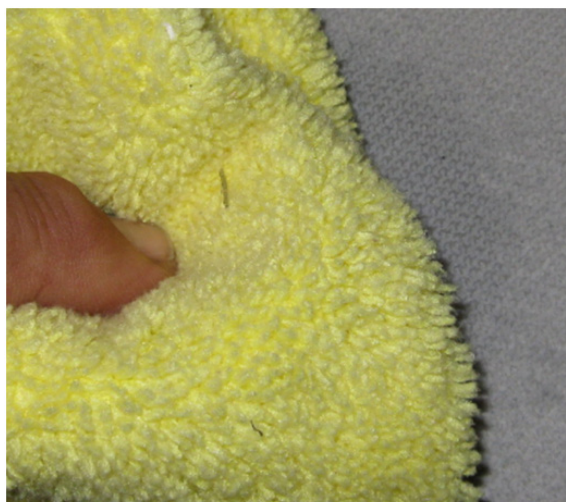
STEP 4- Once the stain is removed, spray the affected area sparingly with clean, warm water* and dry the area with a clean detail towel. A quality microfiber towel works well for this purpose.

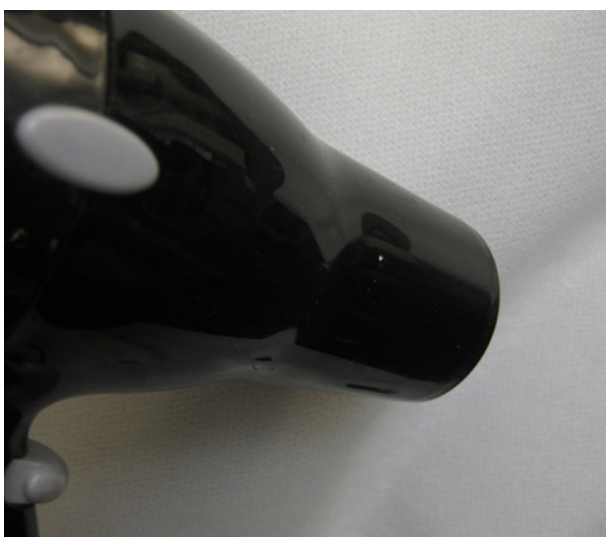
STEP 6- Once the stain is fully removed, complete the drying of the affected area using a hair / blow dryer on the **LOW** heat setting.
