# Service Bulletin

Bulletin No.: PIP5188

**Subject:** Diagnostic Tips For Raw Fuel In The EVAP Canister

**Models:** 2014 Chevrolet Corvette  
Equipped with engine RPO LT1 6.2L

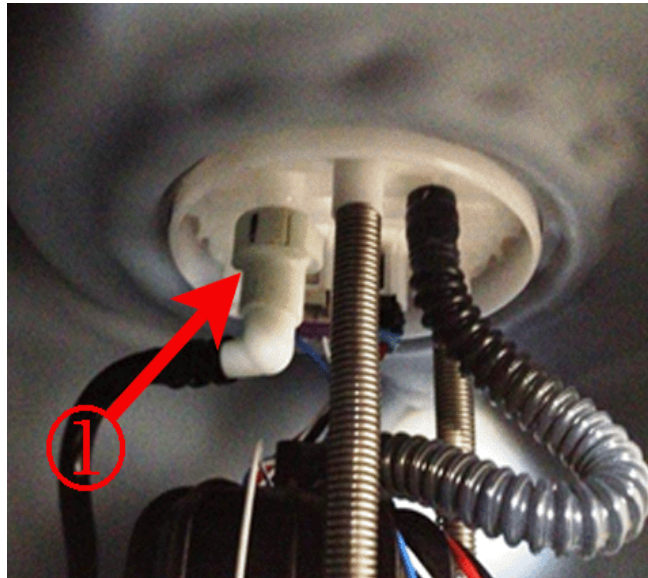
3752902

This connection is in the left fuel tank

If this is encountered there are some connections in the fuel tank that should be inspected.

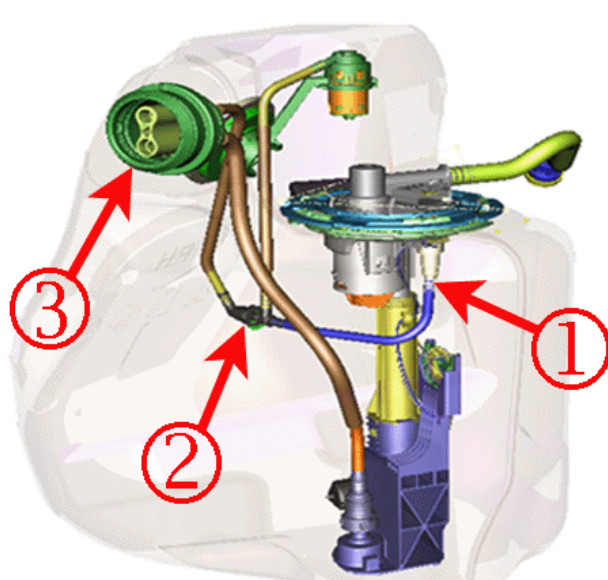
3752898

These connection are in the right side fuel tank

Note the connections at the crossover pipe are not super easy to detect.
