Service Bulletin

Bulletin No.: PI1181

Subject: Oil Pan Heater Cord Replacement

Models: 2012-2014 Chevrolet Sonic
Equipped with 1.8L Engines (RPO LUW, LWE)
and Oil Pan Heater (RPO KPK)
Vehicles Built Prior to September 6, 2013

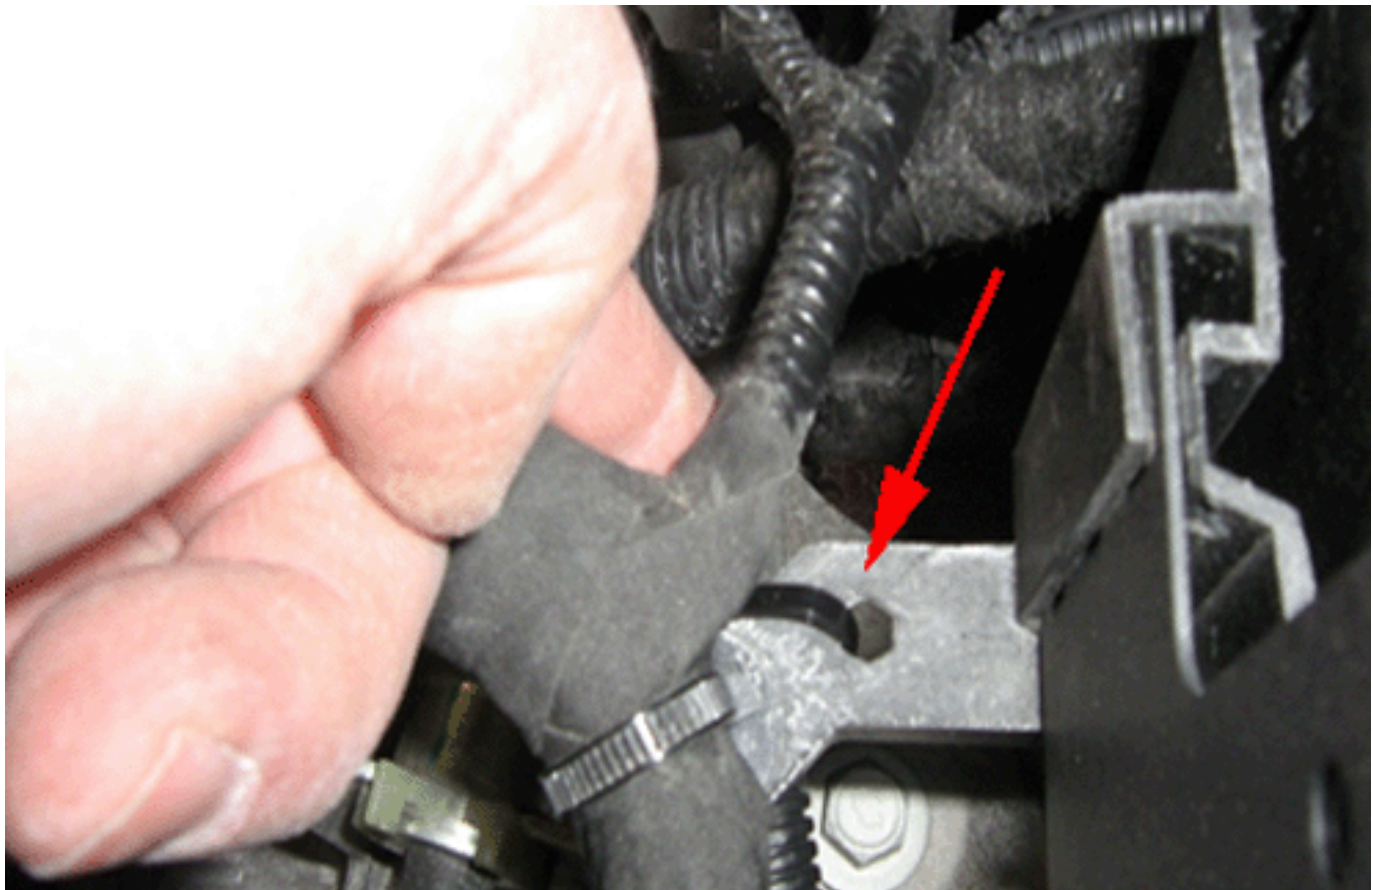
- Tie strap the new cord to the existing hole on the battery tray while routing the cord underneath the ECM harness as shown in the illustration above.

1. Prep the new cord for installation by removing all the clips except the one closest to the female end of the cord.
2. Remove each end of the cord where it enters and exits the vehicle harness and discard the ends and associated clips.
3. Plug the new cord into the oil pan heater and route the cord along the top of the existing vehicle harness using tie straps to secure.

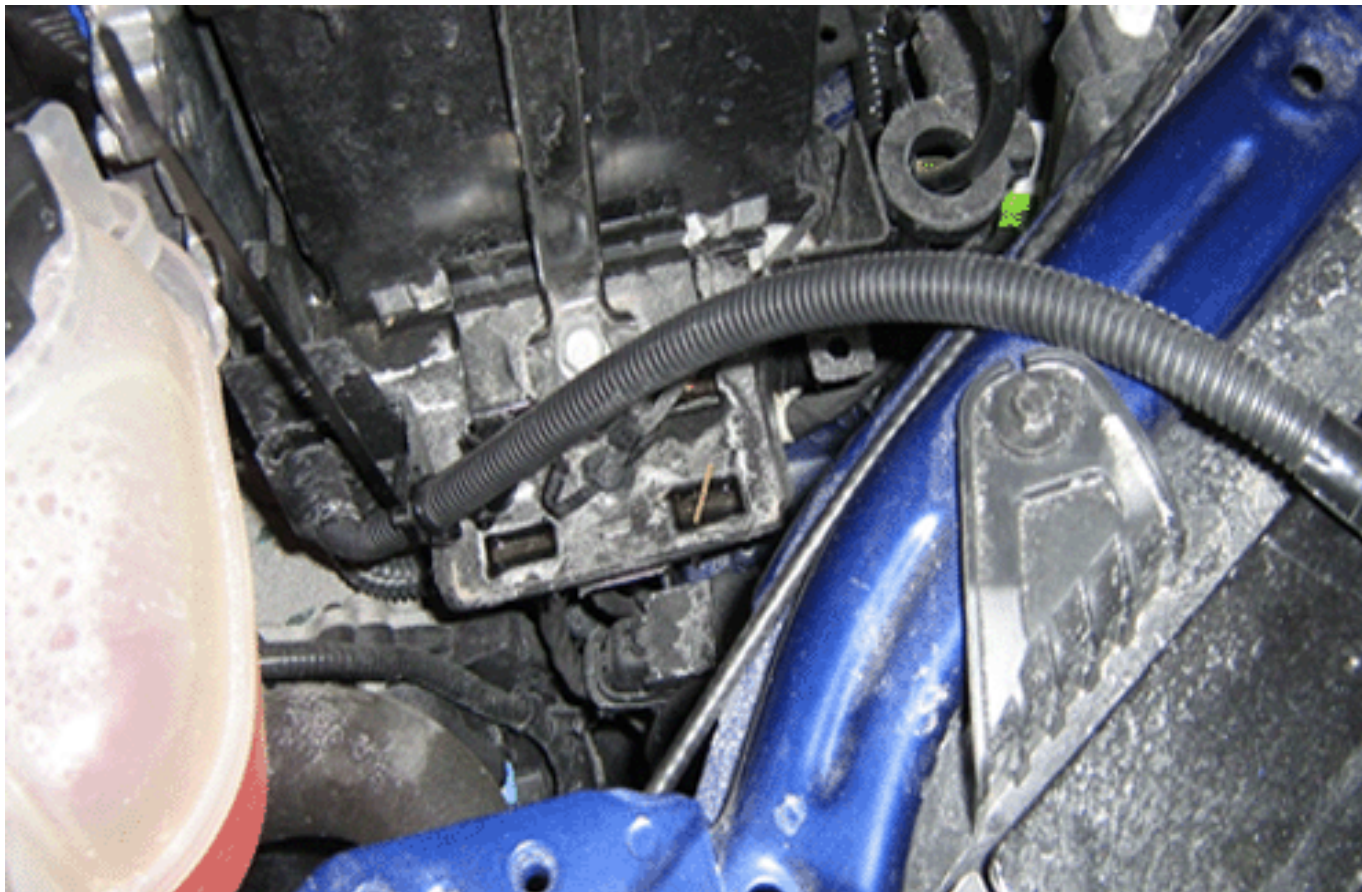
3721569

- Route the remainder portion of the cord exiting between the high and low beam headlamp as shown in the illustration above.
