Service Bulletin

Bulletin No.: PIP5247

Subject: P06DE Low Oil Pressure Piston Oil Nozzle Squirter Parts Found In Oil Pan

Models: 2013-2014 Cadillac ATS
2014 Cadillac CTS
2013-2014 Chevrolet Impala
2013-2014 Chevrolet Malibu
2014 Buick Regal
equipped with 2.0L or 2.5L (RPO codes LTG, LCV or LKW)

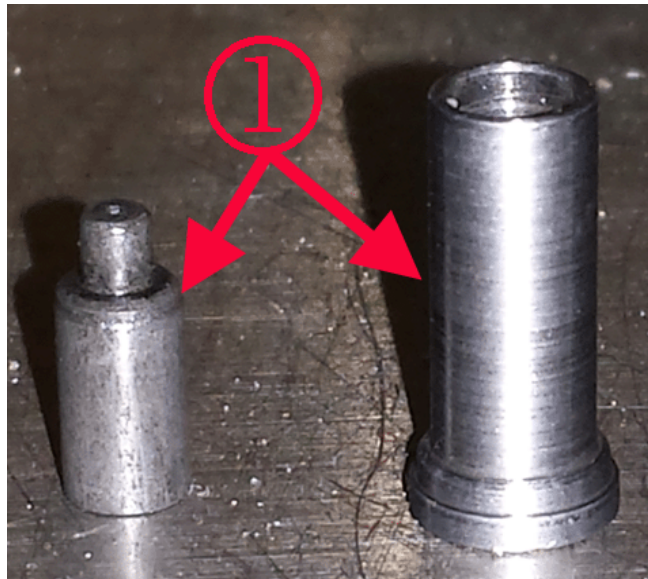
4041662

Technician may also find objects in the oil pan / bottom end of the engine and /or in the oil pick up tube

If the objects match the pictures below, they are internal components from a broken piston oil nozzle / squirter.

1. Internal parts of a piston oil nozzle / squirter
2. Damaged piston oil nozzle / squirter where internal parts came from
3. Undamaged piston oil nozzle / squirter
4. Cross section view of a piston oil nozzle / squirter

Replace the broken oil nozzle(s) / squirter(s) as long as the engine does not have any damage which warrants engine replacement.
