Service Bulletin

Bulletin No.: PIT5270

Subject: Driver Door Lock Cylinder Cover Missing

Models: 2015 Cadillac Escalade Models

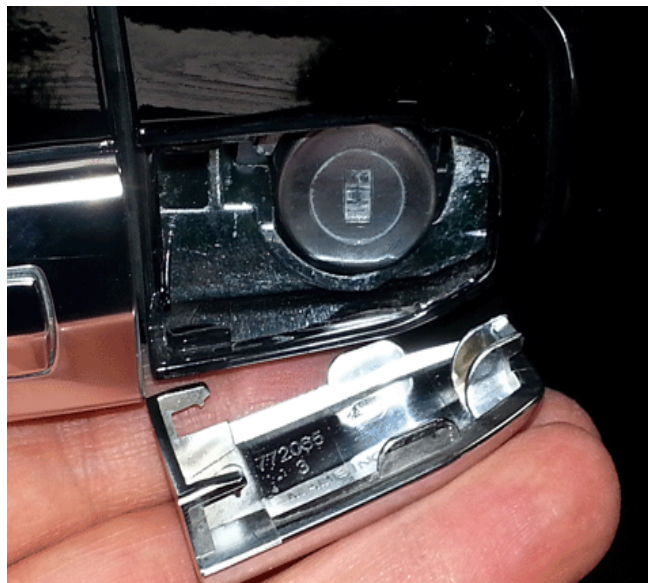
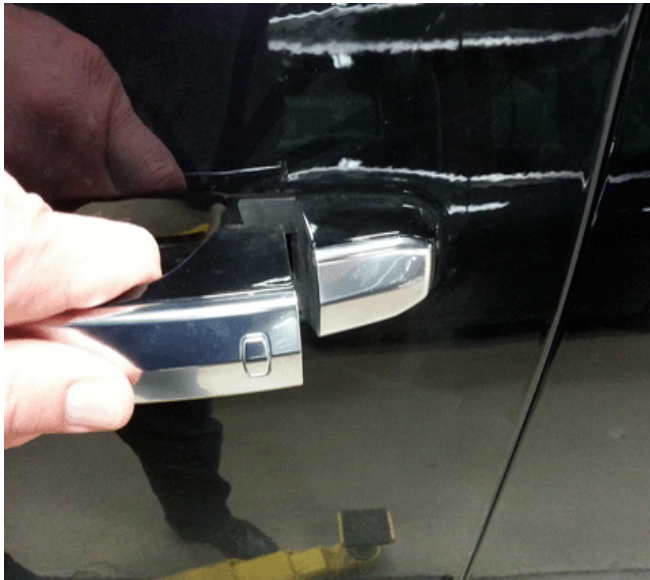
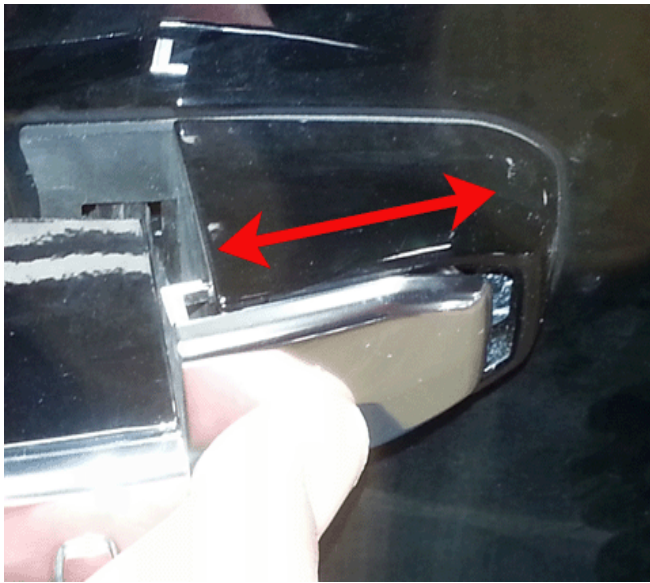
If the driver's door lock cylinder cover is missing, it may have been removed to access the key cylinder while shipping in transport mode.

If the cover is missing or damaged, it will need to be replaced.

To install or remove the door lock cylinder cover, pull the door handle out and slide the door handle forward, then slide the cover forward to release it or slide the cover rearward to install it. See the pictures below for reference.
