Service Bulletin

Bulletin No.: PIT5274

Subject: Roof Beacon Lighting Harness Location

Models: 2015 Chevrolet Silverado
2014 Chevrolet Silverado 1500
2015 GMC Sierra
2014 GMC Sierra 1500
With Roof Lamp / Beacon Wiring Provisions (RPO TRW) or Snow Plow Prep Package (RPO VYU)

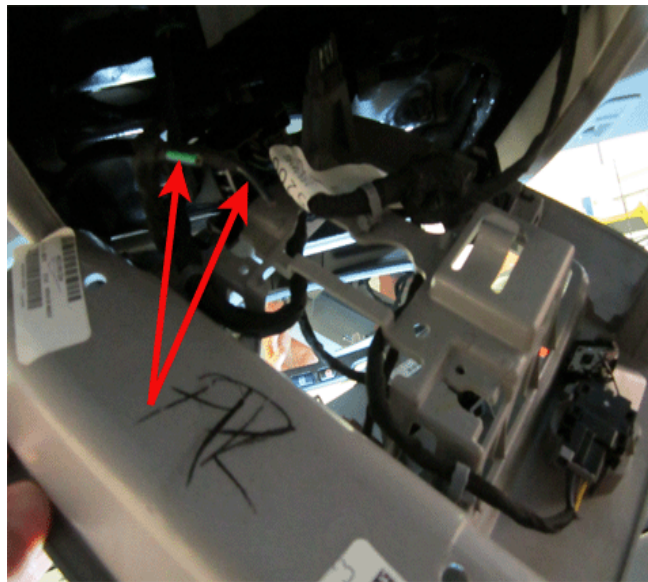
3794424

There are two wires located directly above the overhead roof console. Remove the complete overhead roof console and the wires are taped to the harness, as shown below.

Note: The roof beacon relay is located directly above the overhead roof console.
