Service Bulletin

Bulletin No.: PI1203

Subject: Information on Steam/Vapor Coming from Front Grille or Radiator Area

Models: 2014 Chevrolet Impala
Condition/Concern

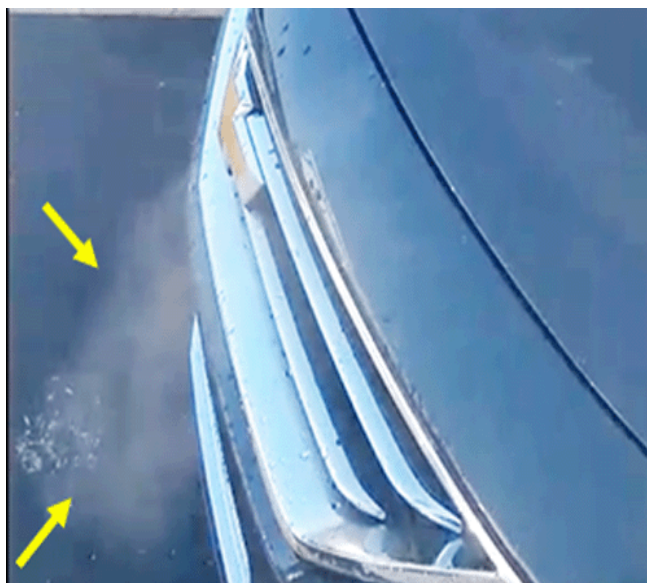
3770252

Some customers may comment that steam is coming from the front grille at idle, or on seeing vapor coming from the radiator after car washes.

The cause of this condition may be the result of rain or car-wash runoff water reaching the condenser, radiator and fan module (CRFM) where it can be vaporized and, with the right weather, can become visible condensate.

Important: This condition does not affect the performance or driveability of the vehicle, and is temporary; only lasting until all the moisture has vaporized.

Engineering is aware of the concern and is working on a resolution. Once a solution is available, this PI will be updated.
