# Service Bulletin

Bulletin No.: P1255A

**Subject:** Changing Outside Rearview Mirrors

**Models:** 2014 Chevrolet Silverado 1500  
2015 Chevrolet Silverado 2500  
2014 GMC Sierra 1500  
2015 GMC Sierra 2500  
Equipped with RPOs DL3, DL8, DE2, DPN, DF2

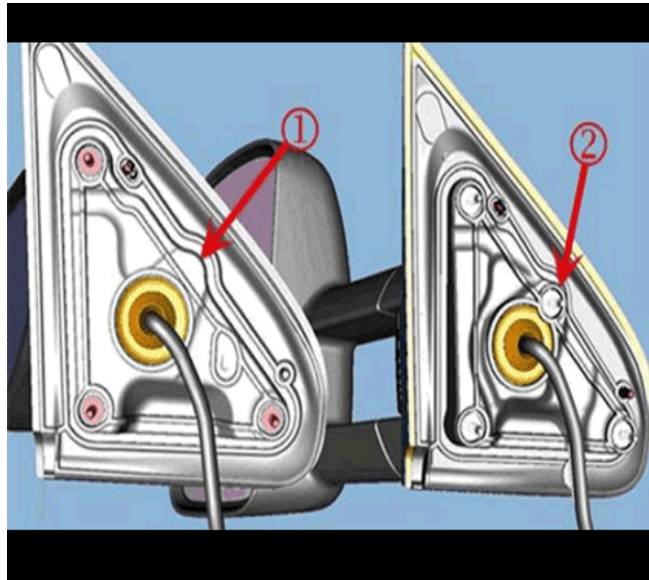
3802187

\*\*Due to content differences, some vehicles may require the drivers and passengers door harnesses to be replaced. To determine if the door harness needs to be replaced, inspect connector X510 (Pins 5 and 13) and connector X610 (pins 5 and 13). If the cavities are empty, the door harnesses MUST be replaced.

1. Remove the front side door trim. Refer to Front Side Door Trim Replacement in SI.
2. Remove the front side door window garnish molding. Refer to Front Side Door Window Garnish Molding Replacement in SI.
3. Remove the outside rearview mirror nuts, disconnect electrical and remove the mirror.
4. If necessary, drill out the fourth hole (see chart above).
5. Install the new mirror, mirror nuts and connect the electrical.
6. Install new door harness (if necessary).
7. Install the new switch to the bezel.
8. Install the front side door window garnish molding. Refer to Front Side Door Window Garnish Molding Replacement in SI.
9. Install the front side door trim. Refer to Front Side Door Trim Replacement in SI.
