Service Bulletin

Bulletin No.: PI1264

Subject: Accessory Fog Lamp Kit Inoperative

Models: 2014-2015 Chevrolet Equinox
Equipped with RPO SSD

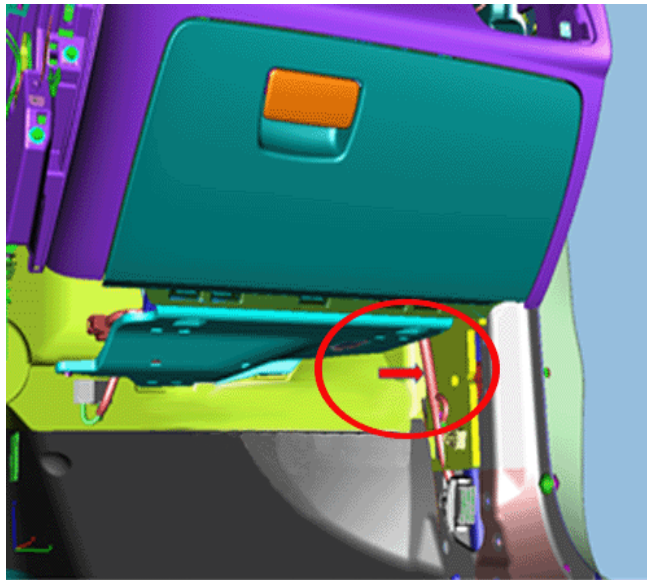
3942259

2.1. Visually inspect the I/P Harness part number tag on the Harness per below (I/P harness part number tag located between ground 207 and body inline connector):

- 2014 MY Harness Part Numbers # 23164353; 23164354 and 23181681 requires an added circuit.
- 2015 MY Harness Part Numbers # 23235768; 23235769 and 23235770 requires an added circuit.

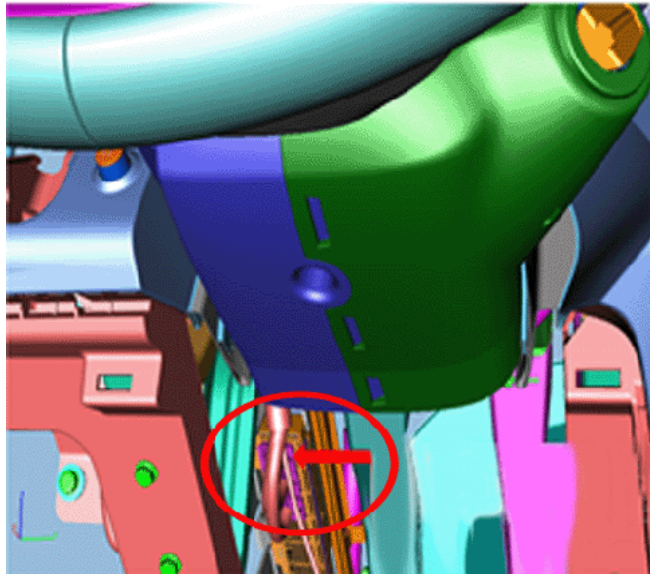
3942260

2.2. Visually inspect the I/P Harness BCM Connector 19151262 Cavity 14.

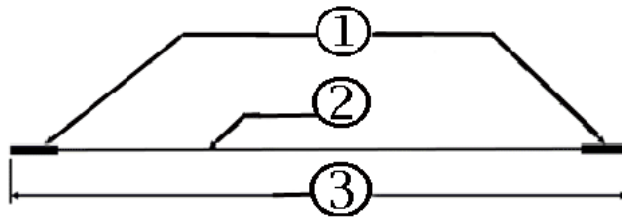
3942263

- (1) JST Terminal: SNAC3-A031T-M0.64. Crimp and solder terminal to wire
- (2) 0.80 (18 ga) TXL
- (3) 1000.0 mm (39.4 in)

-
3. If circuit 192 is missing, create the above circuit.
- Wire size can be from 0.35 to recommended 0.80.
 - Wire insulation type can be TWP or recommended TXL.
