Service Bulletin

Bulletin No.: PI1312

Subject: A/C Compressor and A/C Pipe Assembly Changes

Models: 2015 Chevrolet Equinox (Built Prior to VIN Breakpoint F6126358)
2015 GMC Terrain (Built Prior to VIN Breakpoint F6127049)
Equipped with 3.6L Engine (RPO LFX)

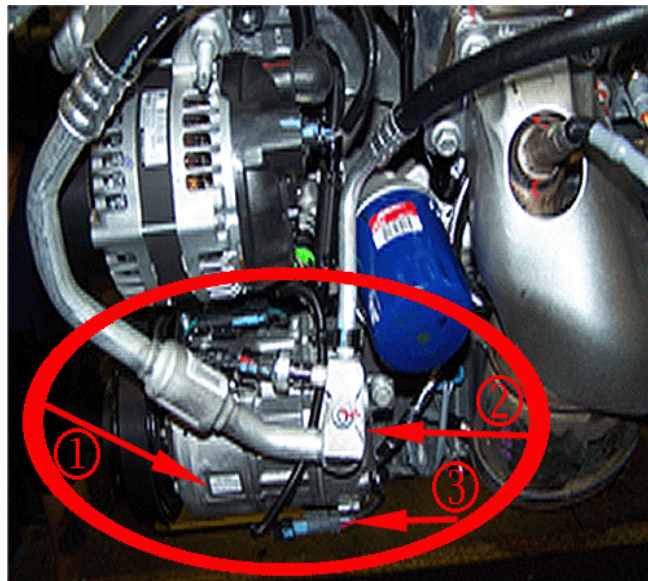
3968746

2010-2014 Model Year A/C Compressor and Pipe Assembly Design

The 2010-2014 A/C compressor and pipe assembly design will have a smaller label on the compressor located near the pulley (1). The location where the A/C pipe housing mounts to the compressor is rectangular (2) and the connector bracket for the compressor harness is horizontal and located on the bottom rear of the compressor (3).

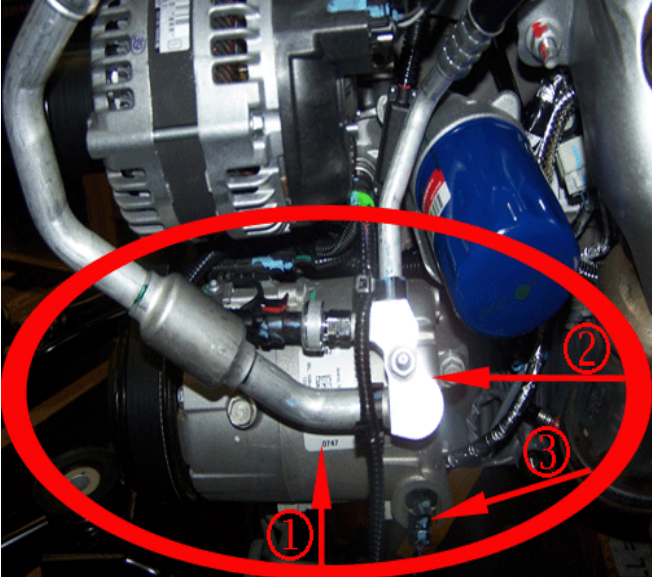
3968758

2015 Model Year A/C Compressor and Pipe Assembly Design Changes

The design changes made for the 2015 model year A/C compressor and pipe assembly consist of a larger label located in the middle of the compressor (1). The A/C pipe housing has a different shape (2) and the connector for the compressor is mounted vertically (3).
