Service Bulletin

Bulletin No.: PIC5779E

Subject: Information On Preparation / Washing To Avoid Damaging Bright Aluminum Moldings

Models: 2014 - 2015 Chevrolet Impala (New Body Style)
2013 - 2015 Cadillac ATS, XTS
2011 - 2015 Chevrolet Cruze
2011 - 2015 Buick Regal
2014 - 2015 Cadillac CTS Sedan VIN A

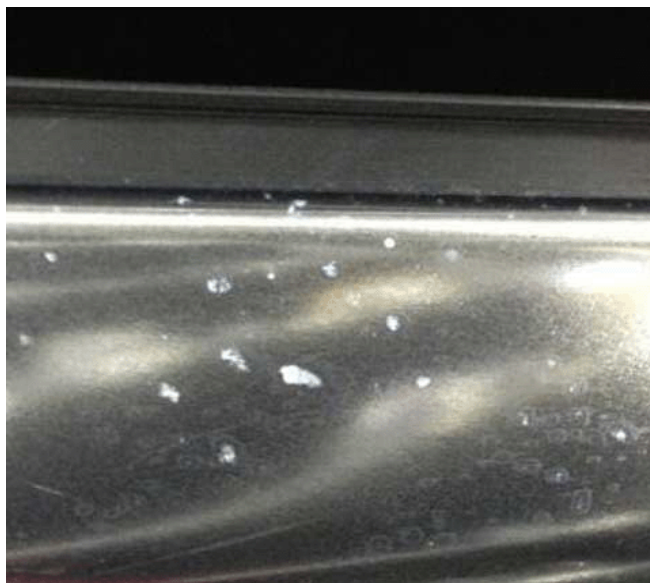
3163627

In order to avoid damage that may not be covered by your warranty, it is recommended that a non-alkaline solution be used for preparation & washing of the Bright Aluminum Moldings.

If a cleaning solution greater than 11.0 pH is used, the following procedure must be used:

- Prewash the vehicle to bring moldings to room temperature.
- Apply cleaning solution out of the sunlight at room temperature.
- Rinse moldings with clean water within 5 minutes of application of cleaning solution.
