Service Bulletin

Bulletin No.: PIC6018

Subject: Windshield Spalling Or Cracks

Models: 2014 Buick Regal

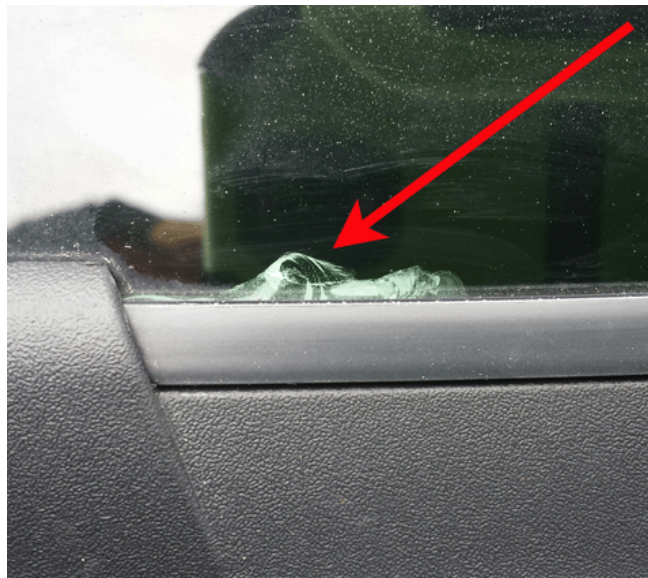
3952466

Windshields may have areas of spalling or cracks that cannot be felt from outside the glass. This concern may affect new unsold units as well as customer owned cars. Reference the attached photo which reflects this condition.

These issues were caused by rigid bonding and it generated from a process issue at the supplier. Inspect the windshield. If spalling or cracks are present and no sign of impact is found, replace the windshield.
