# Service Bulletin

Bulletin No.: PIC6045

**Subject:** Front Seat-Mounted Speaker Buzz

**Models:** 2013 Cadillac XTS  
Equipped with RPO UQS

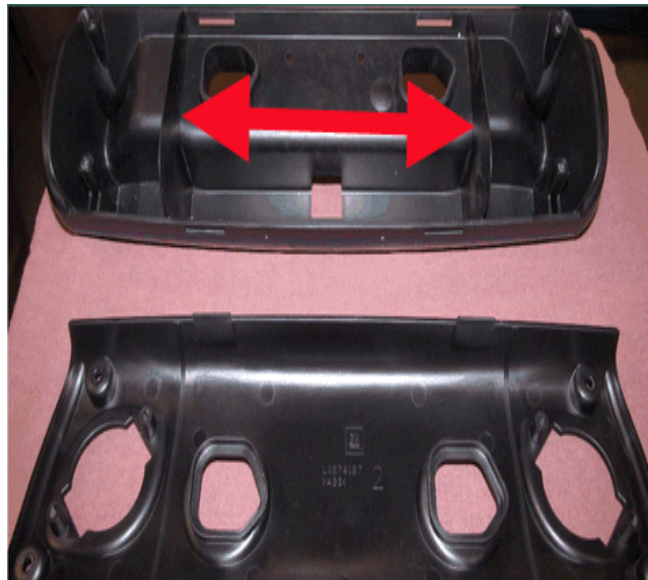
4008911

Some customers may comment that the speakers on top of the seats make a buzz noise. This concern is most likely to be evident on AM or Talk radio.

Verify Service Update 13004 has been performed first, if applicable. If this concern is still present, separate the speaker housing and apply felt tape to the raised section as shown below.
