Service Bulletin

Bulletin No.: PI1331A

Subject: Incorrect Icon for Power Assist Step/Running Board Switch

Models: 2015 Chevrolet Suburban, Tahoe
2015 GMC Yukon Models
Equipped with RPOs BRS, JF4, UFL (EXC JHD)

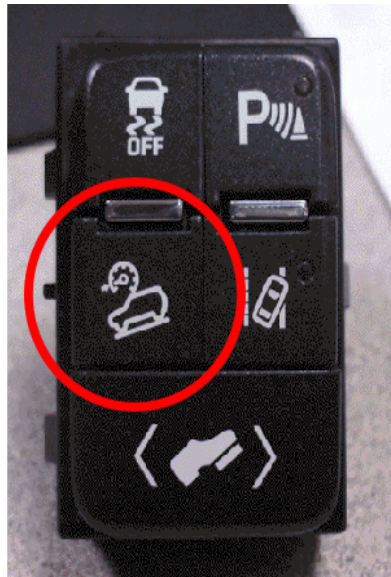
3995324

During PDI Inspection it may be noticed that the multi-switch pod located left of the instrument cluster may be missing the power assist step/running board switch. The typical location for this switch may instead show hill descent control.

Some vehicles may have been built with the correct switch part number but produced with the wrong icon for the power assist step/running board button as shown below.

(1) Incorrect Icon

If identified as having an incorrect icon, technicians should replace the switch pod using the part number listed below. Refer to Vehicle Stability Control System Switch Replacement in SI.

| Part Number | Description |
|---|---|
| 22827588 | SWITCH ASM-VEH STABILITY CONT SYS |

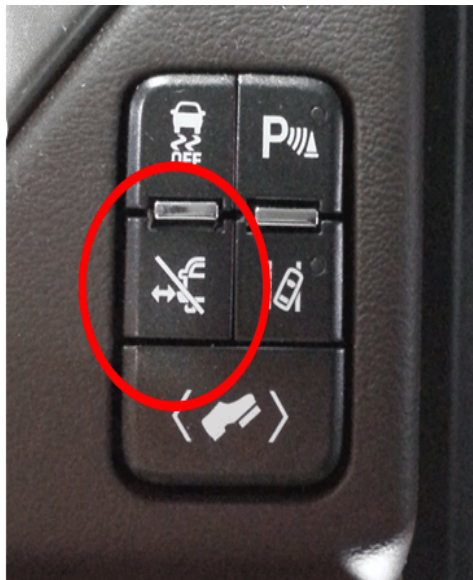
3995325

(2) Correct Icon
