## SERVICE BULLETIN

**APPLICABILITY:** 2012-13MY Impreza and XV Crosstrek Models

**NUMBER:** 12-165-14

**SUBJECT:** Premature Wear of Front Seat Fabric

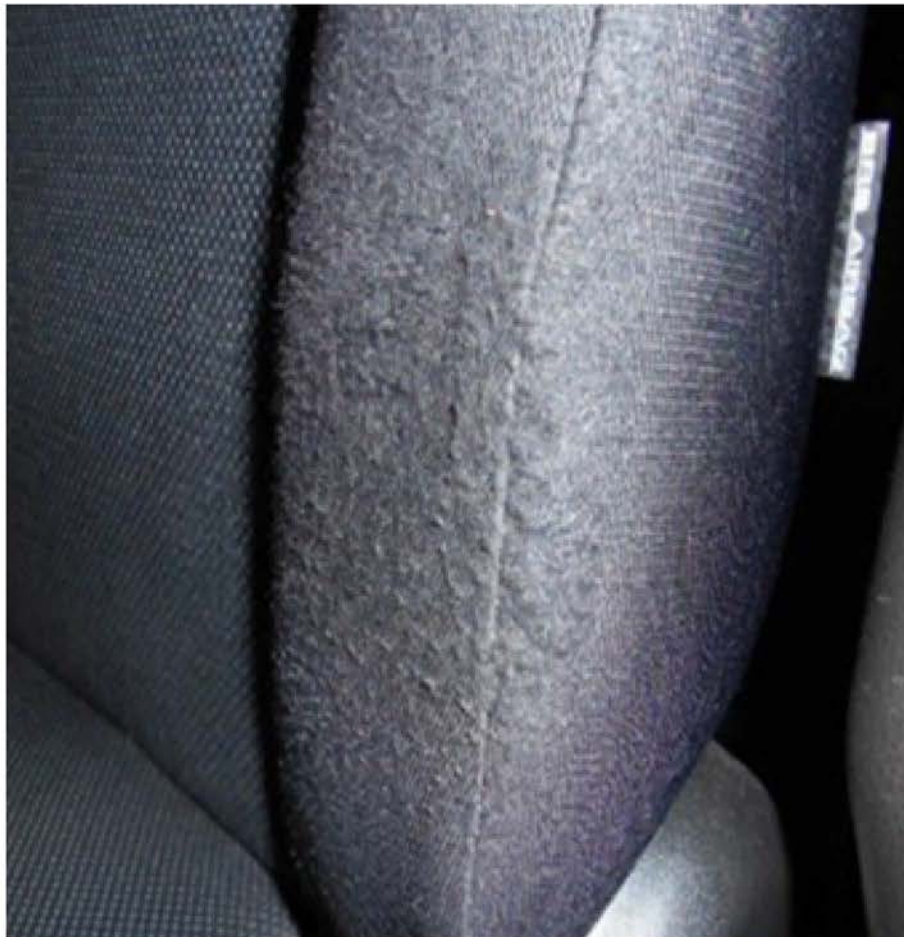
This bulletin announces the availability of revised front seat upholstery for both the seat cushion and backrest made with a revised fabric material which will provide increased durability and prevent pilling or fuzzing of the side bolster areas as shown in the example photo below. These new materials have increased abrasion resistance along with a resin coating on the fabric's backing to prevent thread pull-out.

The new seat cover fabric materials were incorporated at the start of 2014MY production.

When replacing the seat cover(s), follow the procedure outlined in the applicable Service Manual.

**NOTE:** When repairing the passenger seat, the re-zeroing (calibration) procedure for the Occupant Detection System (ODS) must also be completed before releasing the vehicle.
