Service Bulletin

SUBJECT: Service Update for Inventory Vehicles Only
Passenger Side Front Air Bag Replacement
Expires October 31, 2015

MODELS: 2014 Cadillac Escalade
2014 Chevrolet Suburban, Tahoe
2014 GMC Yukon, Yukon XL

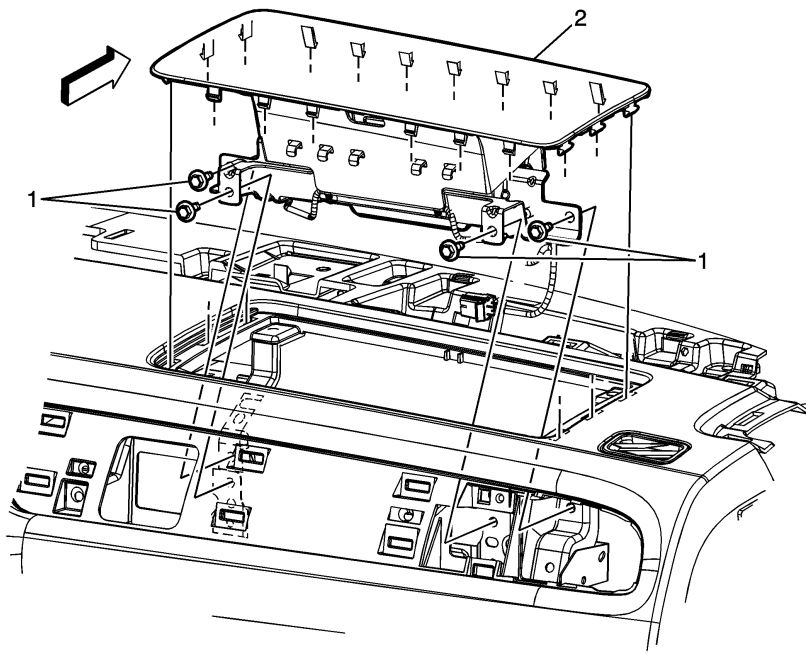
1692831

This bulletin provides a service procedure to replace the passenger side front air bag on certain 2014 model year Cadillac Escalade; Chevrolet Suburban, Tahoe; and GMC Yukon, Yukon XL vehicles. These vehicles may have a condition in which the passenger side front air bag will not function as designed due to an electrical connector not being properly engaged. This condition may set diagnostic trouble code (DTC) B0020 – Passenger Frontal Deployment Loop Stage 2 Resistance Above Threshold. If this occurs, the Sensing and Diagnostic Module (SDM) will request the instrument cluster to illuminate the air bag malfunction indicator lamp. If a crash event occurs the SDM will attempt air bag deployment, but, if the mating terminals do not make contact, the secondary stage of the passenger side front air bag will not deploy, increasing the risk of injury to the occupant.

1. Remove the passenger side airbag module. Refer to *Airbag Instrument Panel Module* in SI.
2. Install a new passenger side airbag module. Refer to *Airbag Instrument Panel Module* in SI.
