HFL Microphone Concern? *Don't* Replace the Front Individual Map Light Assembly

2015 CR-V (EX and above)

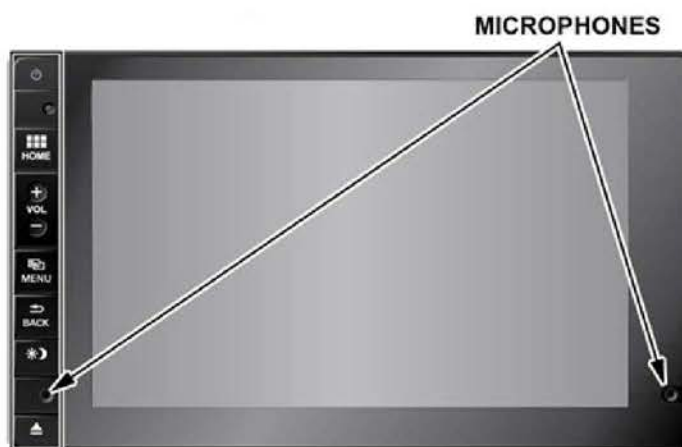
Starting with the 2015 CR-V (EX and above), the *Bluetooth*® HandsFreeLink® (HFL) and HFL microphone are built into audio unit/audio-navigation unit. There's no longer a separate HFL control unit in the shift lever panel or HFL microphone in the front individual map light assembly.

Keep this in mind if you're troubleshooting the HFL for a microphone concern. Replacing the front individual map light assembly **won't** fix anything since there's no microphone in this part!
