**April 24, 2015**

40918-01887 Version 10

**Safety Recall: Driver's Airbag Inflator Can Be Over-Pressurized**Supersedes 08-093, dated April 14, 2014, to revise the information highlighted in **yellow****AFFECTED VEHICLES**

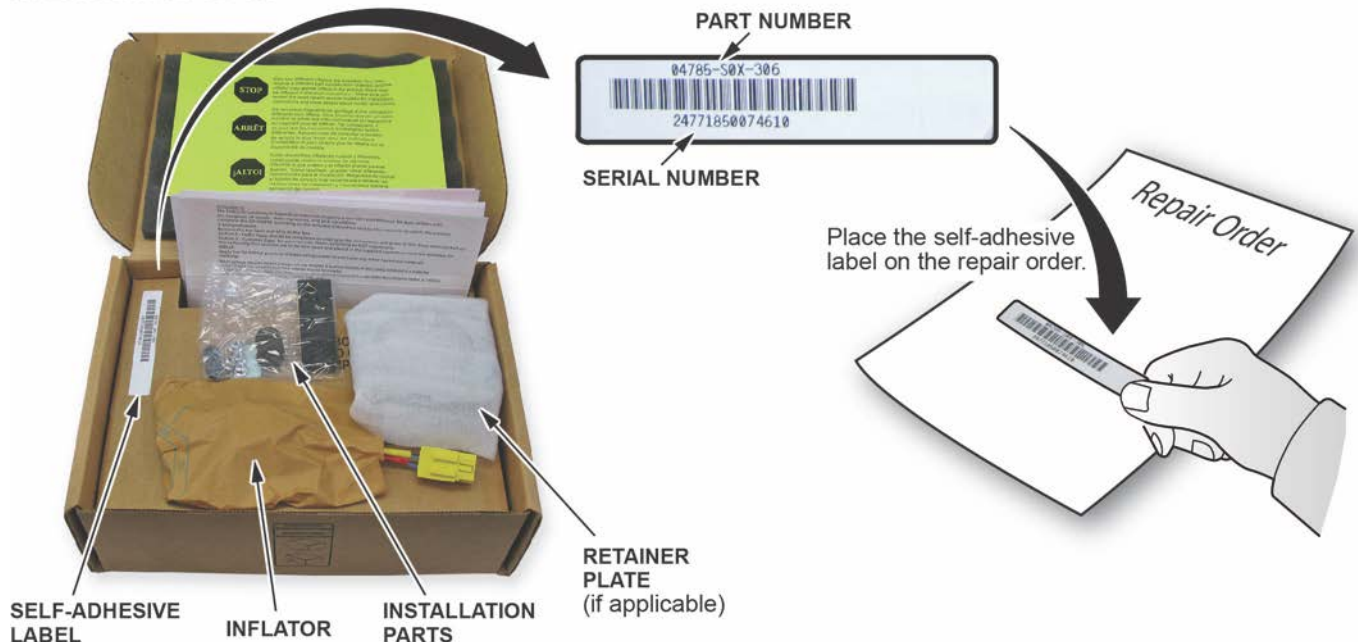
### INFLATOR PARTS BOX

- The replacement part number is printed on the top part of the label and the serial number is printed on the bottom. **Make sure you attach the label to the R.O. and give it to the warranty clerk.**
- There may also be a colored sticker located in the kit, ignore it because it is not used.
- Not all inflator kits have a label included. In those cases, write the serial number and part number from the side of the inflator box on the R.O. The part number always starts with 047.

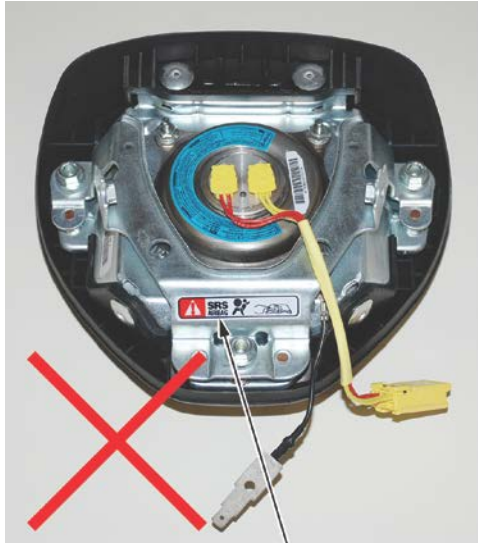
NON-STANDARD  
SAFETY LABEL

3. Place the airbag, face down, on a clean shop towel.
4. Visually inspect the airbag and the inflator for any unusual writing or markings.
  - If there is nothing unusual about the airbag or the inflator, go to step 5.
  - If there are any unusual markings, like an incorrect label or a model year written in marker, the airbag and inflator may not be the correct airbag and/or inflator for the vehicle or it may be a counterfeit part. For more information about counterfeit airbags, you can refer to [safercar.gov](http://safercar.gov), enter keywords **MANAGING COUNTERFEIT**, and select **Recommended Dealer Guidance for Managing Counterfeit Air Bags** from the list. **If you suspect that the airbag or inflator is counterfeit, do not continue this procedure.** Contact your DPSM for assistance.

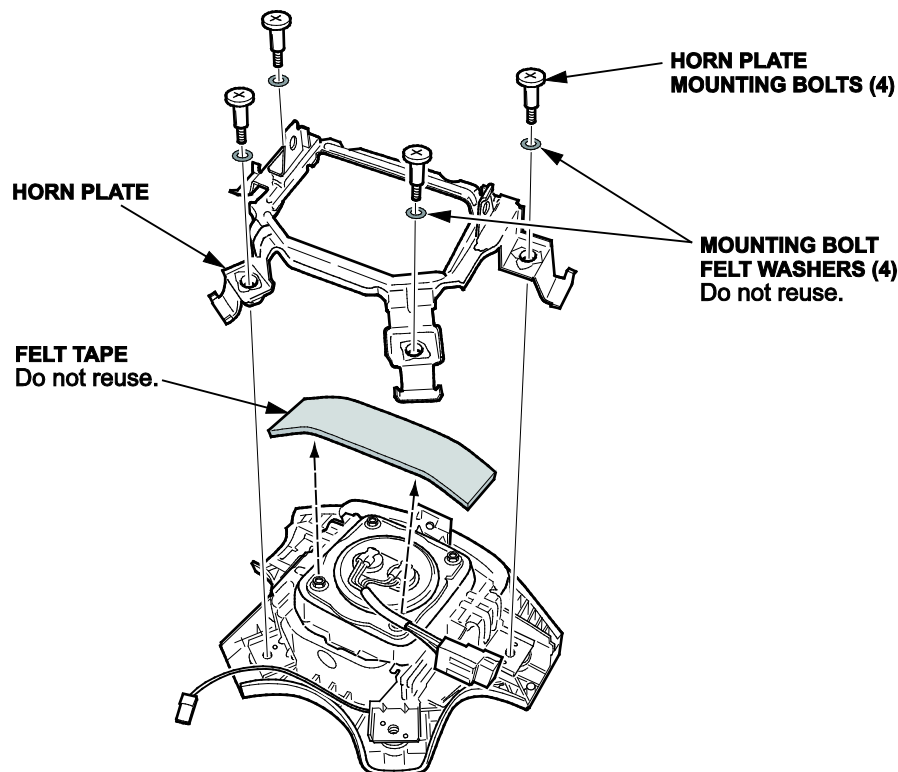
5. Remove the four horn plate mounting bolts, the mounting bolt felt washers, and the horn plate. The felt washers will not be reused.

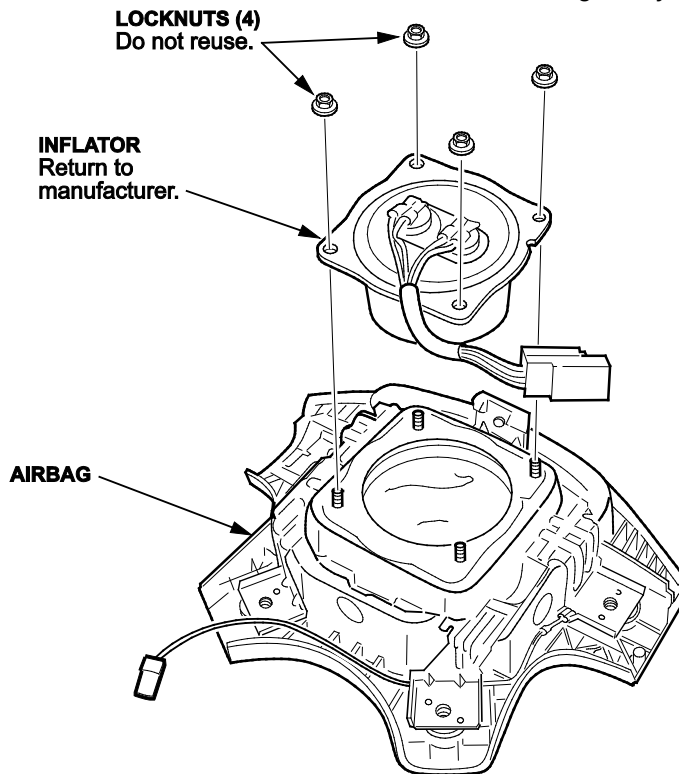
6. Remove and discard the felt tape covering the lower two inflator locknuts.
7. Using needle-nose vise grips or a 3/8 in. 6-point socket, remove the four locknuts from the inflator. The locknuts will not be reused.

NOTE: Do not remove the inflator from the airbag until you complete step 8.

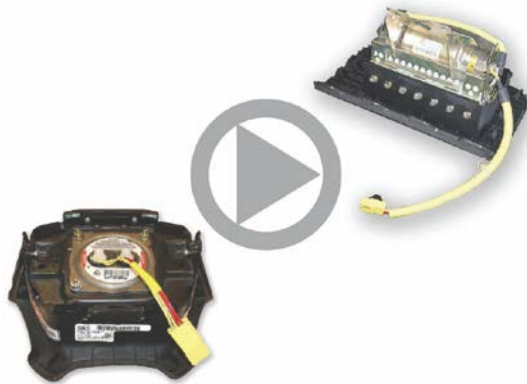
Click on the image below for a short video about the different variations of the driver's and front passenger's replacement inflators involved with the recalls related to Takata inflators. While both the driver's and front passenger's inflators are shown in the video, this is informational only. Replace inflators only as directed by the iN VIN status inquiry.

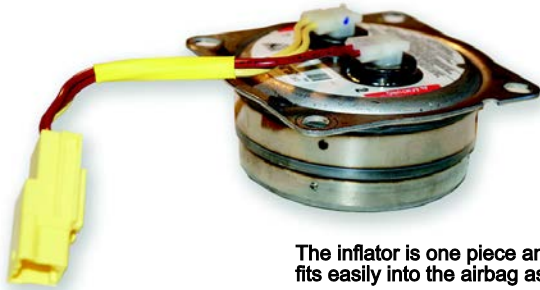
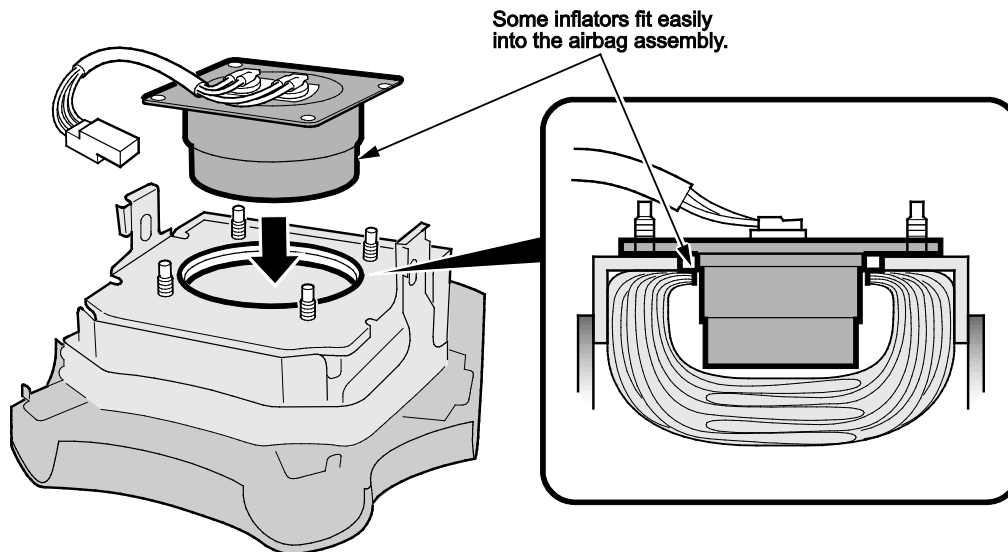
04770-S5A-305

The inflator is one piece and fits easily into the airbag assembly.

- Insert the inflator into the opening.

NOTE: Make sure the inflator wires are positioned toward the bottom of the airbag. If you install the inflator incorrectly, you may not be able to reconnect the SRS airbag harness.

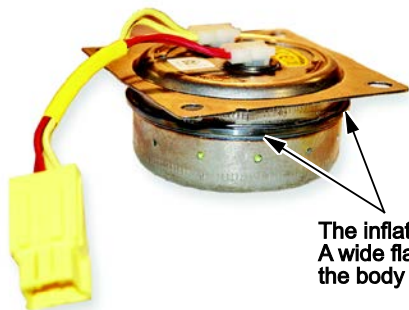
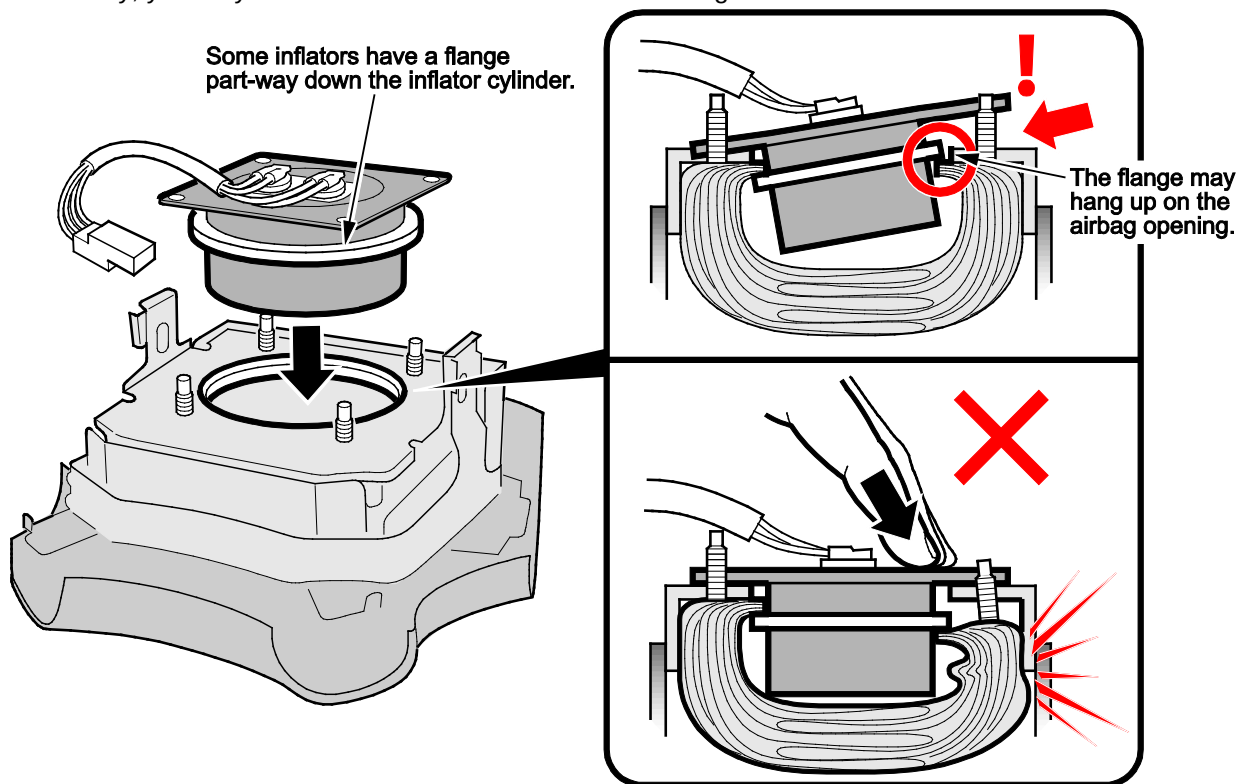
04770-S5A-405

The inflator is one piece.  
A wide flange is halfway up  
the body of the inflator.

- Insert the airbag inflator into the opening. Do not force it into the airbag module.

NOTE: Make sure the inflator wires are positioned toward the bottom of the airbag. If you install the inflator incorrectly, you may not be able to reconnect the SRS airbag harness.

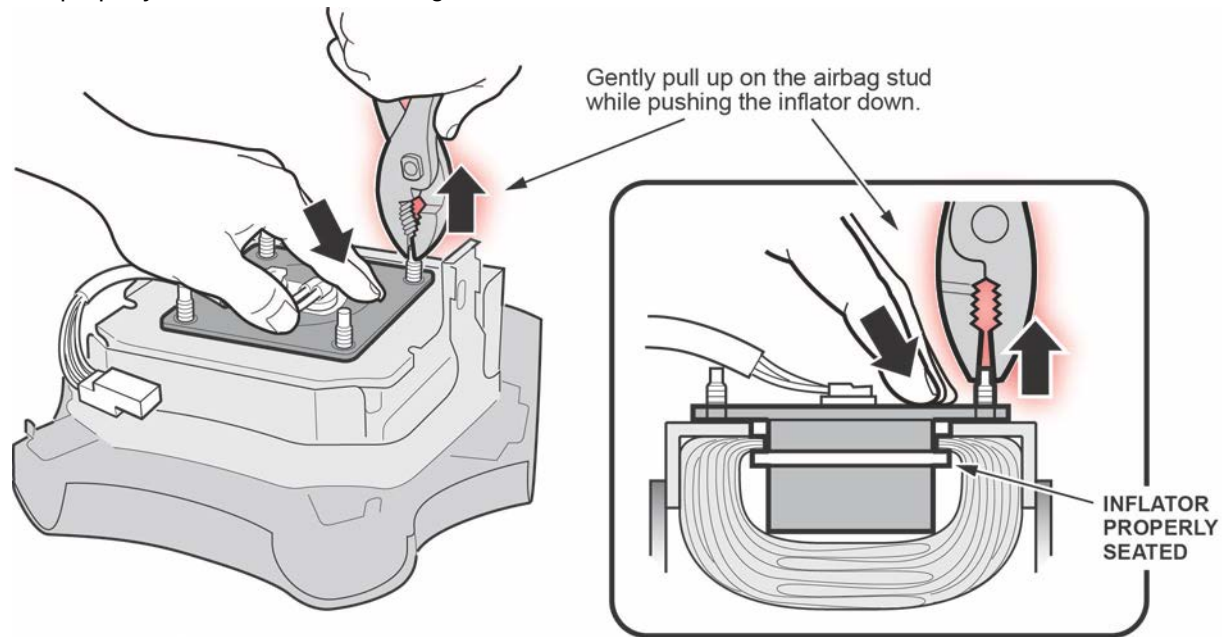
- Using a pair of pliers, gently pull up on each stud up while pushing the inflator module down until the airbag is properly seated within the airbag module.

11. Install and torque the new locknuts to **3.9 N·m (2.8 lb-ft, 34 lb-in)**.
12. Cover the lower two inflator locknuts with new felt tape.
13. Reinstall the horn plate with new felt washers on its mounting bolts. Torque the mounting bolts to **3.9 N·m (2.5 lb-ft, 30 lb-in)**, then make sure the horn plate moves freely.
14. Reinstall the driver's airbag using new Torx bolts. Torque the bolts to **9.8 N·m (7.2 lb-ft)**.
15. Give your warranty clerk the R.O. that includes the inflator serial number and replacement part number. For the warranty claim to be paid, the **replacement inflator part number** must be on the warranty claim and your warranty clerk must enter the serial number in the Diagnostic Trouble Codes field.

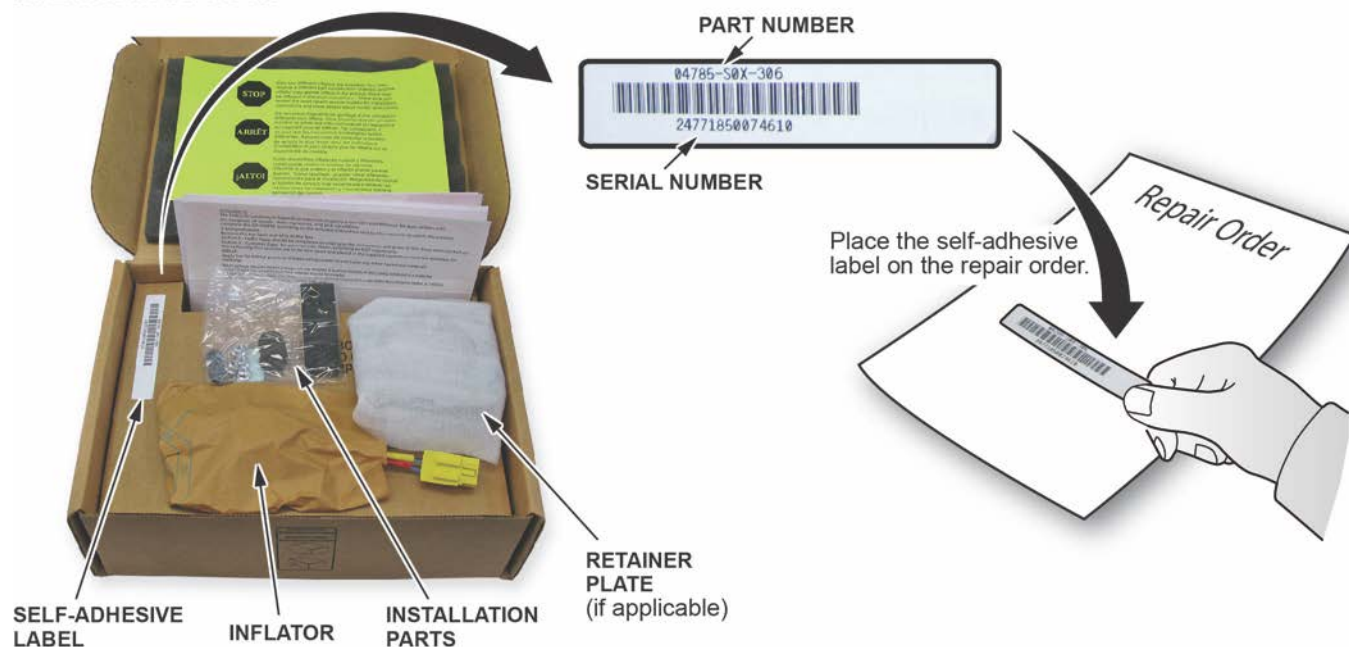
### INFLATOR PARTS BOX

- The replacement part number is printed on the top part of the label and the serial number is printed on the bottom. **Make sure you attach the label to the R.O. and give it to the warranty clerk.**
- There may also be a colored sticker located in the kit, ignore it because it is not used.
- Not all inflator kits have a label included. In those cases, write the serial number and part number from the side of the inflator box on the R.O. The part number always starts with 047.

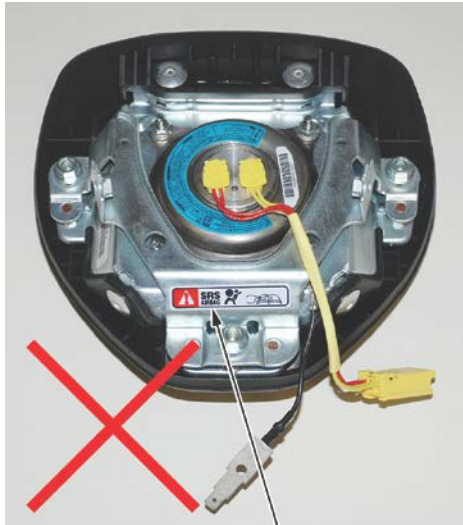
NON-STANDARD  
SAFETY LABEL

4. Visually inspect the airbag and the inflator for any unusual writing or markings.
  - If there is nothing unusual about the airbag or the inflator, go to step 5.
  - If there are any unusual markings, like an incorrect label or a model year written in marker, the airbag and inflator may not be the correct airbag and/or inflator for the vehicle or it may be a counterfeit part. For more information about counterfeit airbags, you can refer to [safercar.gov](http://safercar.gov), enter keywords **MANAGING COUNTERFEIT**, and select **Recommended Dealer Guidance for Managing Counterfeit Air Bags** from the list. **If you suspect that the airbag or inflator is counterfeit, do not continue this procedure.** Contact your DPSM for assistance.

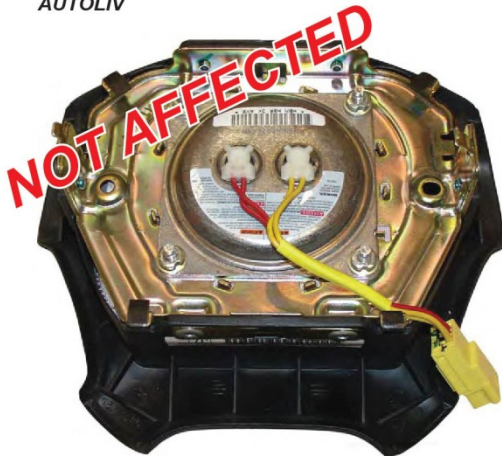
AUTOLIV

5. **Civic only** - Determine if the airbag is made by Autoliv or Takata by comparing the inflators to those in the images below.

NOTE: The Autoliv serial number label is different from the Takata label; the Autoliv has 11 characters, the Takata has 9.

- If the airbag is made by Autoliv, the airbag is OK. Reinstall the airbag using new Torx bolts. Torque the bolts to **9.8 N·m (7.2 lb·ft)**. If you already received a replacement inflator, return the unopened kit to American Honda.
- If the airbag is made by Takata, go to step 6.

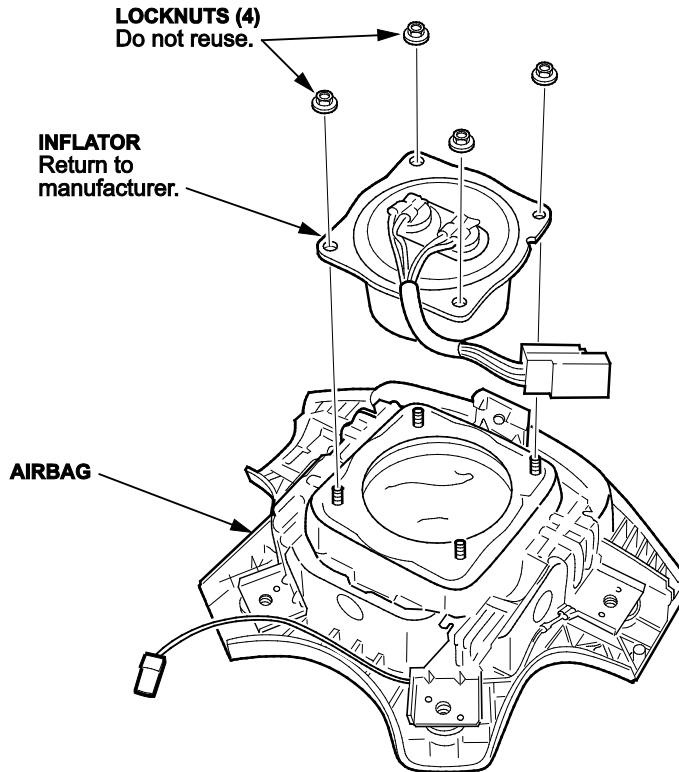
6. Using needle-nose vise grips or a 3/8 in. 6-point socket, remove the four locknuts from the inflator. The locknuts will not be reused.

NOTE: Do not remove the inflator from the airbag until you complete step 7.

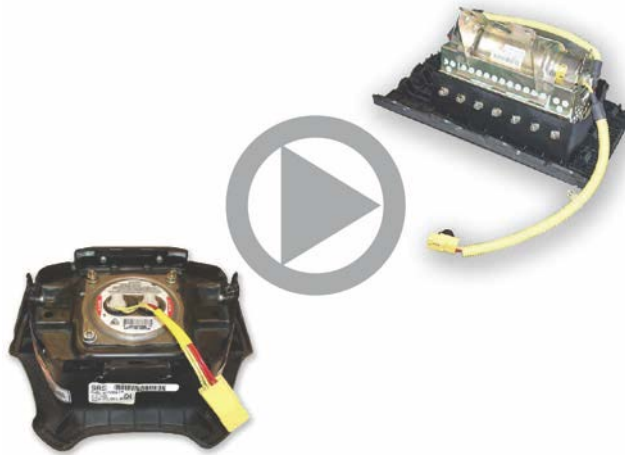
NOTE: There may be some minor surface rust or corrosion on the new inflator; this is OK.  
Click on the image below for a short video about the different inflators.

9. Install the new inflator in the airbag.

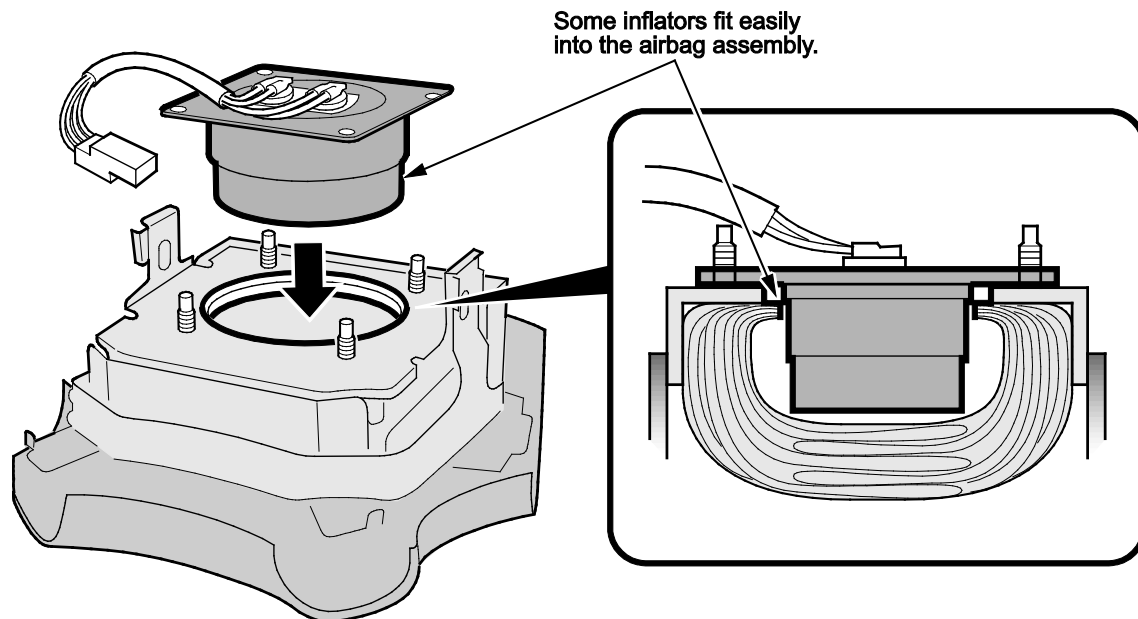
- Insert the inflator into the opening.

NOTE: Make sure the inflator wires are positioned toward the bottom of the airbag. If you install the inflator incorrectly, you may not be able to reconnect the SRS airbag harness.

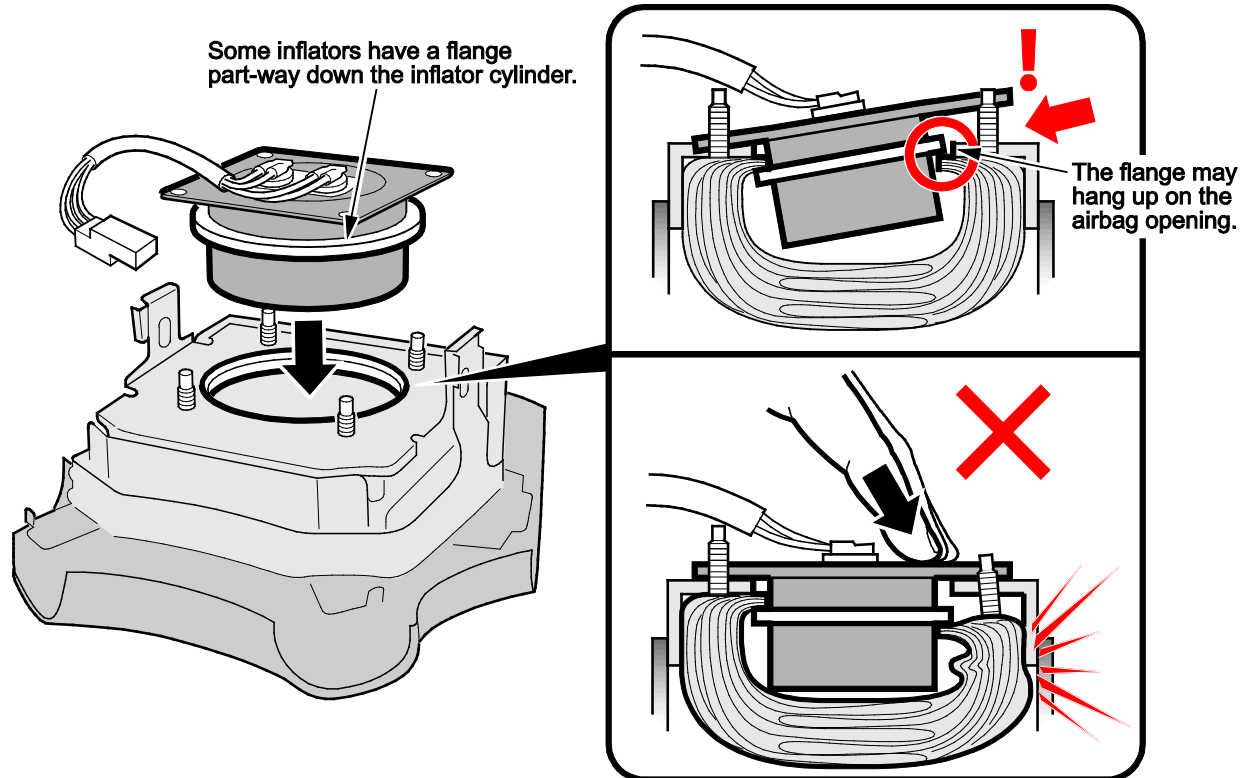
- Insert the airbag inflator into the opening. Do not force it into the airbag module.

NOTE: Make sure the inflator wires are positioned toward the bottom of the airbag. If you install the inflator incorrectly, you may not be able to reconnect the SRS airbag harness.

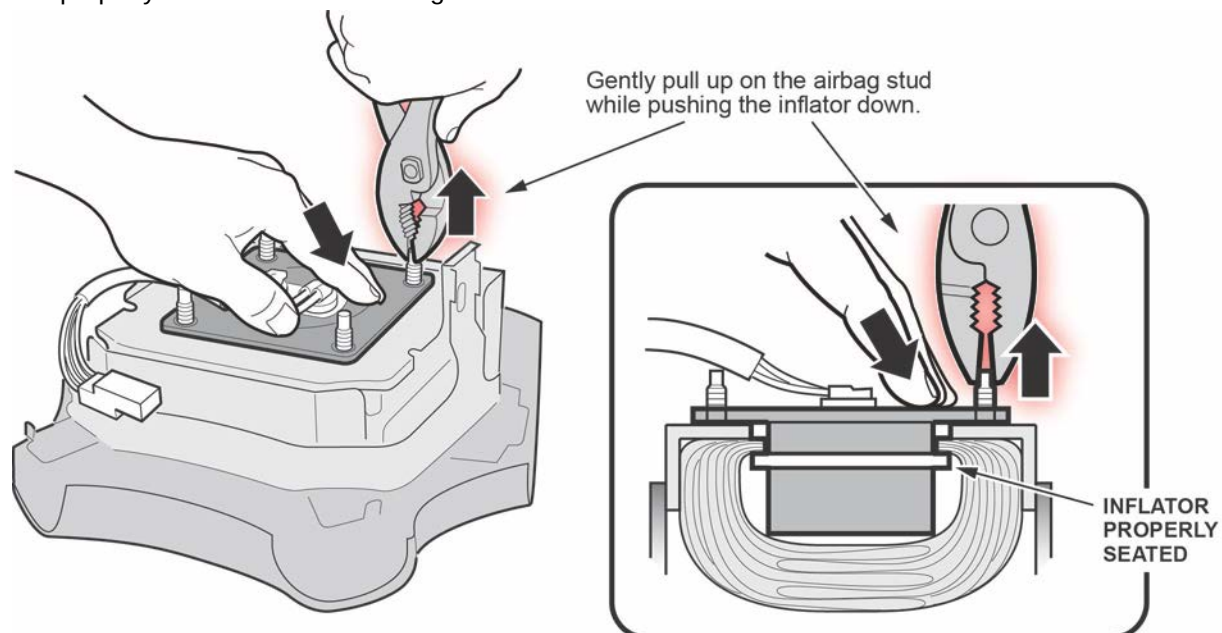
- Using a pair of pliers, gently pull up on each stud up while pushing the inflator module down until the airbag is properly seated within the airbag module.

10. Install and torque the new locknuts to **3.9 N·m (2.8 lb-ft, 34 lb-in)**.
11. Reinstall the driver's airbag using new Torx bolts. Torque the bolts to **9.8 N·m (7.2 lb-ft)**.
12. Give your warranty clerk the R.O. that includes the inflator serial number and replacement part number. For the warranty claim to be paid, the **replacement inflator part number** must be on the warranty claim and your warranty clerk must enter the serial number in the Diagnostic Trouble Codes field.

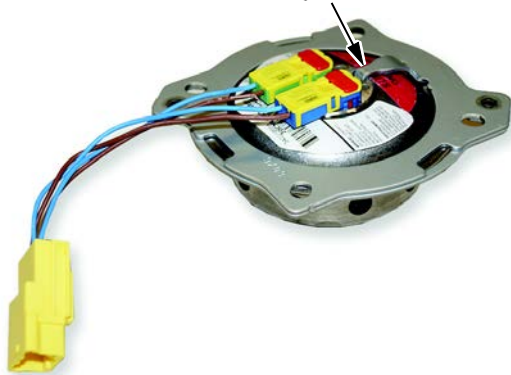
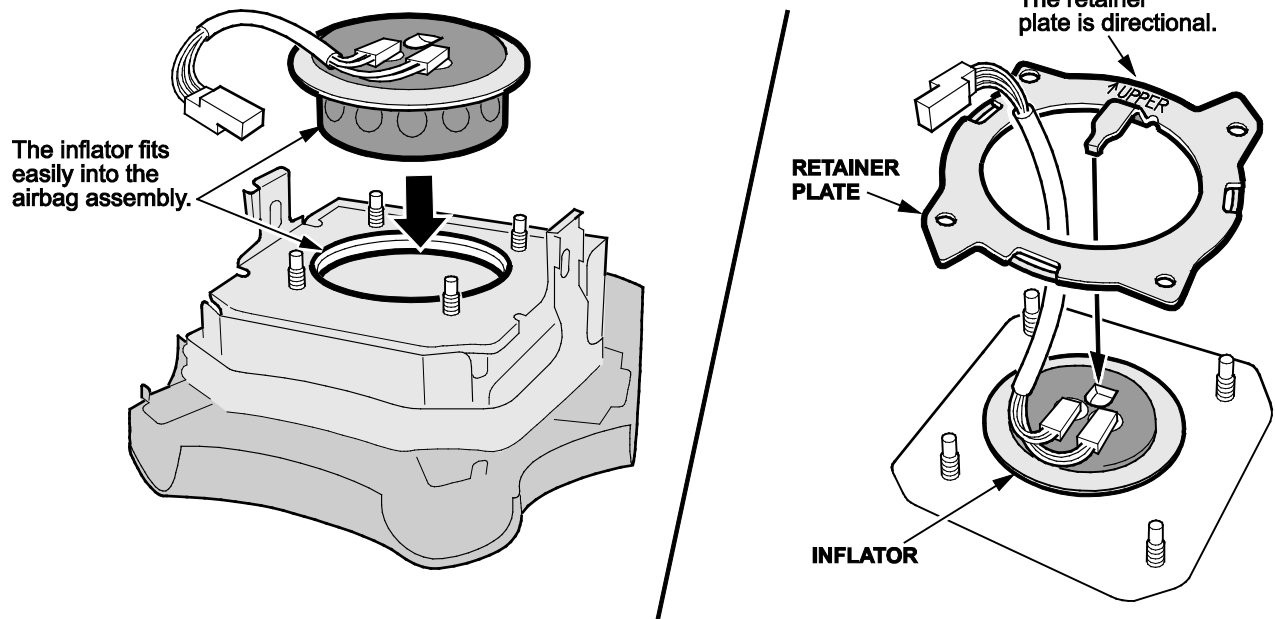
04770-S5A-408 Refer to **Driver's Inflator Type 3** in the video.

The inflator is held down by a directional retainer that is keyed to the inflator.

- Place the inflator into the opening with the inflator harness toward the bottom of the airbag.

- Install the bracket onto the studs. Make sure the locator tab fits into the locator hole as shown.

**NOTE:** Make sure the harness comes out through the center opening. Do not install the bracket over the harness wires.

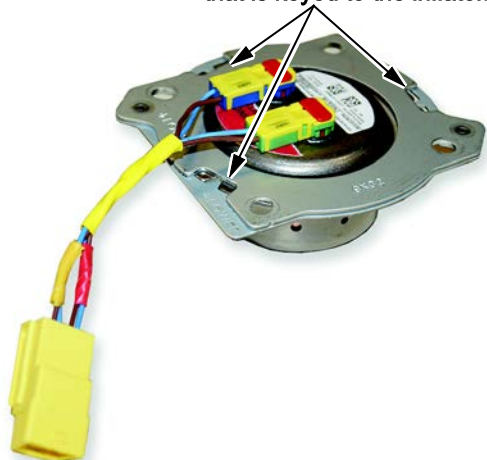
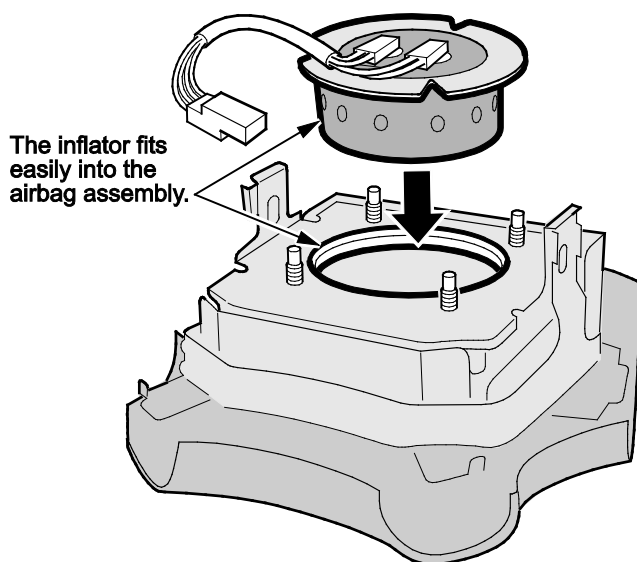
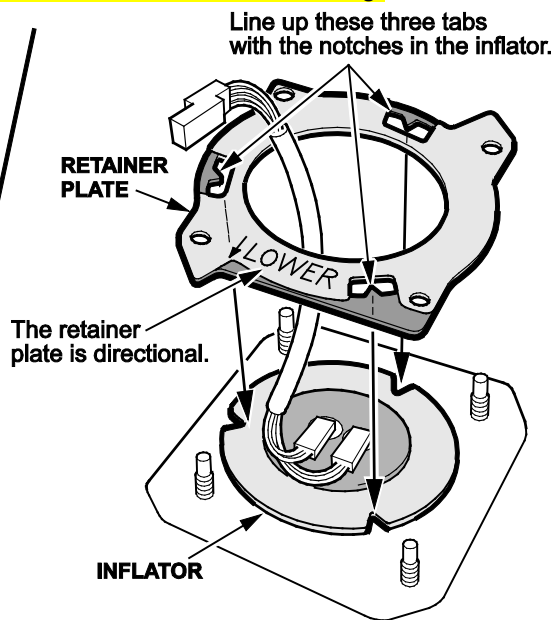
04770-S9A-409

The inflator is held down by a directional retainer that is keyed to the inflator.

- Place the inflator into the opening with the inflator harness toward the bottom of the airbag.

- Install the bracket onto the studs with the stamp **LOWER** at the bottom of the airbag.
- Make sure the three tabs and notches are properly aligned.

- The tabs and notches are designed to align in one direction only. If the tabs and notches are not aligned, the inflator and bracket are not installed correctly.
- Make sure the harness comes out through the center opening. Do not install the bracket over the harness wires.
