49387-01804 Version 6

## **Safety Recall: Front Passenger's Airbag Inflator Can Be Over-Pressurized**

**Supersedes 13-034, dated December 11, 2014, to revise the information highlighted in yellow**

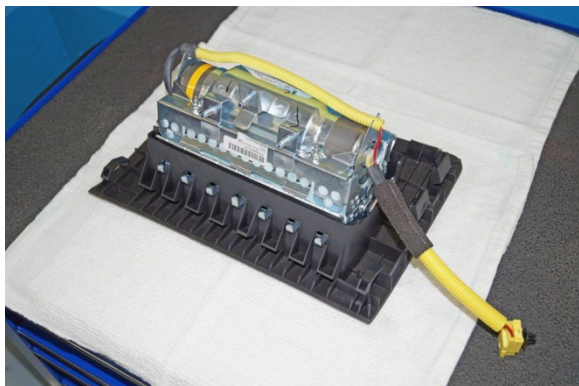
- The orientation of the airbag is critical because if the inflator is installed incorrectly, the harness will be too short when you reinstall the airbag.
- The brackets between the various models are similar but may differ from the example shown.

2. Remove the front passenger's airbag.
3. Place the airbag, face-down, on a clean shop towel.

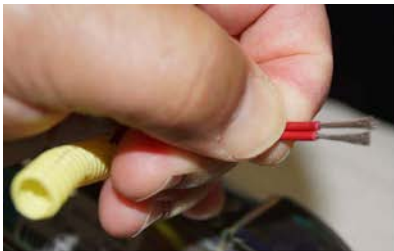
- Strip away about 1 inch of the wire insulation, then twist the wires together.

- Tape the twisted ends with electrical tape.

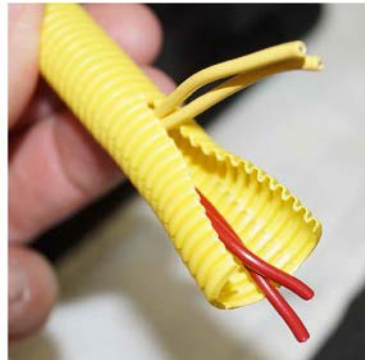
- Cut about 2 inches of the corrugated tube, then pull out the yellow wires.

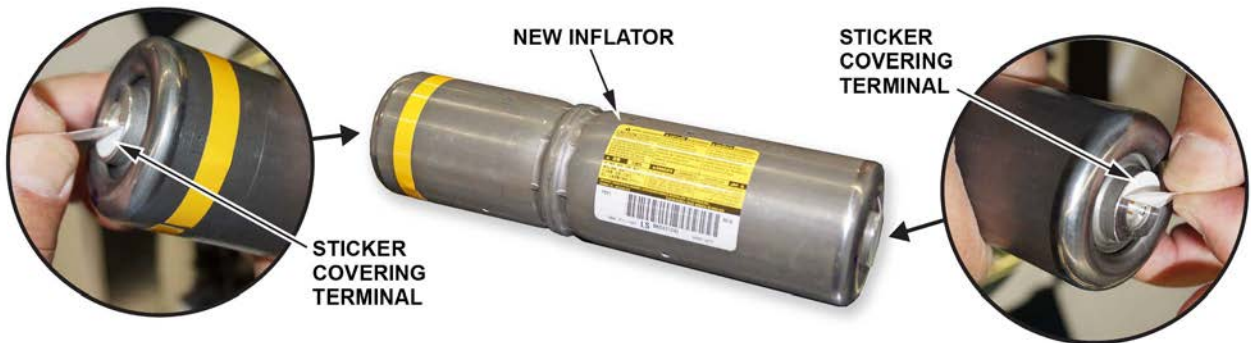
13. Remove the stickers covering the terminals on both sides of the new inflator.
